Quartermaster Buildings: Records and Plans

Bolling Smith

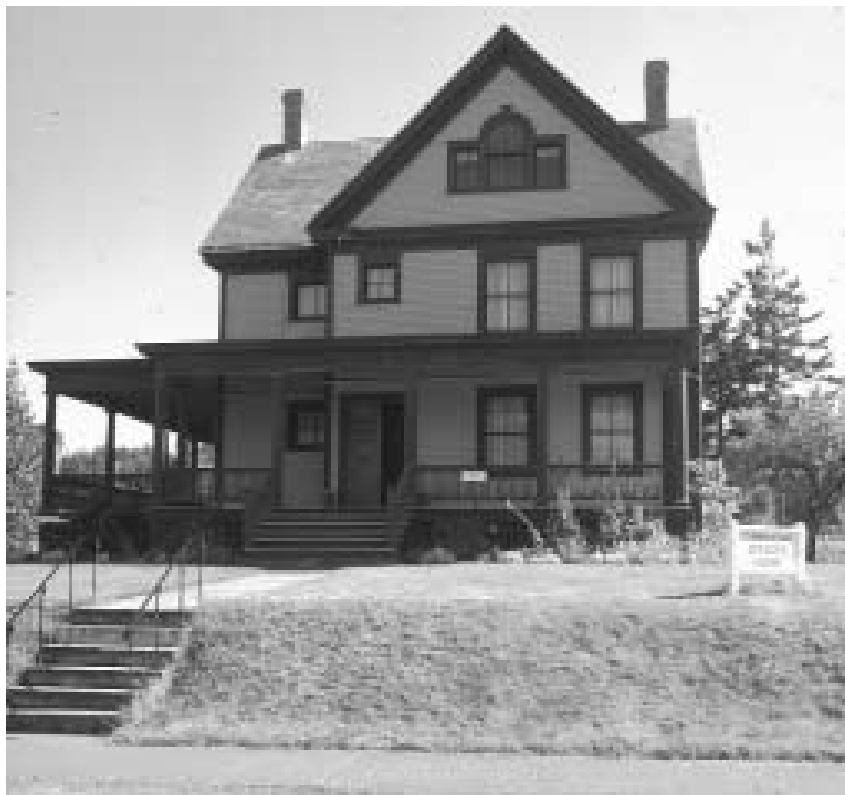
Figure 1.

Quarters, which included barracks and houses for officers and NCOs, along with the buildings that most closely represented the service, such as administration buildings, guardhouses, post exchanges, and theaters, tended to be attractive buildings. Built in a number of styles at different posts, they were intended to create an atmosphere of attractive order. The surviving quarters at Fort Worden, WA, are excellent examples of this sense of style and appearance of class. Figure 1 shows a modern view of the commanding officer’s quarters at Fort Worden, WA. Figure 2 is a copy of the Form 117 for this building, while Figure 3 is an enlargement of the photo on this form.

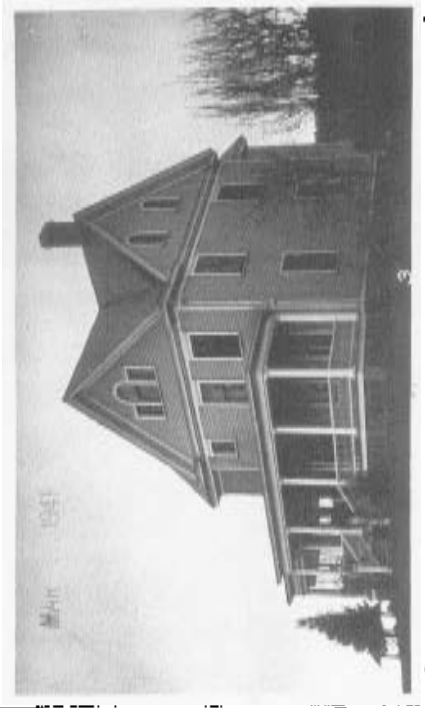
Figure 2.

Place Fort Corbett, Washington
 Designation of building Field Officer Quarters Capacity 1 Enlist. Off.
 Date completed April 15, 1904
 Total no. of floors 2
 Materials: Walls Stone
 Roof Shale
 Total floor area above basement, square feet 2,110 Basement 1,100
 Size: Main building 17' x 53' Wings None Height of first floor above ground 4'
 Foundation Block
Oil burner Automatic Oil Burner
 Stairs None Low lighted Electricity
Automatic Oil Water Heater Water connections Yes
 Gas connections Yes
 REFRIGERATORS INSTALLED None
 COOKING RANGES INSTALLED None
 Meters installed:
 Gas None
 Electric 21-46 115VAC-60 220
 Water None
 Sewer None

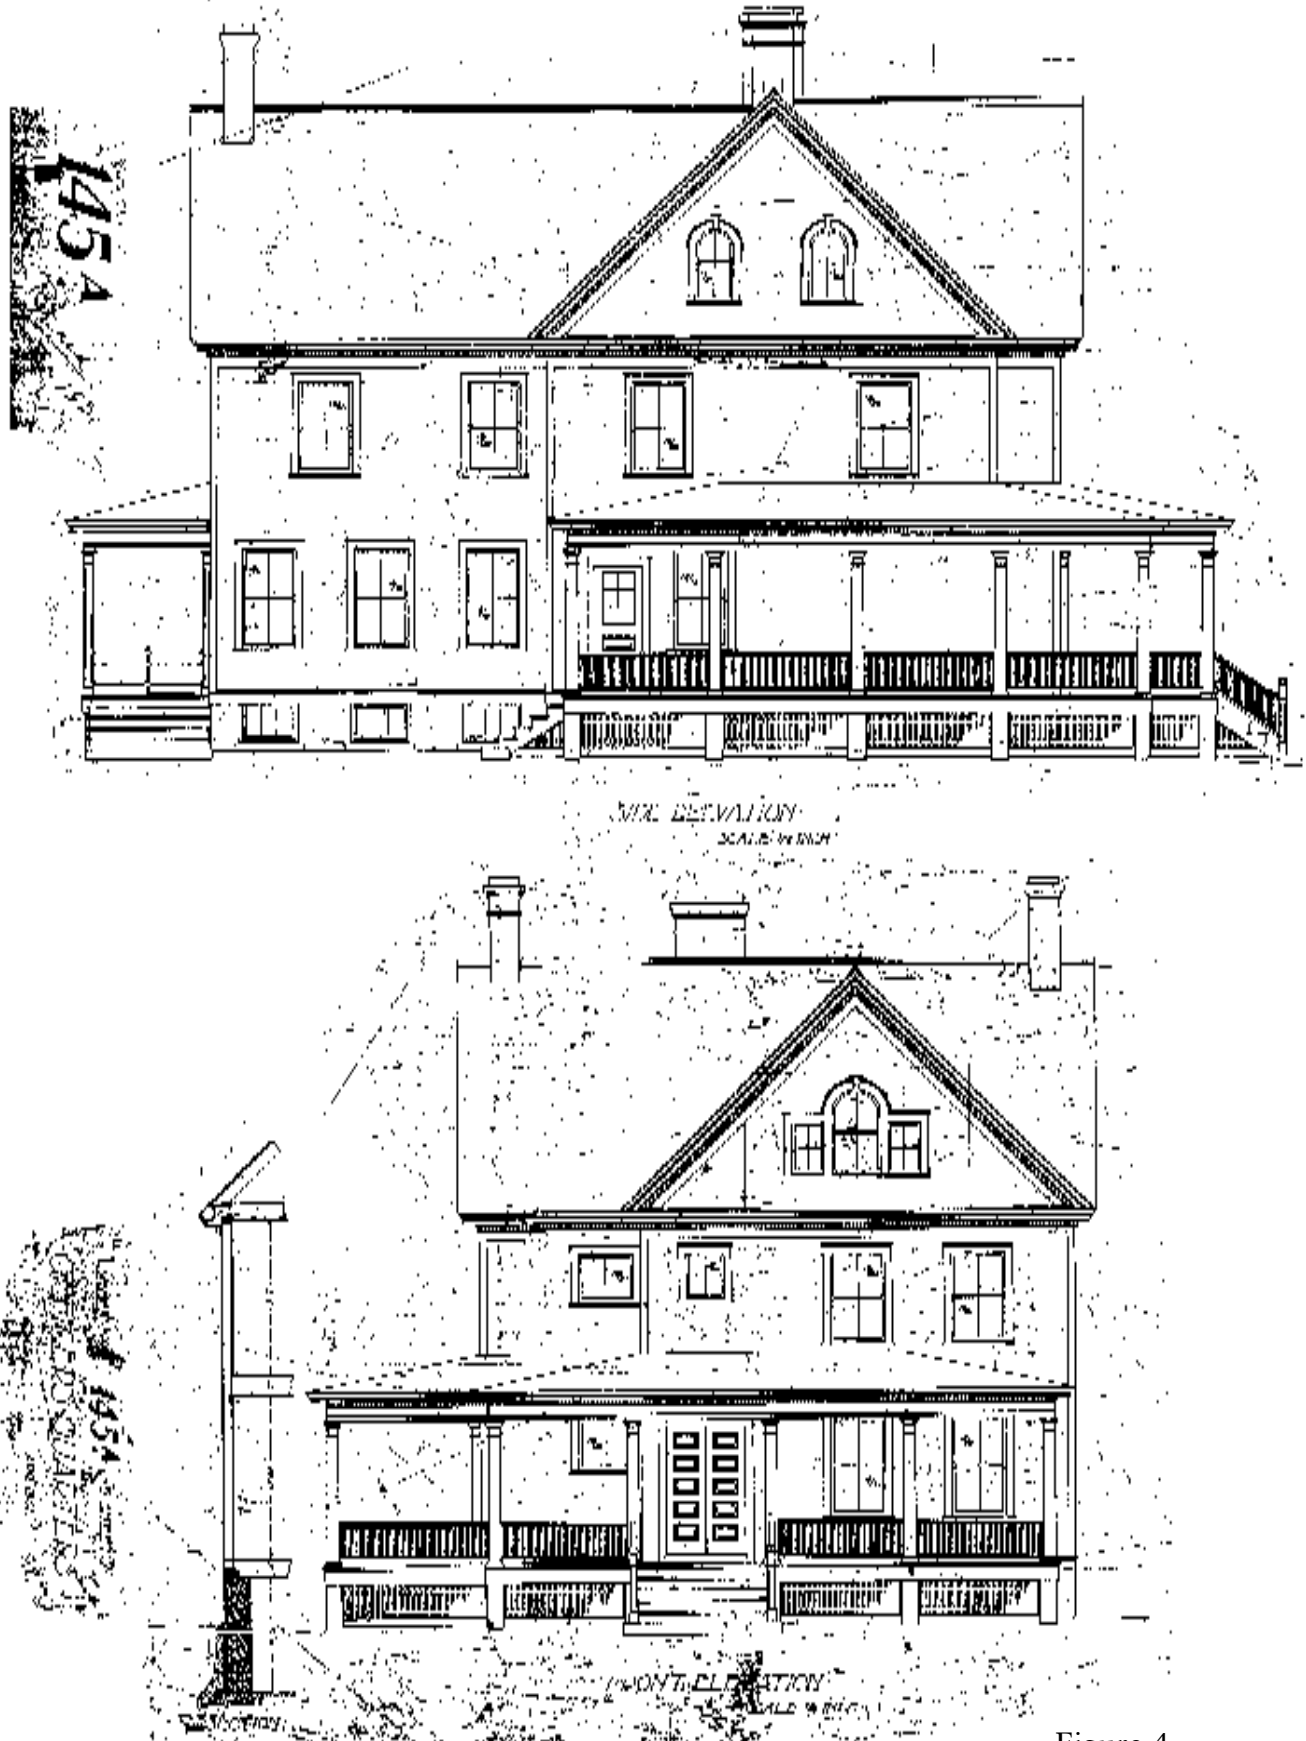
Figure 4.

Figures 4 through 11 show Standard Plans No. 145 A, which were used for the commanding officer's quarters at Fort Worden.

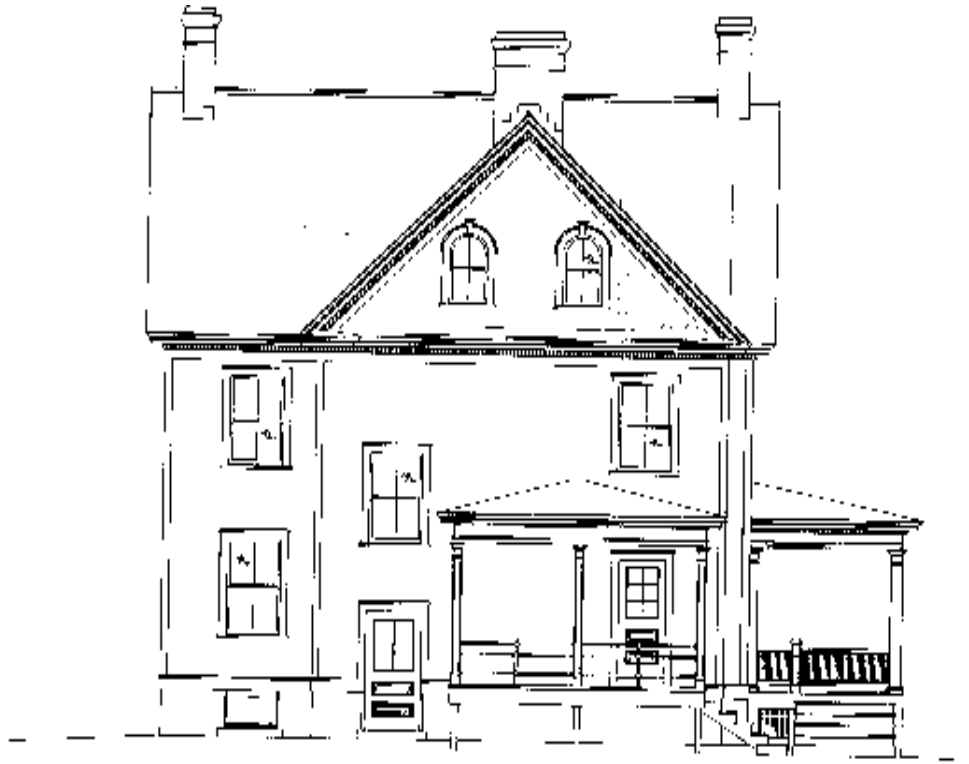
REAR ELEVATION
SCALE 1/4" = 1'-0"

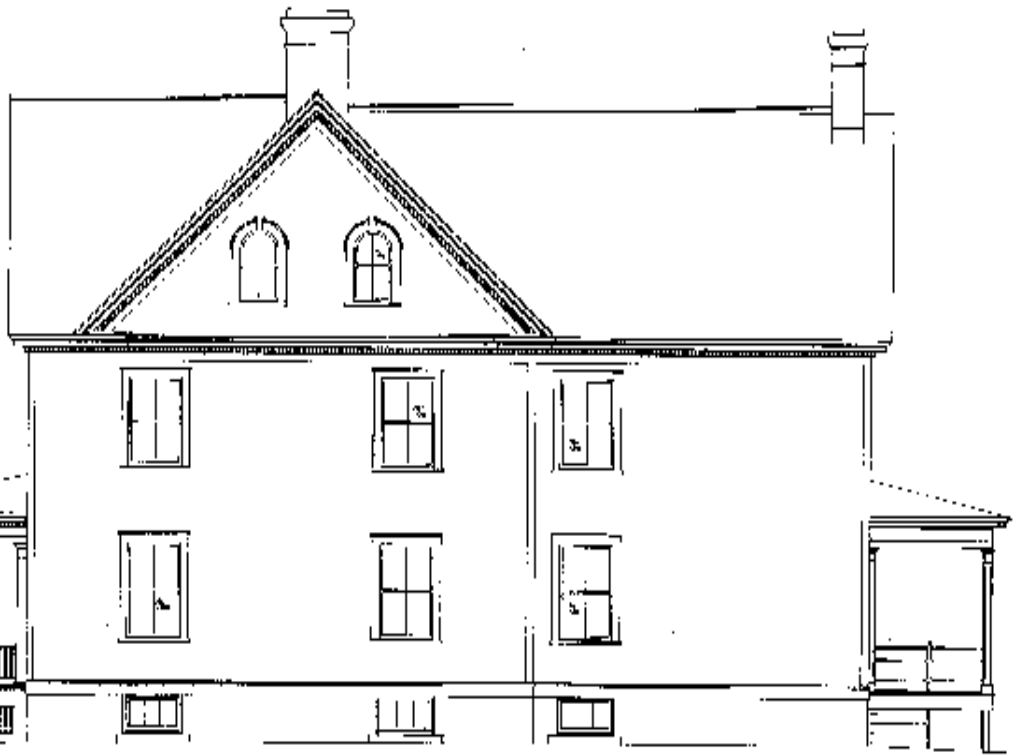
Figure 5.

SIDE ELEVATION
SCALE 1/4" = 1'-0"

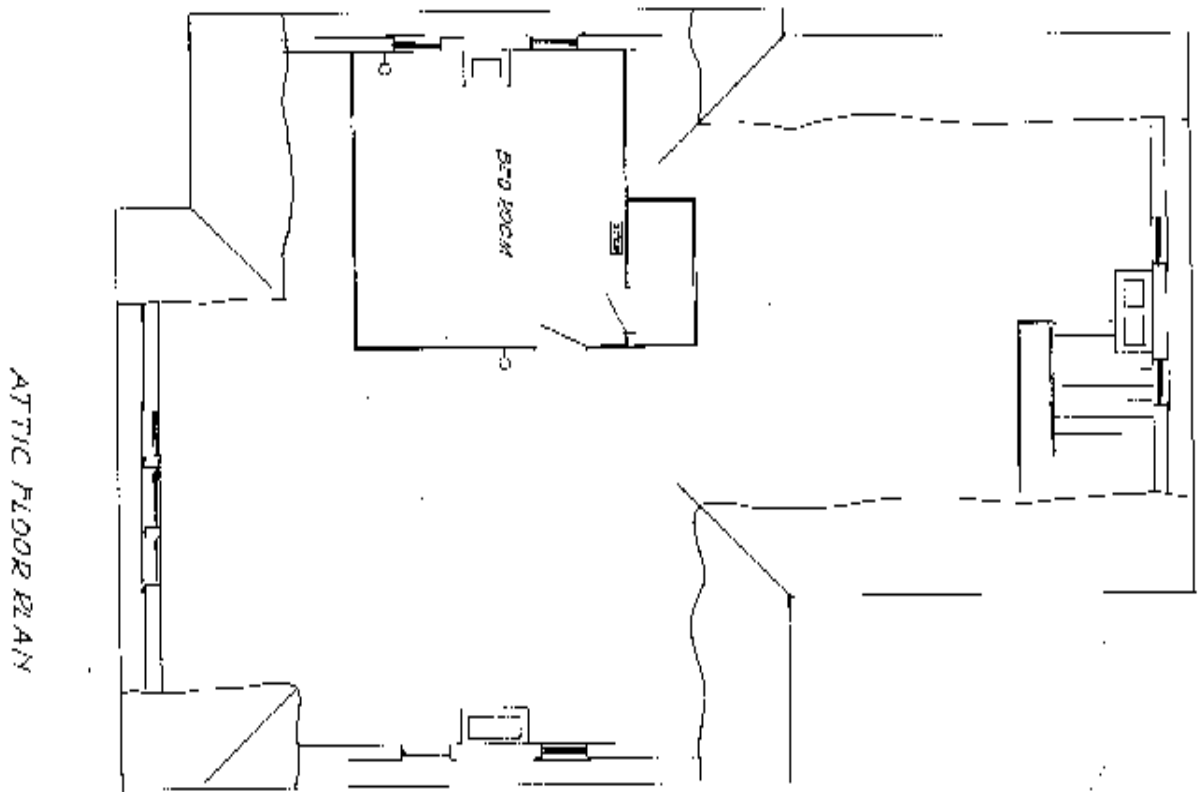
ATTIC FLOOR PLAN

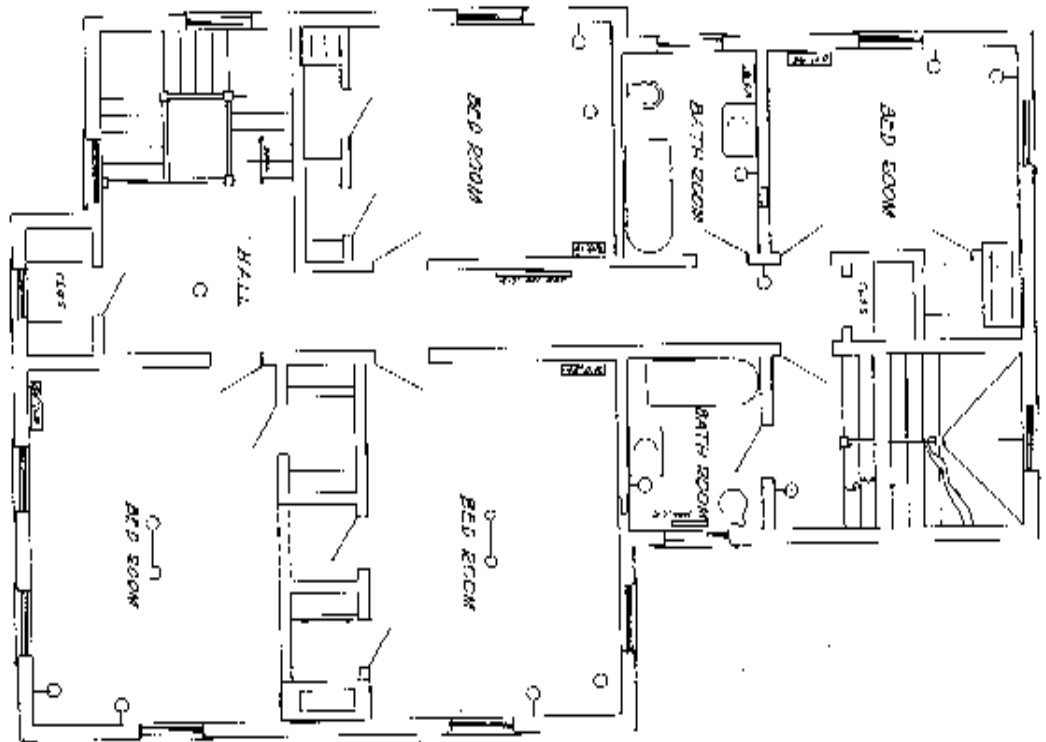
Figure 11.

SECOND STORY PLAN

HOT WATER HEATING 120°
UNDERFLOOR
145A
OFFICERS' QUARTERS
41450
JAN 1917
