## A Brief Visit to Fort Drum, Manila Bay – February 2, 2020

## An Afternoon Visit to Fort Wint, Grande Island, Subic Bay – February 2, 2020

## 2020 CDSG Special Tour to Corregidor

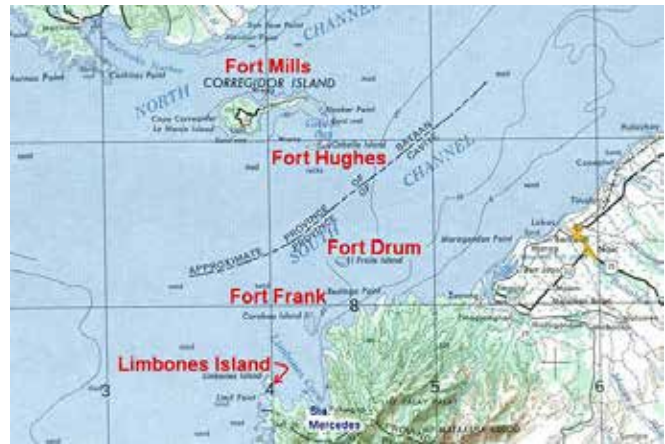
We first visited the upper deck of the fort where the two 14-inch turrets are the dominant feature. The primary change on these turrets since my last visit was the deterioration of the steel. Advanced rusting has turned the steel very brittle and patches of spalling were evident, resulting in piles of rust on the deck. A very sad development on the upper turret (Battery Wilson) was the collapse of the interior mantel along with the two 14-inch barrels; they are now vertical inside the turret well (all the interior turret decks had been scrapped years ago). The lower turret (Battery Marshall) showed the same rust problems as the upper turret, while the barrels are showing more deterioration as the wire-wound barrels are breaking down. The concrete deck appears to have more rubble and the concrete seems more brittle than during my visit in 2006.

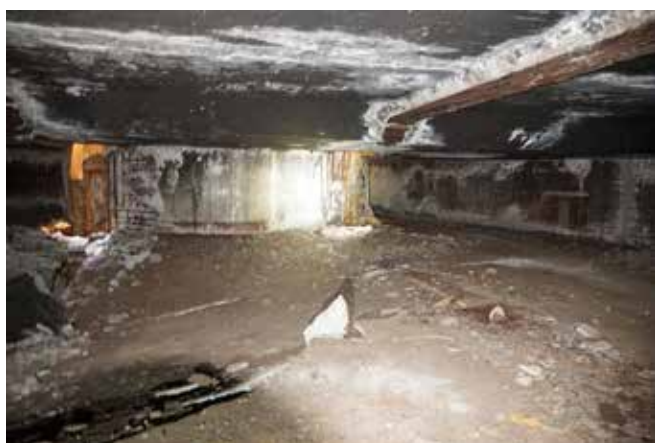
Moving to the large hole in the deck caused by the explosion of Battery McCrea's magazines (two casemated 6-inch guns), we climbed down into the remains of the casemate. The deterioration of the steel is most evident as rust penetrates and corrodes the metal. The two-level casemate now has little steel flooring remaining, with only the heavy steel pieces, such as the armored shields and base sections of the mounts, still intact. Passing through the concrete wall onto the main deck where the barracks area was located, the scene has not changed much, though it felt like the floor has more distortions than before.

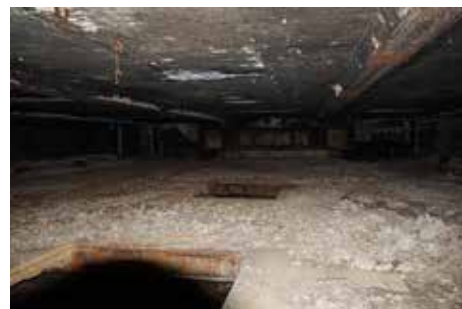
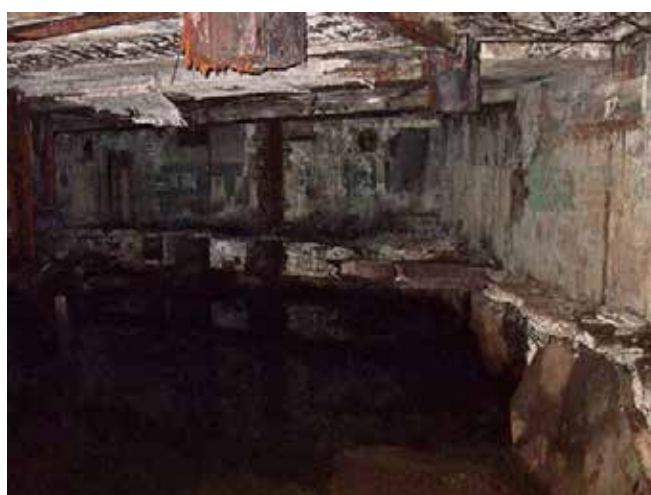
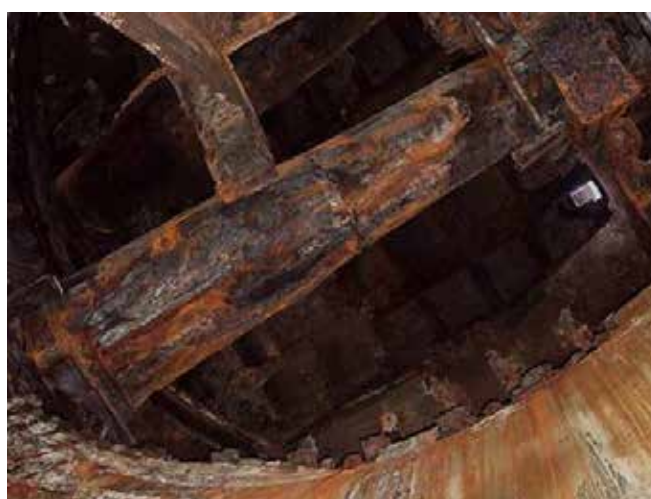
turret well for the forward battery (Battery Marshall) has fallen a bit further onto the magazine deck below, limiting the floor area which you can explore. Walking down to the magazine and mess deck, we were able to look into the engine room, which is still full of water. The lack of strong flashlights limited our view of these spaces. Standing water at the storage tank and engine room deck stopped us from exploring this level.

Returning to the barracks deck, we visited the 6-inch casemate for Battery Roberts. The remaining 6-inch barrel is still lodged in the upper casemate, but the delamination and fragmentation of that barrel is well advanced. The deterioration of both the concrete and steel is apparent from comparing my 2020 photographs to the ones I took in 2006. We did not see any recent scraping of steel at Fort Drum, but the damage from the past has severely

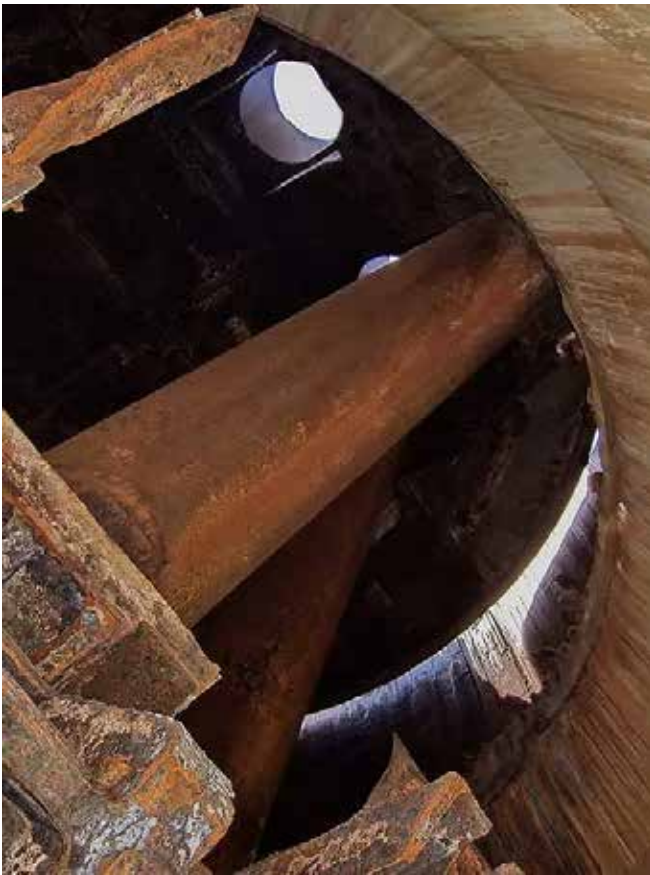
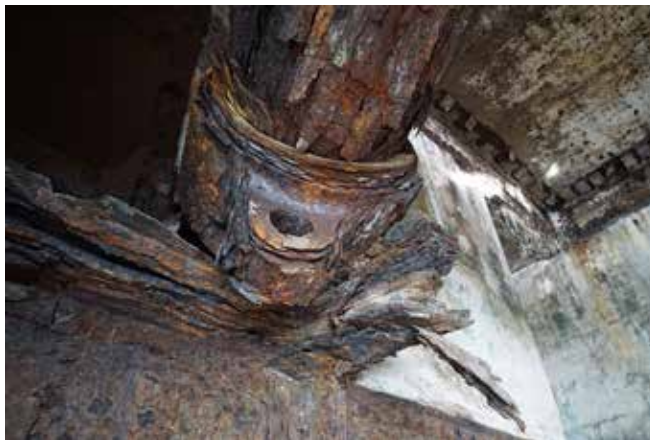
compromised the entire interior structure. We climbed up to the upper deck by tracing our steps back to Battery McCrea's casemate. With one last look around the upper deck, we climbed into our helicopter to return to Manila. It was sad to leave Fort Drum abandoned and deteriorating, without knowing when we would have the opportunity to visit this wonderful fort again.

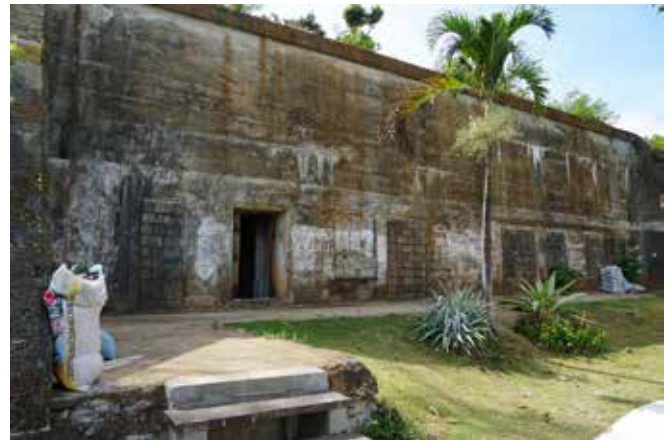
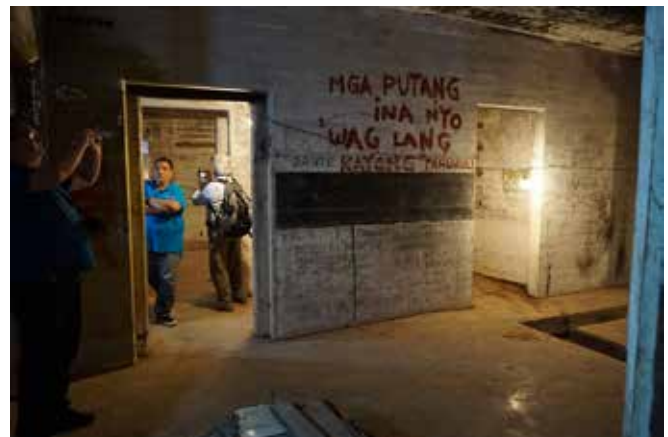
Mine Casemate

little hiking was required during our tour. Our first stop was the former mine casemate on the very north end of the island. The large protected structure had been clean-out since I was last on the island. The cinder blocks covering the main door had been removed and interior lighting had been installed. The resort plans for this structure to become a museum of the island's history. The casemate is near the water and located next to several beach villas. Our next stop was Battery Jewell (4-3 in PM) on the ridge line above the mine casemate. Ruth had arranged for the resort's staff to clear half of the battery so we could easily walk around the emplacement. The battery once contained four 3-inch M1903 guns, but today the battery is abandoned with several magazines containing machinery from the post-war US Navy.

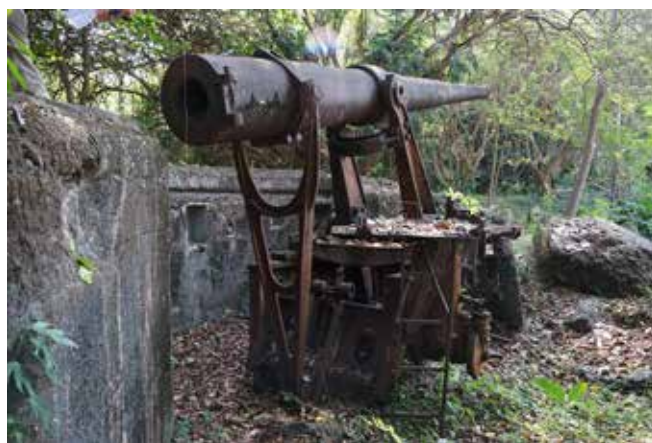
The jeepney took us down the dirt road to the next battery in line (Battery Woodruff) but we ended up at Battery Hall (2-6 in DC). The Grande Island resort folks only knew of one 6-inch battery on the island. Battery Hall retains its two 6-inch M1905 guns on M1905 disappearing carriages, making this location the

highlight of our visit to the island fort. The battery's transverse magazine had exploded in 1945 due to American bombing of the island, though the Japanese made no effort to use these guns in defending Subic Bay. Luckily, the two guns received limited

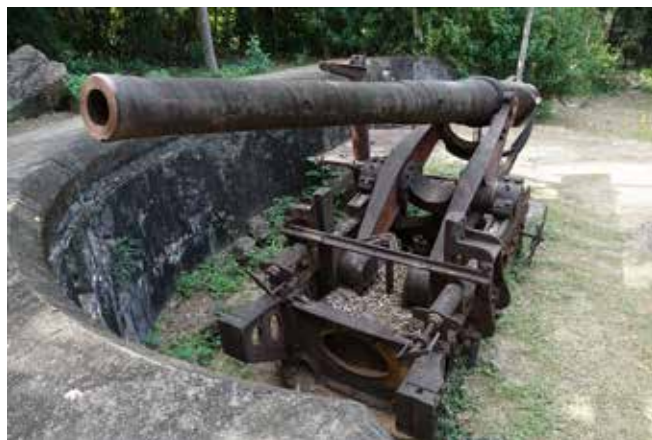
damage so we could photograph and climb on them. I asked Ruth if we could take one of the guns with us back to the States and she told me I need to talk with the leadership of the Subic Bay Metropolitan Authority as they owned the island. Given the 6-inch gun size and weight I doubted it would fit in my overhead bin on the return trip. The guns themselves looked much the same at my last visit, though with no care, you could tell rusting was slowly eating into the steel. Adjacent to the 6-inch battery is the former Battery Flake (4-3 in PM). The battery was abandoned, without armament, and cleared of brush, but several large trees were impacting the battery's concrete. We posed for a group photo at Battery Flake with Ruth and her team.

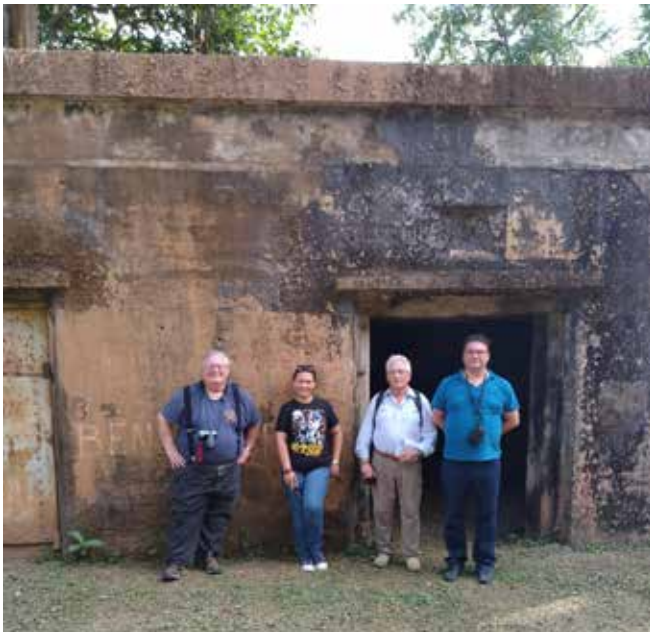
Our next target was Battery Warwick (2-10 in DC), although the Grande Island Resort folks were unfamiliar with such a place. We describe the big concrete structure painted white so they took us around the island again. They took us to a trail to Battery Warwick (according to our hosts). We tried this trail which took us to the remains of the fort commander's station and Battery Warwick's primary fire control station. The lower station was missing so we climbed up to the upper station to explore. Repeating our search of Battery Warwick, I directed the

jeepney to the rear of the battery this time. The rear entrance had a locked gate, so we sought out the guards (a doppler VOR ground station covers the top of the emplacement) to see if they would open the gate for us to visit the former battery. The guards declined to let us visit and take photographs the battery without permission from the Subic Bay International Airport authorities. Back onboard our jeepney, we continued our battery hunt for the last-named battery on the island, Battery Woodruff (2-6 in DC). As our host had no idea where this battery was located, I gave them direction. The road to battery was not often used, so it had become overgrown. The battery itself was only a fragment of its original construction due to a post war explosion of its magazine. A couple of sailors thought it was a good location for a smoke, instead it was a deadly experience for them and tragic one for the battery. The battery site was also used by the US Navy for a post-war service structure so only the battery's parapet wall remains today. The site is the resort's dump, so even seeing the parapet wall was difficult. Our hosts had no idea this was the location of a former 6-inch battery.
