Historic Fortification Preservation Handbook

Pacific Northwest Preservation Partnership

Published by Washington State Parks and Recreation Commission, 2003

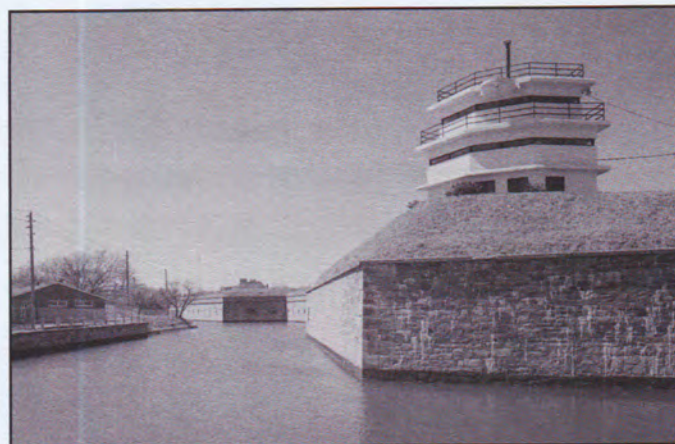
Fort Monroe, Virginia, is a National Historic Landmark. Its span of construction extends from the early 18th century through World War II. Shown here is the 1943 harbor entrance control station, rising above the original walls. The control station is the only architecturally designed fortification structure built in the United States during the 20th century.

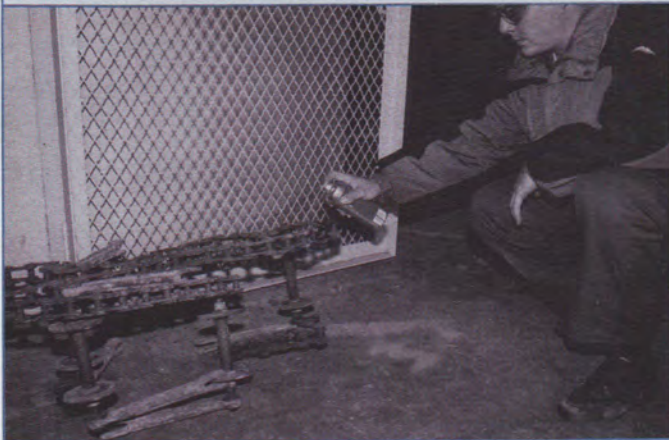
Washington State Parks ranger Evan Roberts applies a corrosion inhibitor to help preserve metal work on an disassembled ammunition hoist at Fort Columbia State Park.

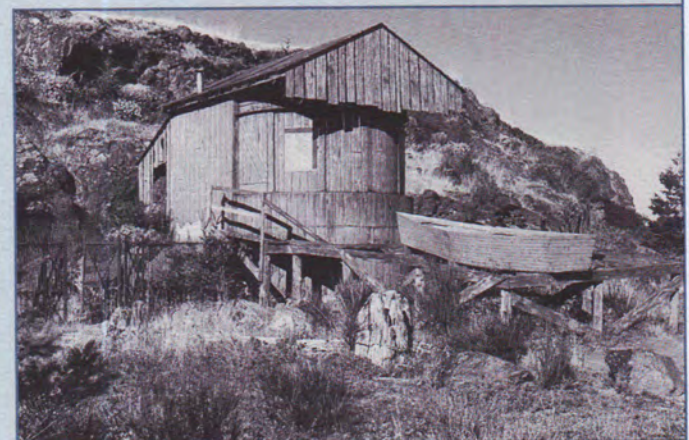
This searchlight shelter at Fort Rodd Hill National Historic Site near Victoria, British Columbia, has been restored to its World War II guise as a beach shanty, complete with false roof and row boat.

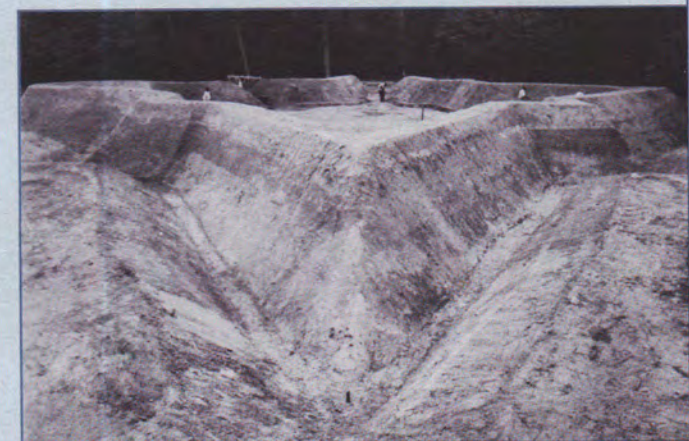
Most reconstruction subjects have been earthworks, as depicted in this 1950s photograph of Fort Raleigh, North Carolina. It is also a good example of the precise geometry that is characteristic of permanent fortification.

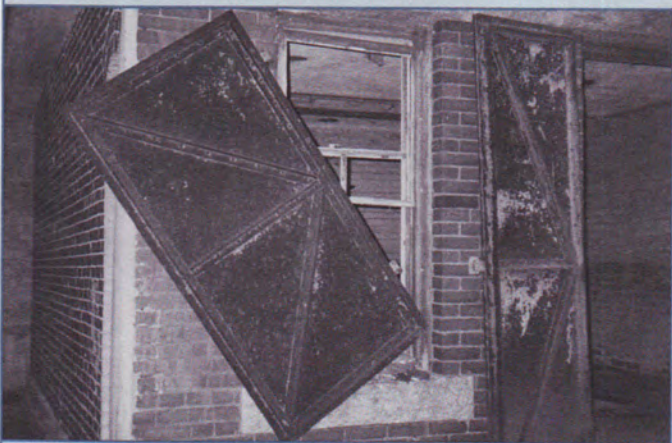
Figure 2. A portion of the 1902 brick mining casemate as it appeared in 1996, with one of the steel window shutters askew. The walls and ceiling of the concrete shell are visible, as is the air space that surrounds the brick walls.

This second structure was built of brick within a heavily reinforced concrete shell covered with sand and sod to protect it from naval gunfire. The brick casemate had several large windows on the rear for light, and featured an air space between it and the walls of the concrete shell (Fig. 2). When this casemate also proved too small during operation, a wood framed, cement plaster addition with a low-pitched roof was put up in 1909 to house storage batteries, a gasoline-powered generator, and a dormitory and latrine (Fig. 3). The experience of the Great War demonstrated the need to provide overhead protection for tactical structures, and as a result, in 1920 a new concrete building, similar to the mine casemate, was constructed for the generator and storage batteries; the wood-frame building was retained as a dormitory. A new range finder station was also added in 1920 (Fig. 4).

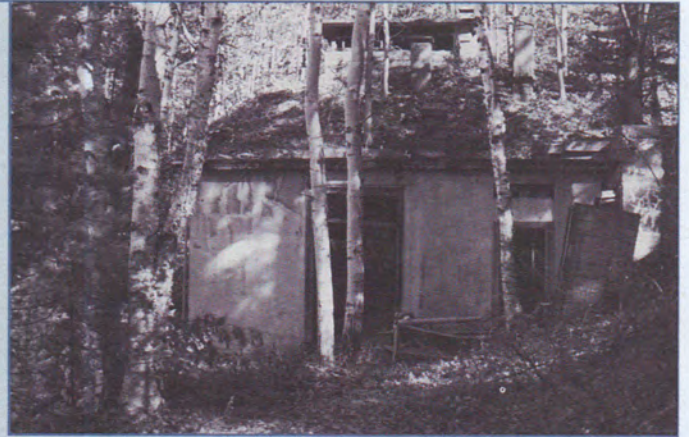
Figure 3. The 1909 wood frame addition to the mining casemate as it appeared in 1996, with the wing on the right collapsed. The earth cover of the 1902 mine casemate is visible above the addition with the 1920 range finder station on top.

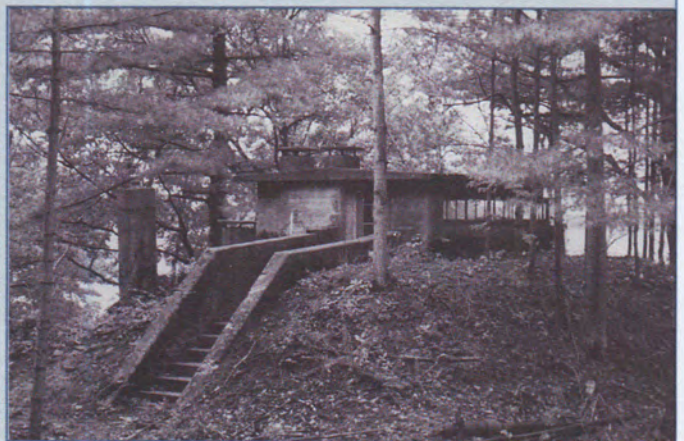
Figure 4. The 1920 range finder station built on top of the 1902 mining casemate. A coincidence range finder mounted in the station was to provide range data to the minefield defense battery located to the right.

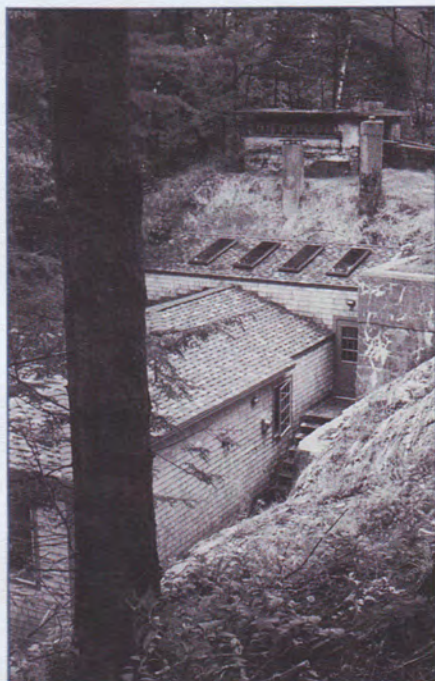
Figure 5. A view of the new residence built on the foot print of the 1909 addition. The connection to the earth-covered 1902 mining casemate is visible, as is the range finder station.

rior walls and ceilings of the residence were plastered like the 1909 structure. The end of the building facing the mine casemate was also plastered and painted by a local artist to resemble the appearance of the original exterior walls. Drinan duplicated the connection between the addition and the mine casemate with modern roofing and skylights.

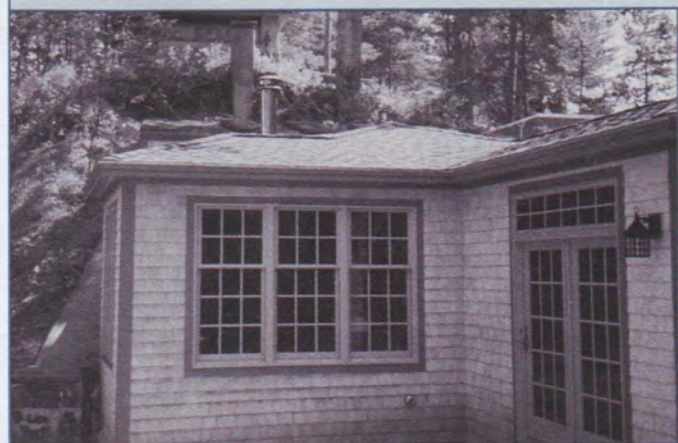
Figure 6. A portion of the new residence that shows the results of the effort to make the structure mimic the original building. The windows and doors are the same sizes and placed in the same locations. The shingled side walls pick up the color of the cement plaster, and the trim is painted in Army olive drab.

By the time the mining complex lot was sold by the developer in 1996, the 1909 wood-frame addition had deteriorated beyond repair. The owner, Ed Drinan, hired an architect with historic preservation experience to design a residence that would be as similar as practicable to the original building. The plan was endorsed enthusiastically by the Maine Historic Preservation Commission, which oversees National Register activities in the state. The new structure used the foundation of the original building, and utilities entered the site via the original concrete conduits (Fig. 5). The windows and doors duplicated those in the original structure in size, style, and location. The building was sided with wood shingles over plywood and the trim painted to match the original army olive drab (Fig. 6). The inte-

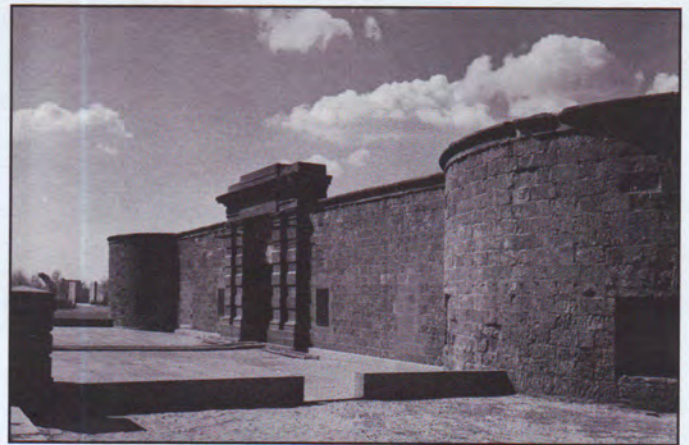
The distinctive vertical walls and rounded forms inspired by Montalembert's design. Castle Clinton, New York, New York.

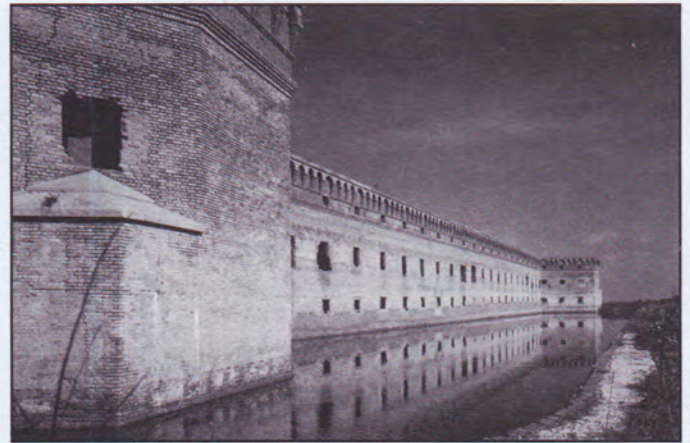
Vertical walls became taller and more massive in many works of the Third System. Fort Jefferson, Dry Tortugas, Florida.

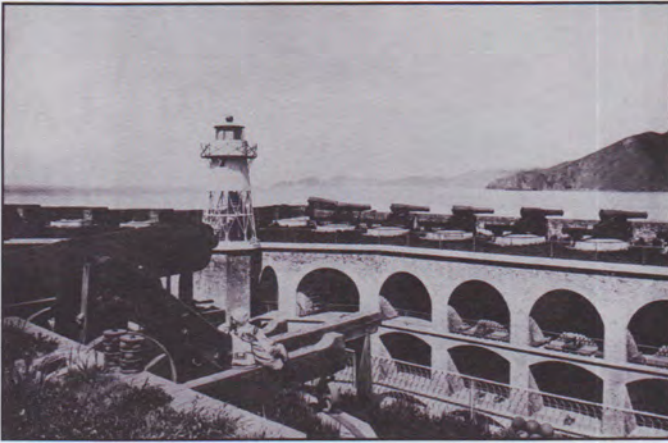
The casemates of a Third System fortification. Fort Point, San Francisco, California.

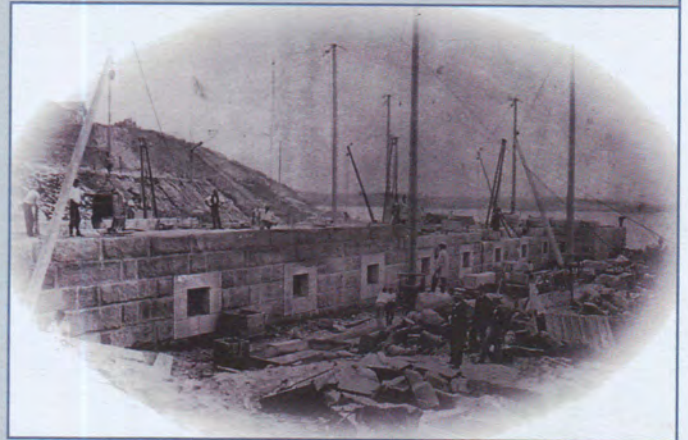
Steampower. Building in concrete left old technology behind. By the 1890s, steam engines did the heavy work, assisted by more powerful machines, although men and horses played a central role. In the middle photo, a pair of derricks moves materials and buckets of concrete over the construction site of a 10-inch battery at Fort San Jacinto in Galveston harbor during the reconstruction of the storm-damaged defenses in 1904. Just as the old masonry fortifications had been replaced, so too had the means of building them.

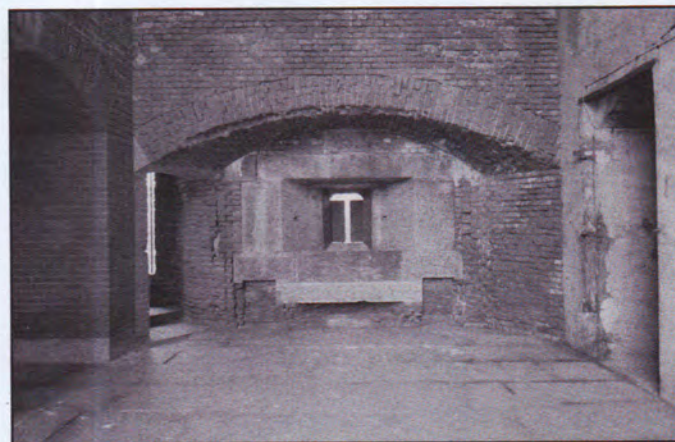
Casemate interior looking toward the embrasure that has been fitted with iron shutters. Fort Delaware, Pea Patch Island, Delaware.

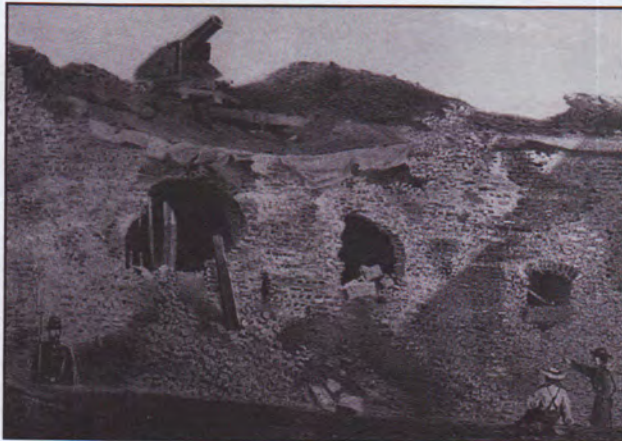
Union gunners breached the walls of Fort Pulaski in 1863, signalling the end of Third System fortifications.

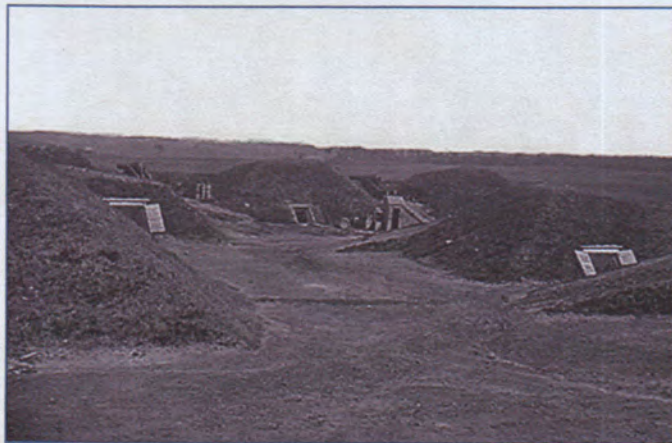
Evolution of Emplacement Design

Earth. During the Civil War, many new fortifications were built of earth. Despite their apparent informality, they were functional and economical, yet intended for only temporary use. This view portrays a land battery protecting Washington, DC. Notable features include the mound-shaped magazine between the gun emplacements, the central entry to the magazine, and the lower floor level of the magazine relative to the gun emplacement.

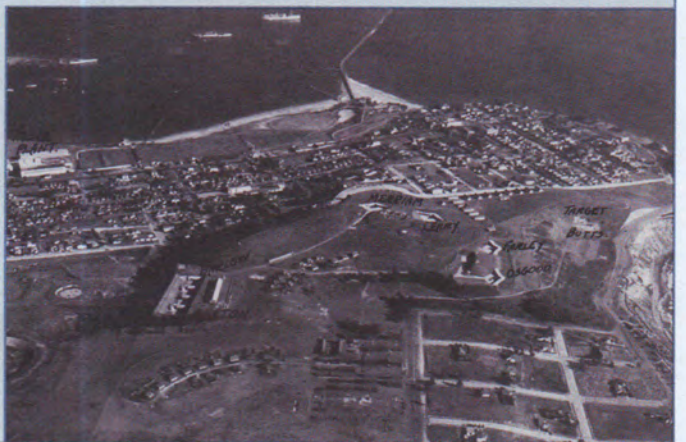
It was not just that the emplacements themselves were getting larger (the percentage of area devoted to circulation actually decreased over the same period), they were gaining new spaces for new functions.

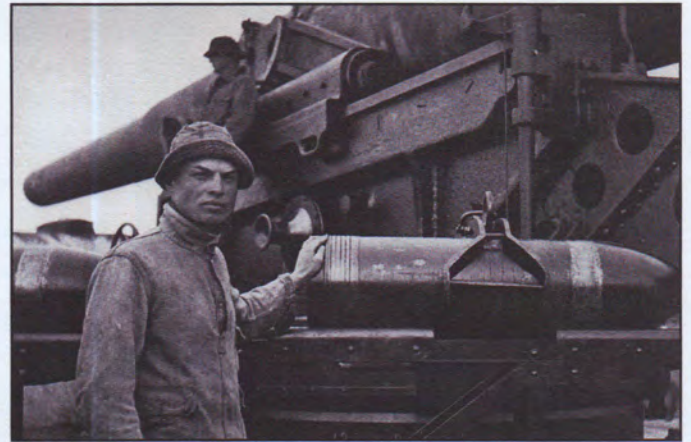
A half-ton projectile mid-way in its journey from the lower level of the emplacement to the breech of the gun. Battery Spenser, Fort Baker, San Francisco, California.

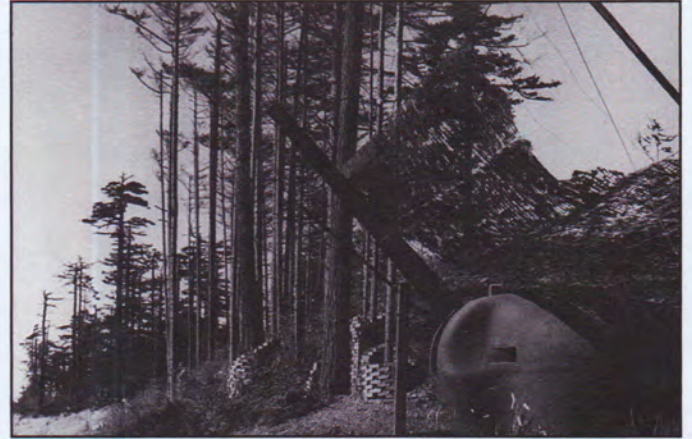
Some fortifications include unusual character-defining features such as these “tree rings” at Fort Ebey, Washington. Although the trees that they encircled are now gone, the rings themselves are still in place today.

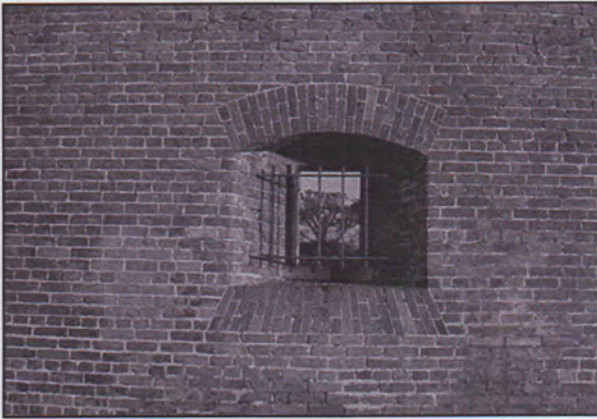
Exterior wall surface in good condition.

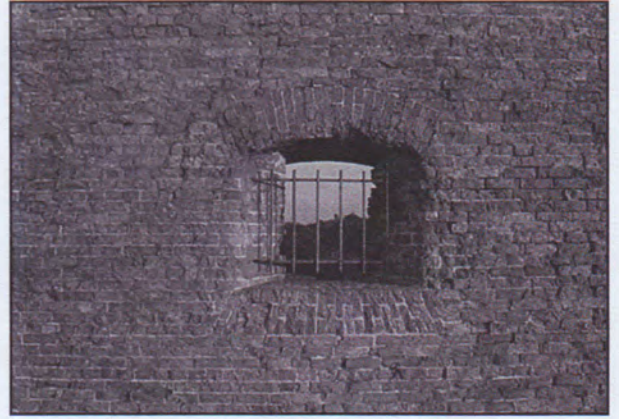
Exterior wall surface in fair condition.

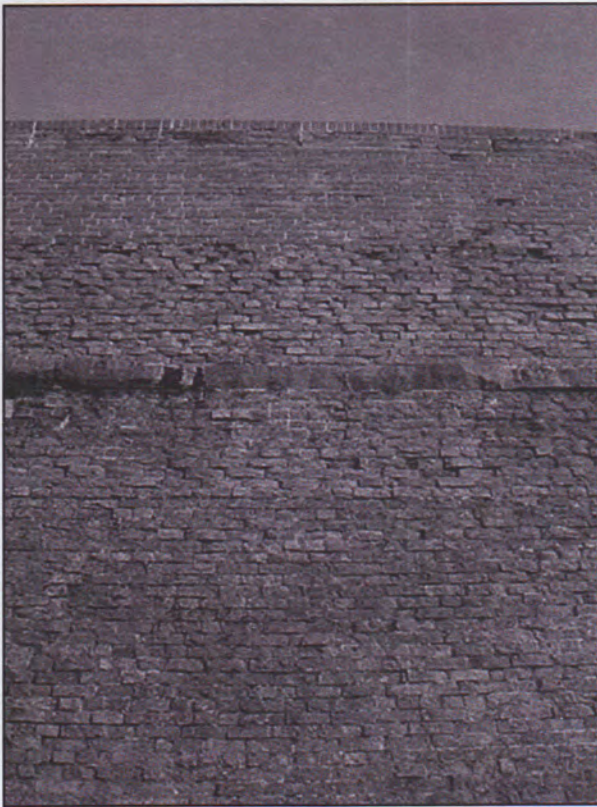
Exterior wall surface in fair to poor condition—note large percentage of open wall joints and eroded surface of bricks.

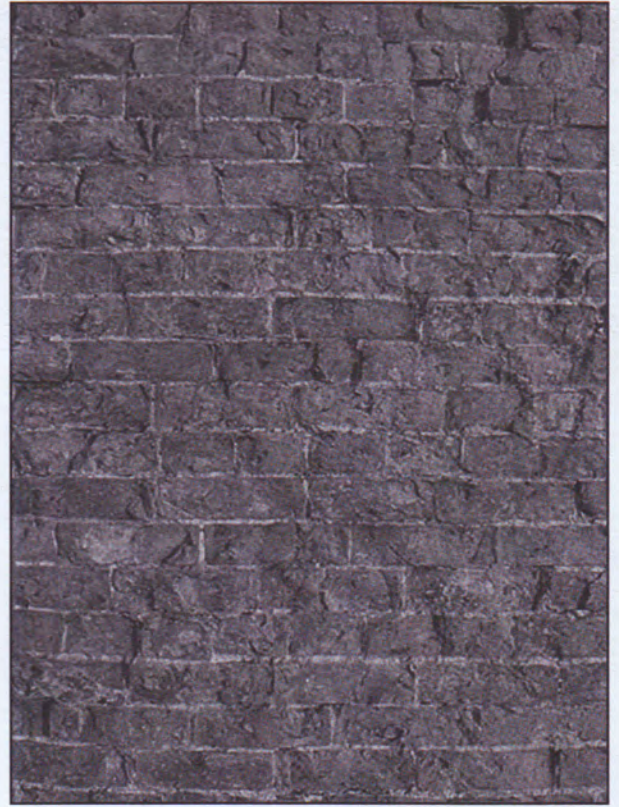
Exterior wall surface in poor condition—note use of non-lime based mortar for finish pointing of joints also eroded face of bricks.

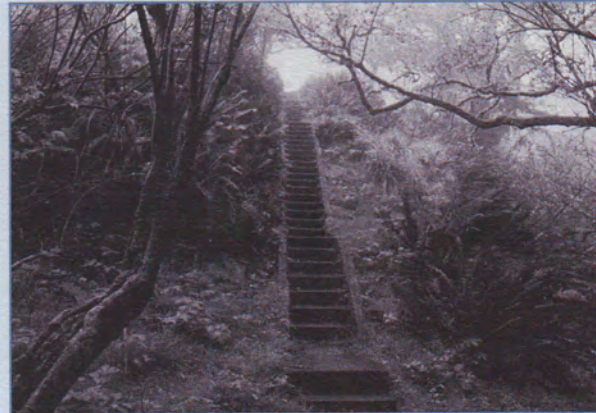
Site Elements, circulation features. Stairway to WWII radar site, Fort Canby.

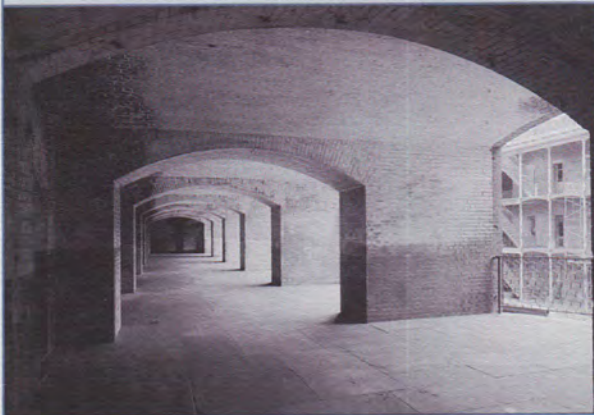
Spatial Relationships. Connected casemates at Fort Point.

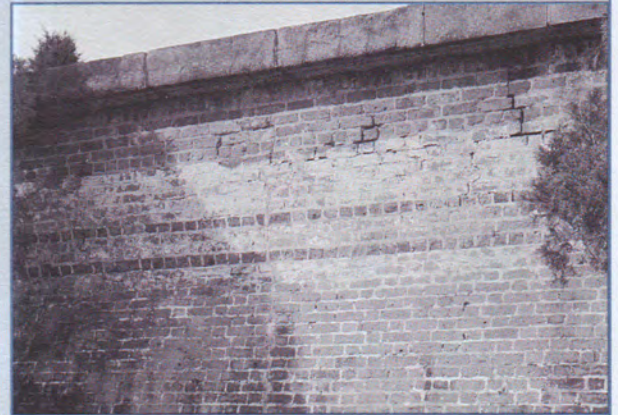
Materials. Masonry bond patterns, Fort Moultrie.

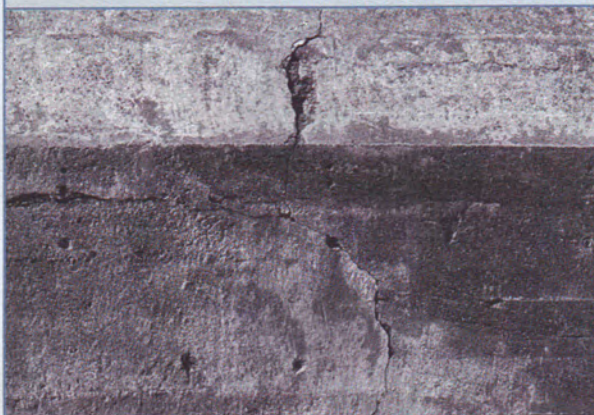
Materials. Concrete surface finishes, Fort Winfield Scott.

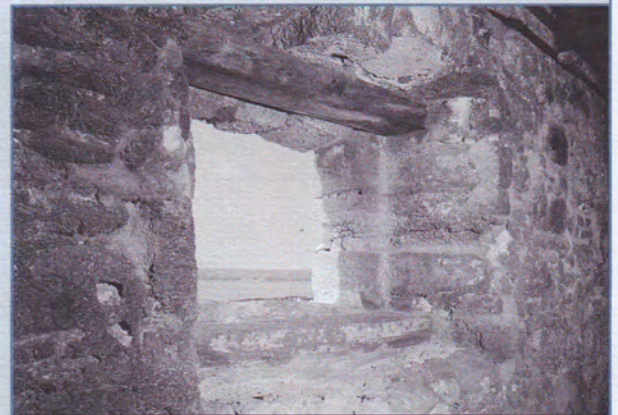
Materials, stone types. Coquina stone, Fort Matanzas.

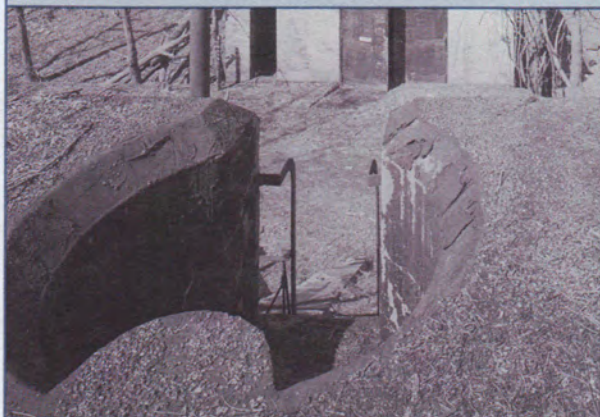
Architectural details. Crow's nest, Battery Richmond, Fort Wadsworth.

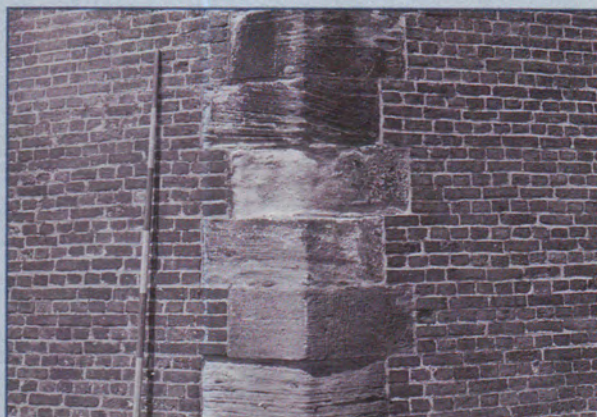
Architectural details. Stone quoins, Fort McHenry.

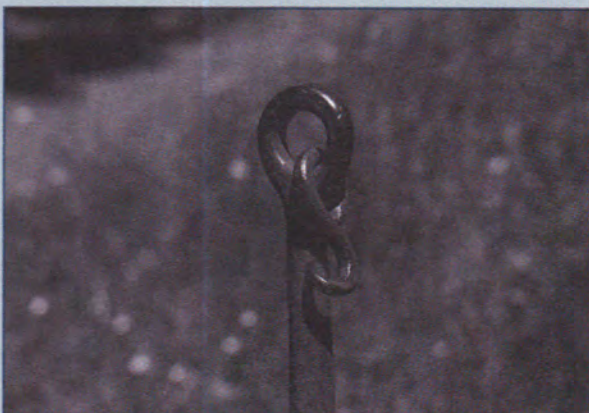
Architectural details. Small-scale features, stanchion and chain attachment, Battery Crenshaw, Fort Columbia.

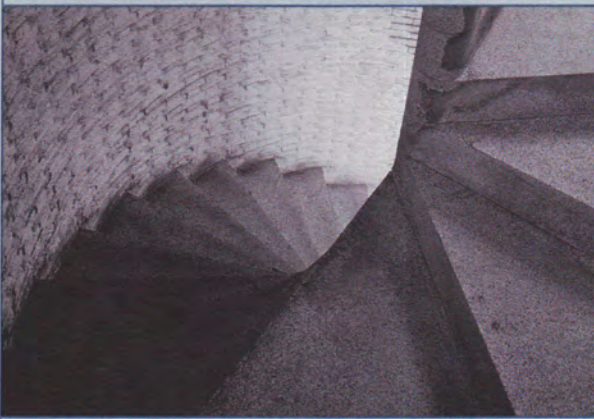
Evidence of skilled workmanship. Spiral granite stair, Fort Point.

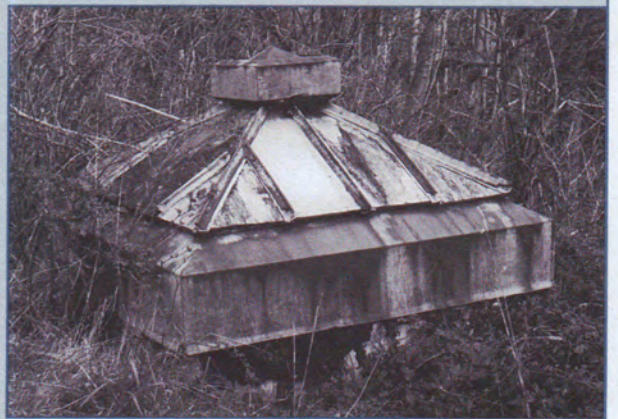
Evidence of skilled workmanship. Galvanized iron ventilator, Fort Columbia.

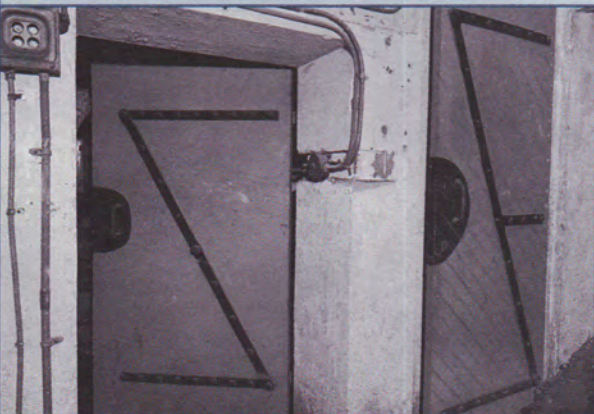
Intact interiors. Mine casemate, Fort Rosecrans.

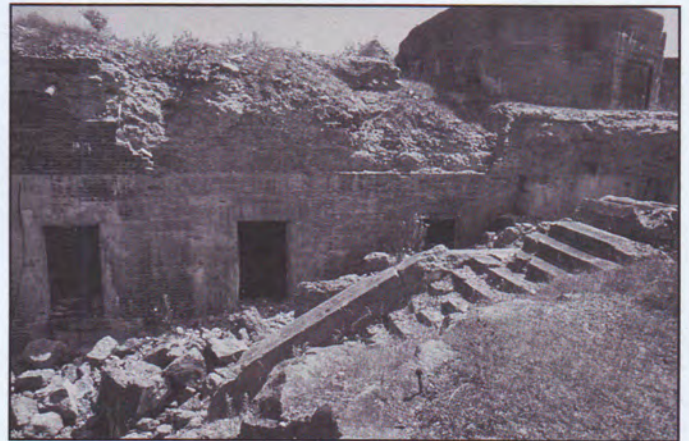
Extreme winter weather conditions have caused severe spalling in this battery at Halifax, Nova Scotia.

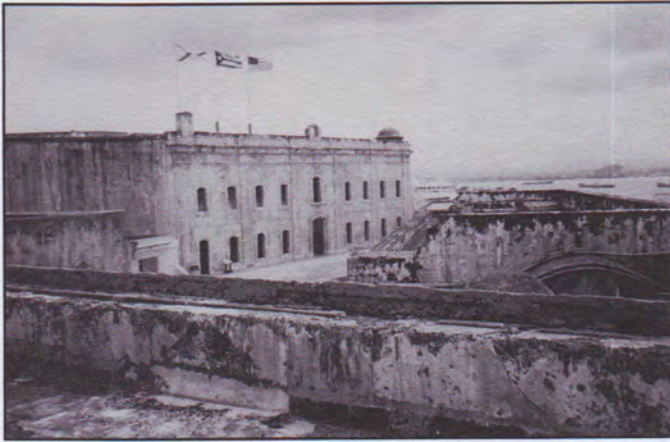
Several varieties of biological growth thrive on mortars in warm environments. San Cristobal, Puerto Rico.

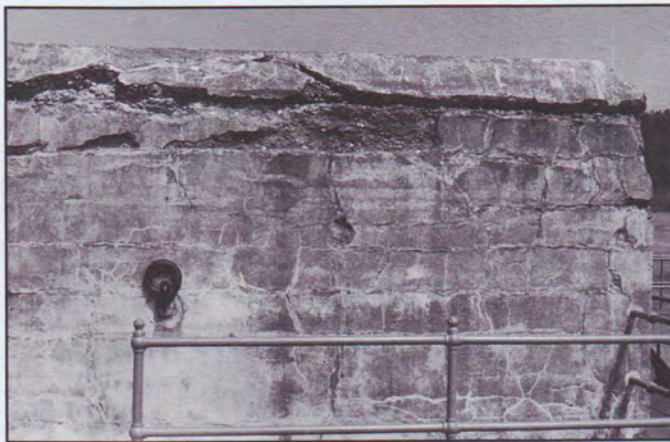
Long regarded as the result of freeze/thaw cycles, this linear spall appears to be more the product of poorly mixed and placed concrete. Fort Casey, Washington.

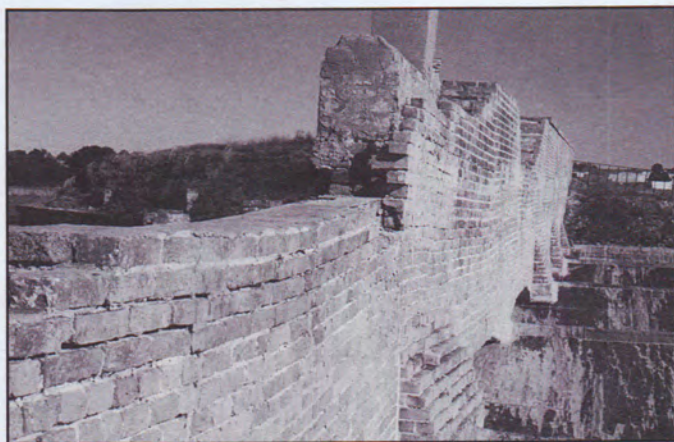
The earth fill behind this masonry wall has been removed. The wall was not designed to stand alone, and it is now unstable and vulnerable to collapse. Fort Pickens, Florida.

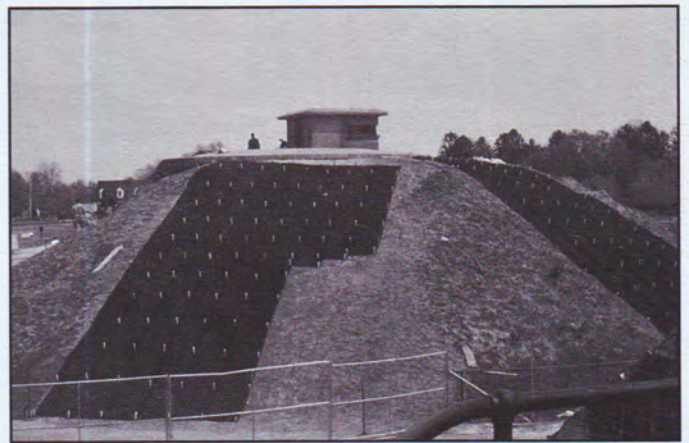
The geotechnical properties of soil were not thoroughly understood when many fortifications were built. An environmental mat helps stabilize the soil on this steep slope. Battery Gregg, Fort Mott, New Jersey.

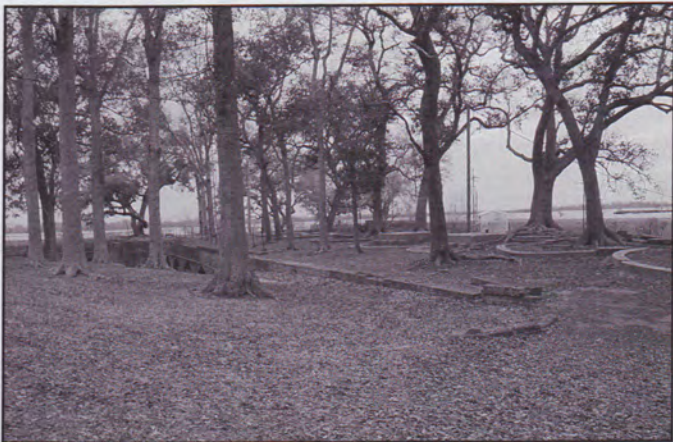
Tree growth can disrupt and damage historic fabric as well as structural underpinnings, leading either to costly repair or the loss of the resource. Fort Jackson, Louisiana.

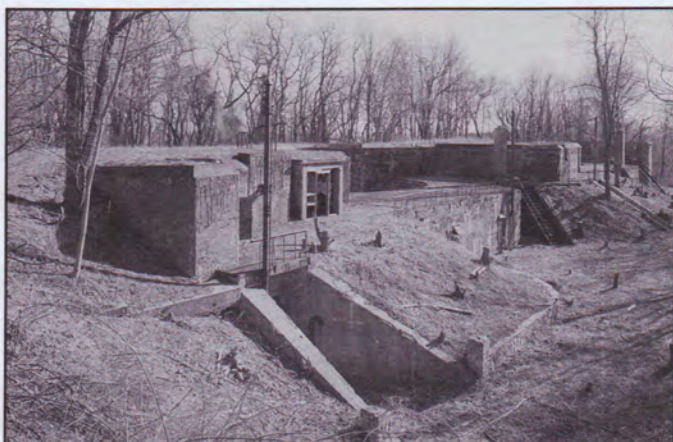
Removing trees and brush from around and on top of fortifications is a sound preservation practice. Battery Richmond, Fort Wadsworth, New York.

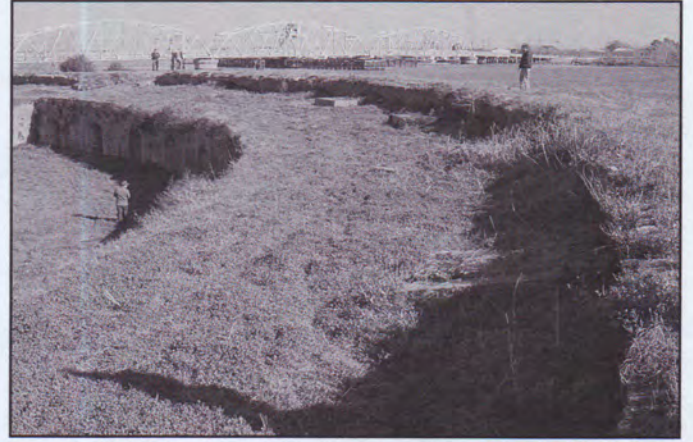
Grass prospers now in areas that were once rendered almost bare from heavy military use. Grass is often an appropriate cover if properly maintained. Fort Macomb, Louisiana.

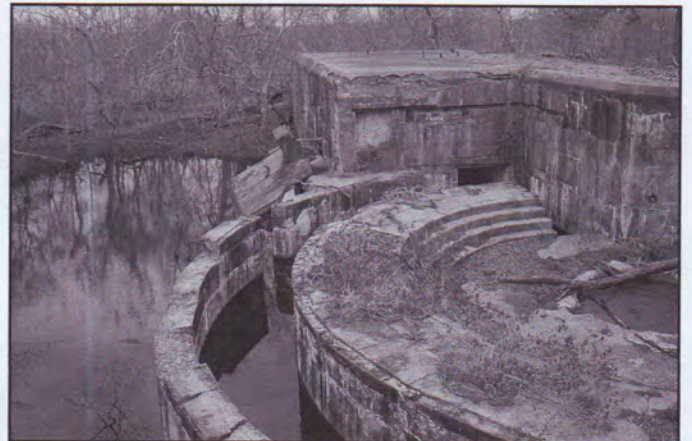
Poor construction sites become poor historic sites, as demonstrated by the persistent high water table at Battery Forse, Fort St. Phillip, Louisiana.

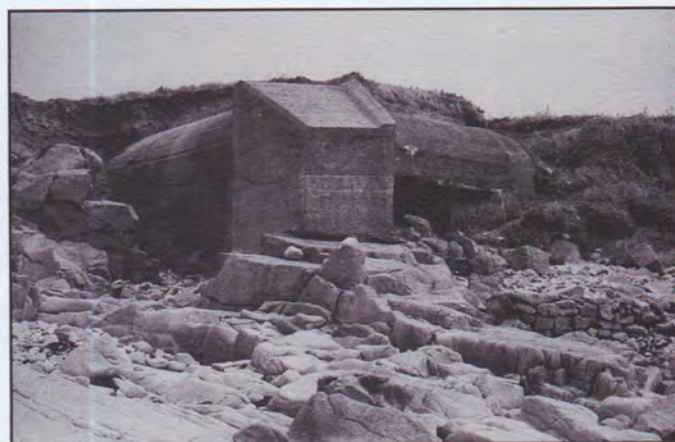
Erosion and deposition can take place simultaneously. This World War II casemate is being exposed on the left as it is being buried on the right. Guernsey, Channel Islands.

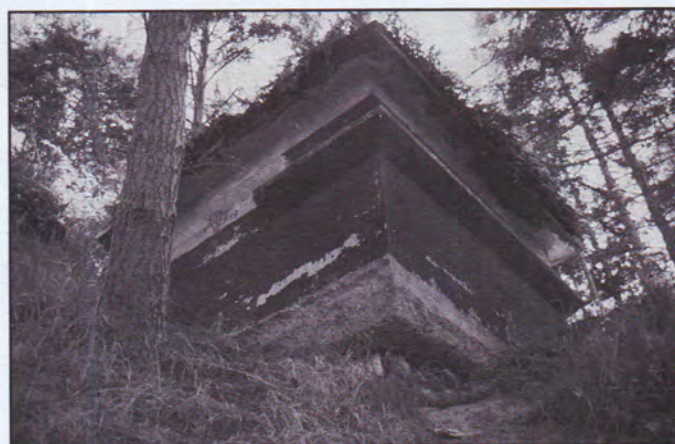
Bluff erosion can undermine structures and pose significant preservation challenges. Battery Kinzie Primary Station, Fort Worden, Washington.

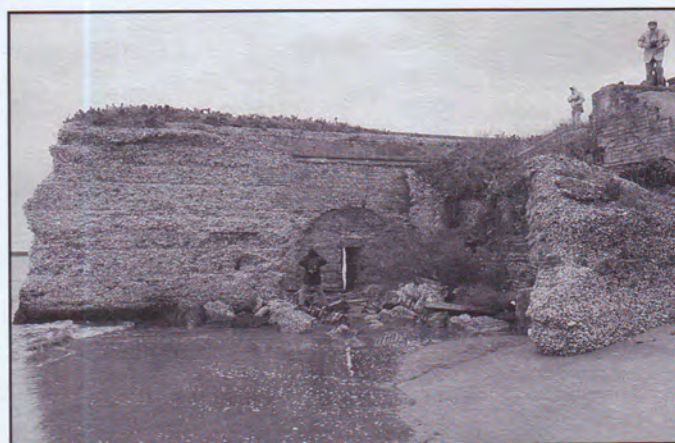
The erosion of low sites is an equally difficult problem. Fort Livingston, Louisiana.

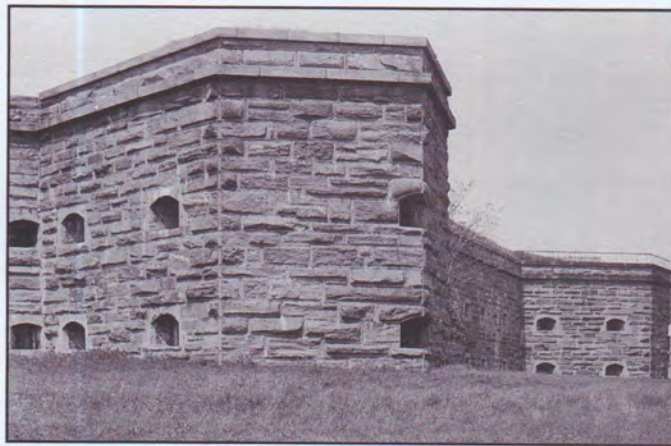
The rock-faced granite ashlar of a bastion at Fort Schuyler, New York, conveys an impression of both power and solidity in this 1934 photograph.

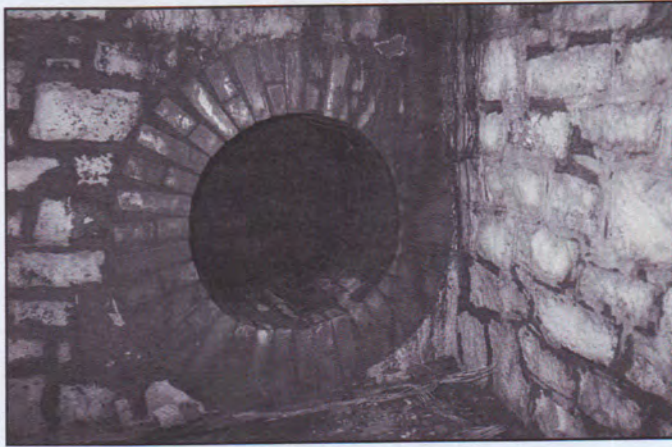
Both brick and stone masonry were used to form this ventilator opening in the otherwise concrete construction of Battery Thompson, Fort McKinley, Maine.

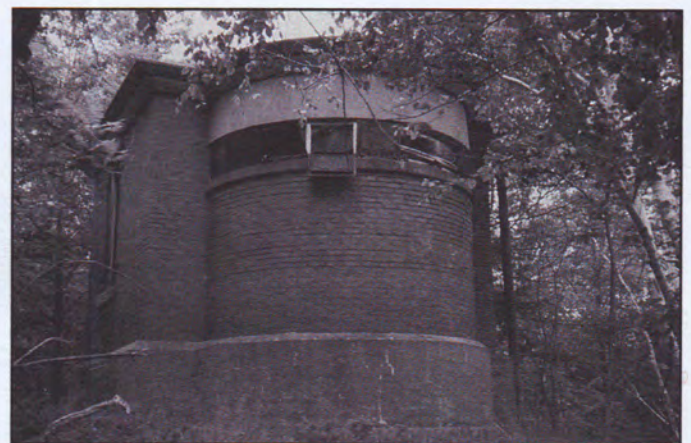
This fire control building at Fort McKinley dates from the early 1900s, and demonstrates the continued use of masonry in the transition to concrete fortifications.

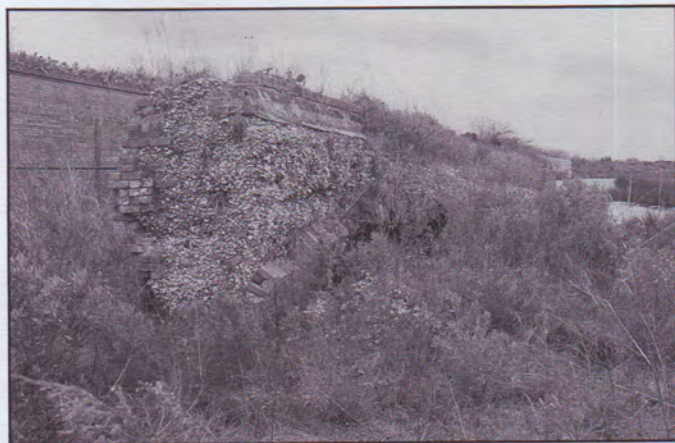
This lightly compacted mixture of a tabby-like material provides in-fill for the masonry walls of Fort Livingston, Louisiana.

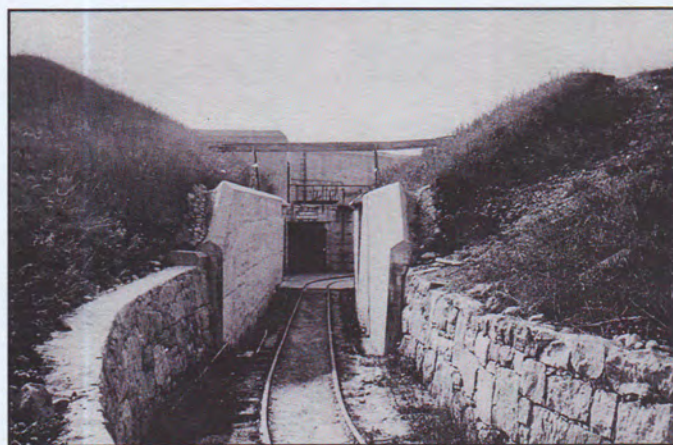
As the shift to concrete construction became more complete, masonry was relegated to a minor role as represented in this 1908 photograph of the retaining wall at the entry to Battery Butterfield, Fort H.G. Wright, New York.

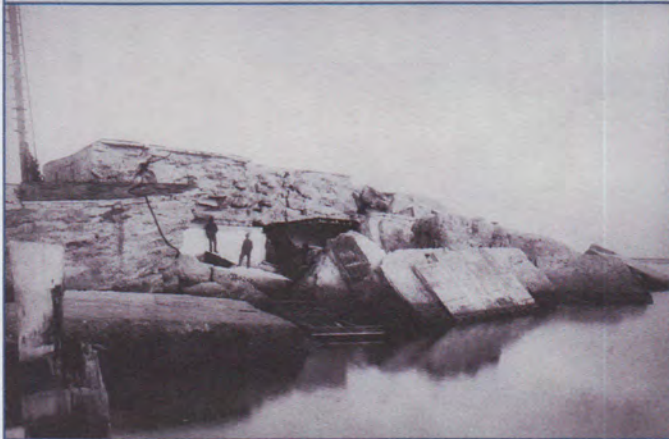
The first concrete batteries had no reinforcing, and structurally were piles of concrete indifferently placed. The Galveston hurricane of 1900 made apparent what the absence of reinforcing could mean. In this view of a battery taken after the storm, it is easy to see the nature of unreinforced mass concrete.

Inundated by a series of storm waves with an energy estimated at two million pounds each, the batteries shattered and their surrounding sites disappeared. They were subsequently rebuilt.

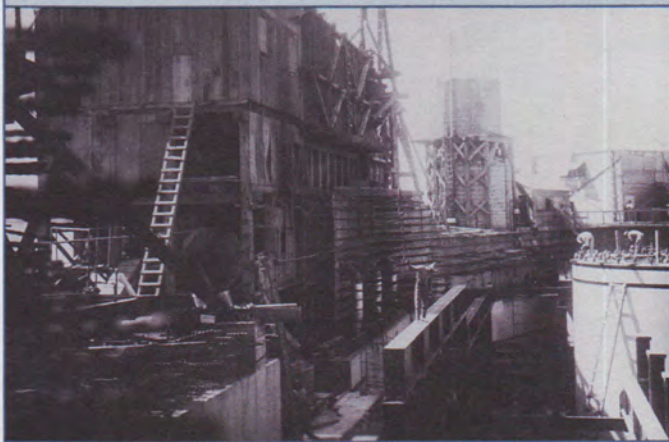
The introduction of reinforcing to fortification practice followed the same outline as its use in other building specialties. Beginning about 1905, new fortifications (or improvements to existing work) were put up with first smooth and then deformed bars. The initial understanding of placement was not well developed, which left the reinforcing vulnerable to carbonation and chloride attack, but that knowledge improved steadily. In this view of Fort Drum, Manila, taken in about 1914, the dense array of bars and load-bearing beams is typical for heavy construction of the period.

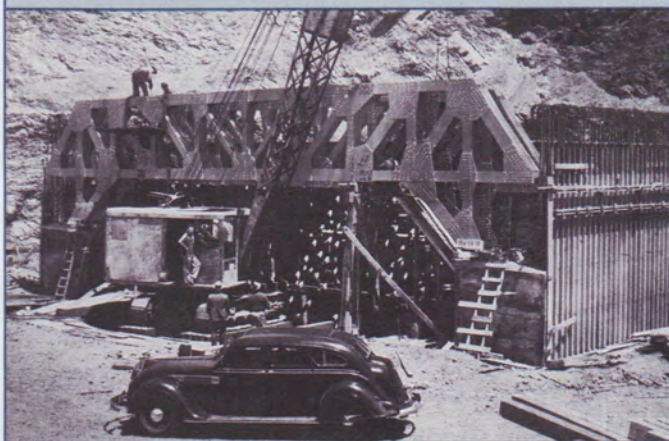
The rapid advance in the power of weaponry first evident on the battlefields of World War I continued through the 1920s and 30s. Fortifications erected in the years prior to World War II responded to the need for ever stronger resistance to bombardment. The amount and size of reinforcing steel increased, and contributed to greater percentages of the volume of the structure. An example is this view of Battery Townsley, Fort Cronkhite, California, with its thicket of bars and deep riveted truss over the opening of the gun emplacement.

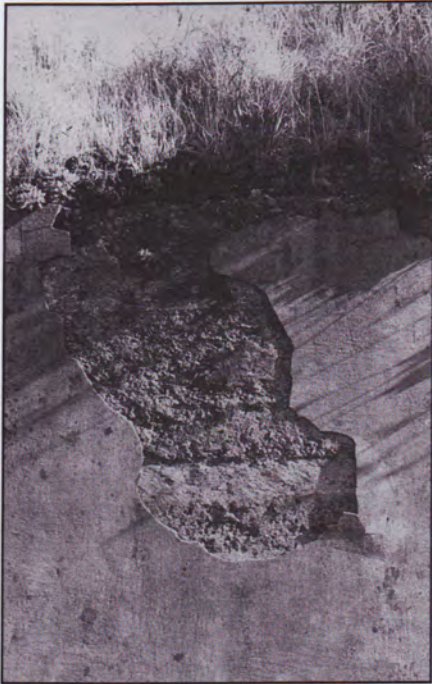
The sub-standard condition of this parge coat could have been detected by simple acoustic impact tests. Battery Cavallo, Fort Baker, California.

Impact Echo or Acoustic Impact. A method that can be as simple as dragging a chain over a surface and listening for the hollows within the material or as complex as much more sensitive (and less subjective) electronic equipment. A hammer test or sounding for masonry serves much the same purpose. An experienced person tapping on a masonry unit can reach some conclusions about the

condition of the individual stone or brick and the quality of its bond by virtue of the different tones made by the impact. In the most sophisticated electronic versions of the method, it can produce good data for granite and sandstone walls and columns that are less than two feet thick. It can give excellent results in detecting stone cracking parallel to the surface, but it is limited where there are multiple layers of material. Successful operation of the equipment requires training as well as material reference standards. Another technique—spectral analysis of surface values—uses the same equipment and can detect similar faults.

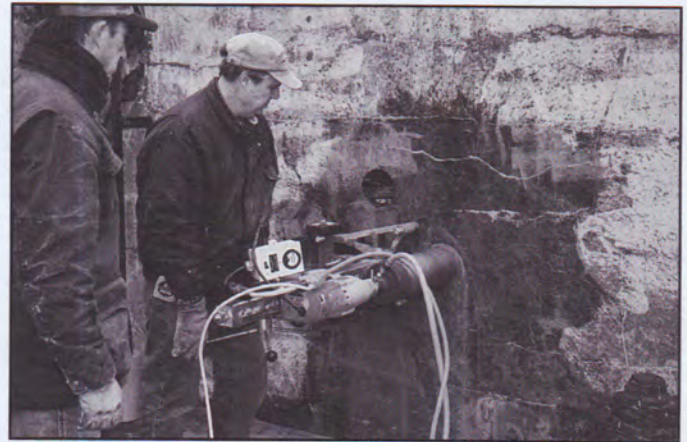
Both water and power are required to operate a coring machine. Battery Worth, Fort Casey, Washington.

Core Sampling. The process of extracting a cylinder of concrete and subjecting it to tests is called core sampling. It is a well-known and widely-used technique, and not all authorities classify it as destructive.⁹ It is regarded as destructive when it is used on historic properties because it mars the surface appearance. The test leaves a hole several inches in diameter and up to several feet deep, as well as additional smaller holes necessary to attach the coring machine to the surface of the structure. The holes can be filled, but the surface is permanently altered.

Core sampling is important because it is the only way to acquire accurate information about the compressive strength of concrete or some sense of the internal character of masonry construction. It can also be the first step in identifying the physical properties of concrete; in most fortifications, arriving at an understanding of those qualities is often as valuable as determining the compressive strength. The samples do not offer this information directly, but only after the cores are subjected to physical and chemical analysis. Chemical tests can determine such important information as cement content, the content of soluble salts and chlorides, and alkali-silica reactivity. In most instances, petrographic examination will provide a more and varied perspective than is available through chemical tests alone.

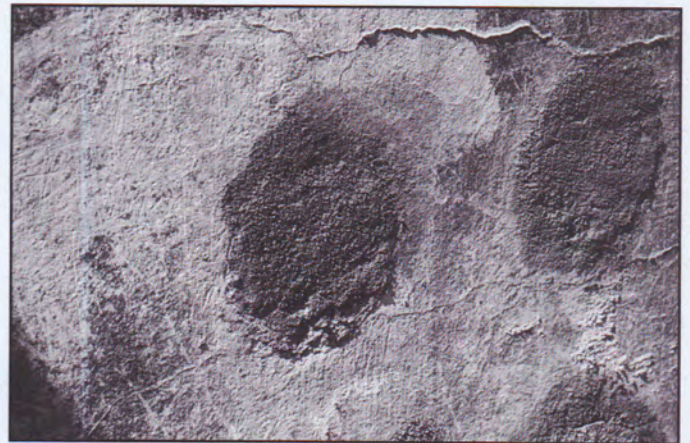
Removing core leaves a large hole that must be repaired. This repair needs to be resurfaced so that it will better match the surrounding historic fabric. Battery Worth.

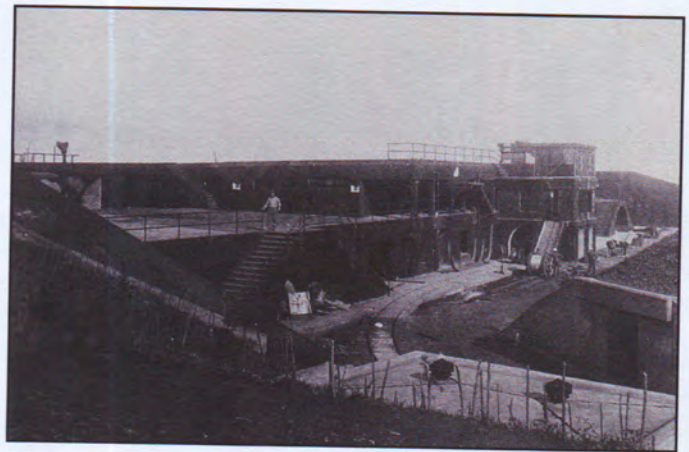
This historic view of Battery Wheeler, Fort Mills, Philippine Islands, shows that the new concrete has been painted a dark color to reduce glare from bright sun.

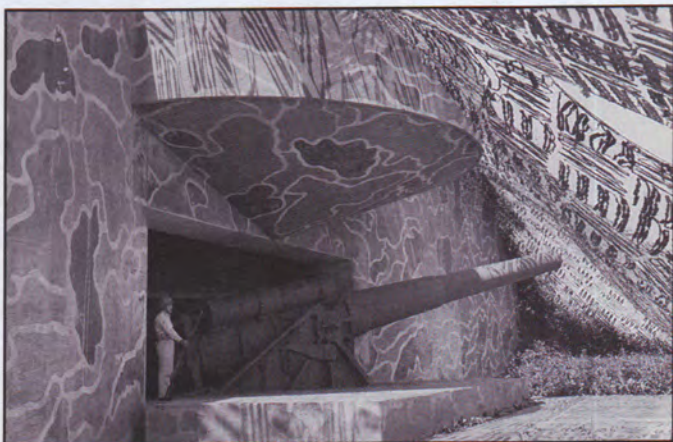
The camouflage is distinctive and clear in this 1943 photo, but such patterns can still be distinguished today, and would be lost in a program of comprehensive cleaning. Battery Reed, Fort Amezquita, Puerto Rico.

become a chaotic layering of surfaces. The blotched pattern of many different and subtle hues is a combination of surviving paint fragments, surface treatments, organic growth, and dirt. To clean is to clean it all; there is no method that can remove only organic growth and dirt, and leave intact other visible traces of the long life of the fortification.

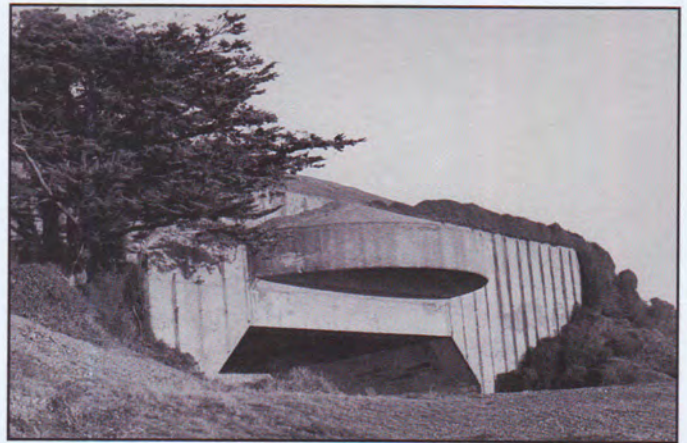
Heavy rust stains mark the exterior of Battery Townsley, Fort Cronkhite, California.

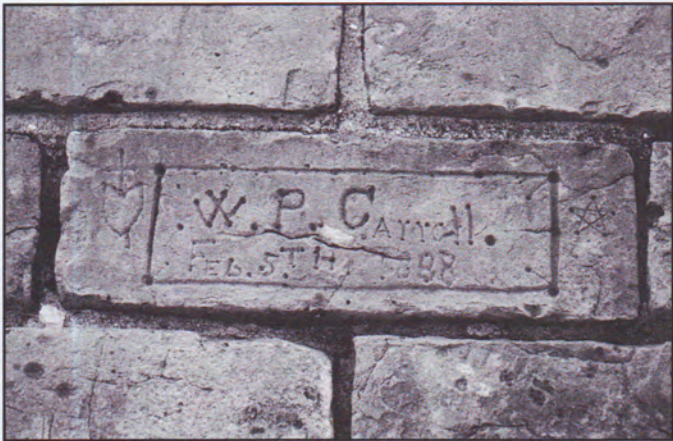
Graffiti that reflects the historic use should be retained intact and not repaired, as in this example from the Advanced Redoubt, near Fort Barrancas, Florida.

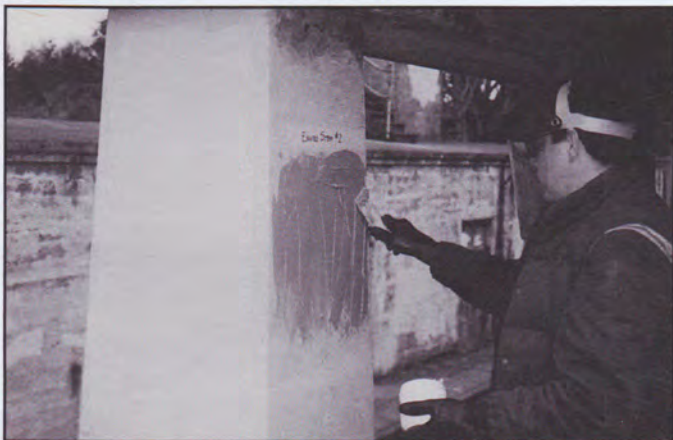
Ranger Todd Jensen experiments with a commercial graffiti remover during cold-weather tests at Fort Worden, Washington. These preparations are often caustic, and protective clothing should be worn.
