Historic Fortification Preservation Handbook

Pacific Northwest Preservation Partnership

Published by Washington State Parks and Recreation Commission, 2003

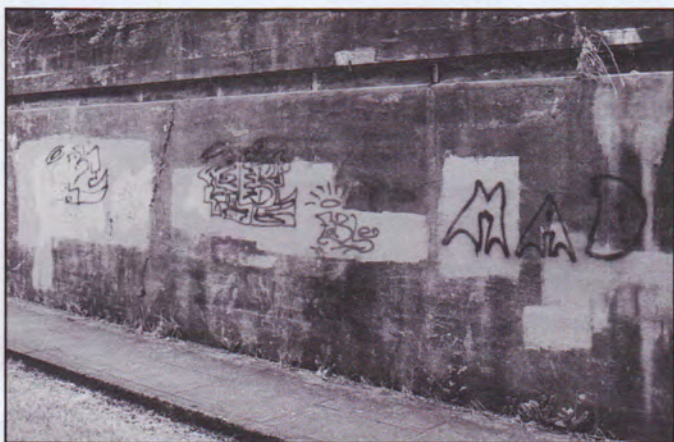
Painting over graffiti applied to concrete is a quick fix, and one that can help control its spread to previously unmarked areas of the structure. Battery Randol, Fort Worden, Washington.

There is another method of treating graffiti that has been applied to concrete fortifications, and that is simply to paint it out. Painting over the marks with latex paint has several advantages. The over-painting requires little skill and equip-

ment, and it is less expensive than commercial graffiti removers. It also tends to attract other graffiti to the painted surface. That seems nonsensical as an advantage, but in providing a clean area for the next graffiti artist, there is less risk that any new marking will be applied to an original and undisturbed surface. Thus, painting over can limit the physical extent of graffiti in a fortification by encouraging it in areas where it has already appeared. The layers of paint can be easily removed as can the accompanying layers of graffiti. This method is not recommended for masonry structures because of the difficulty of removing the paint from the historic fabric.

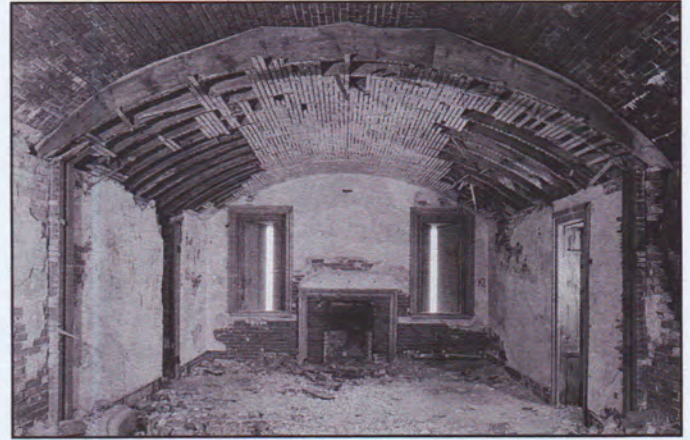
The edge of a sheet metal diversion membrane is visible above the lath and plaster ceiling of this casemate interior at Fort Gorges, Maine.

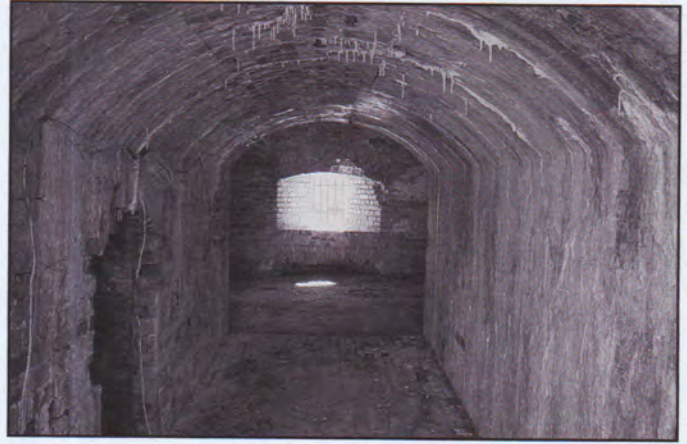
Stalactites and a heavy deposit of calcium carbonate coat the walls of this vault at Fort Macomb, Louisiana.

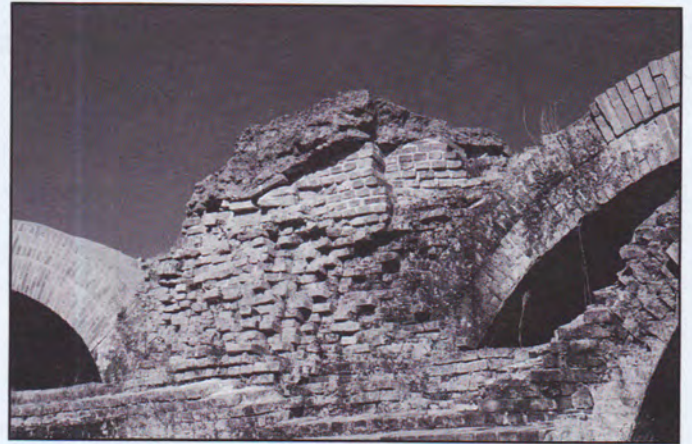
Loose in-fill between the vaults of masonry fortifications provide an ample reservoir for water that can steadily percolate to the interior even in dry weather. Fort Pickens, Florida.

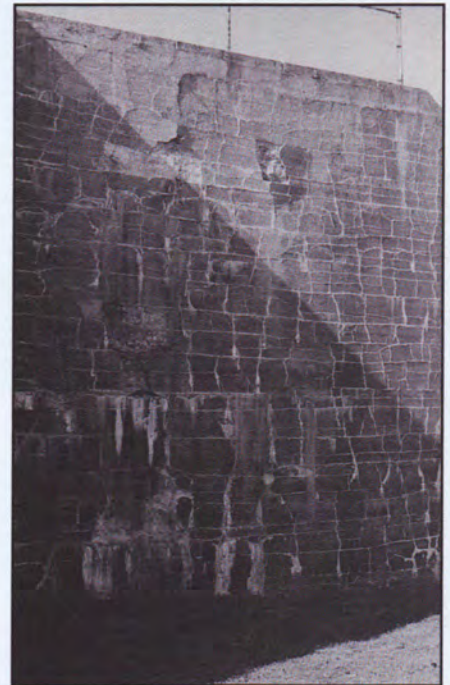
Vertical and horizontal cracks, efflorescence, and chloride deposits are characteristic of concrete fortifications of the early 1900s. Battery Harker, Fort Mott, New Jersey.

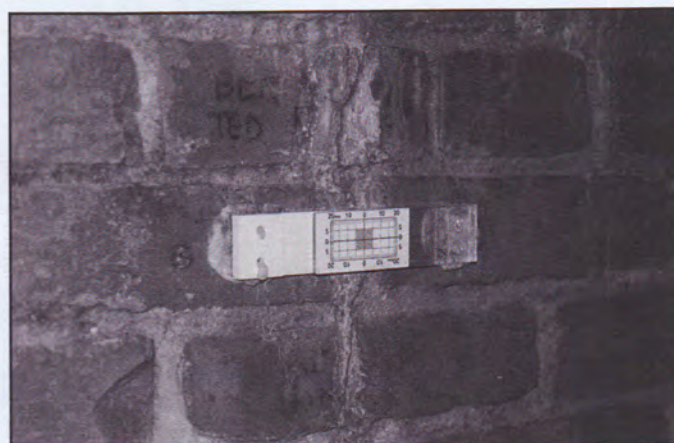
A crack gauge is a useful tool that can help determine extent, rate, and periodicity of movement. Fort Barrancas, Florida.

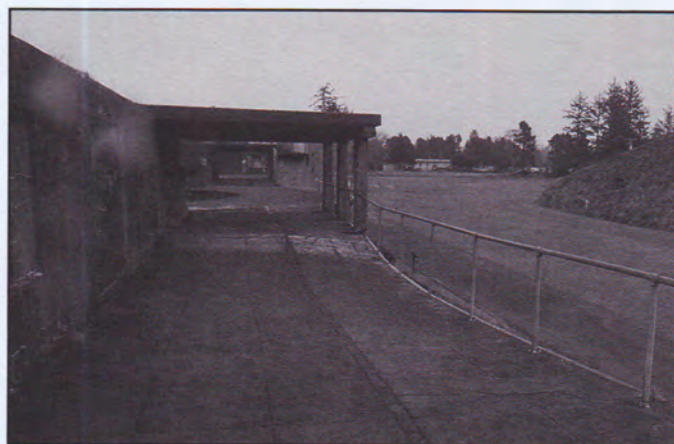
Sagging in a thin section platform extension. Fort Stevens, Oregon.

Sagging is a particular form of deflection. In this instance, it appears that brittleness of the material has been overcome by plasticity, and the material has drooped in response to a lack of support. The most likely place for sagging to occur is in the thin-section platform extensions of concrete gun batteries. While no examples were examined closely in the preparation of the Handbook, it is likely that sagging is the result of multiple micro-fractures induced by the slow and continuous loss of structural support over a long period of time.²⁸

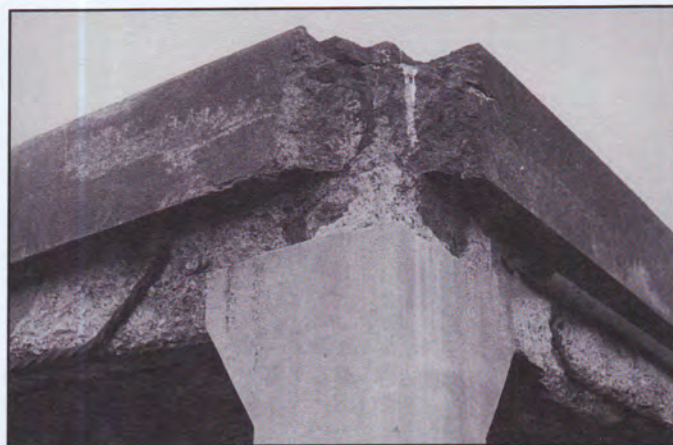
Broken concrete at Battery Mendell, Fort Barry, California. The likely cause is the expansive force of the corroded reinforcing steel visible in the photo.

The causes of this type of loss are many. A heavy blow can chip away a small divot or spall off an irregular block weighing hundreds of pounds. We already know that freezing weather promotes and exploits cracks, and the formation of ice inside a material can often lead to surface loss. Extreme heat from fire has an even more dramatic effect, although it is less common. Mortar can fail, and when that happens there is little to keep a masonry unit from becoming lost from its place. Also evident at some locations is breakage associated with attempts at demolition. Everywhere there are examples of corrosion forcing away spalls and chips as well as producing detachments of considerable size. As distracting as these conditions are, the first task is to treat the ultimate cause of the failure so that the treatments we apply to address the visible problem can have greater assurance of success.

Unlike other forms of deterioration, detachment, breakage, chipping, and spalls may not be the indicators of greater problems elsewhere in the structure. Unless the loss of material has exposed interior reinforcing or vulnerable fills, or is part of an other-wise diagnosed structural issue, these unsightly blemishes may be no more than that and may not necessarily require repair. That is particularly true if the damaged area is stable and not spreading. The decision not to repair may also be related to the historic nature of the damage itself: if a fortification shows

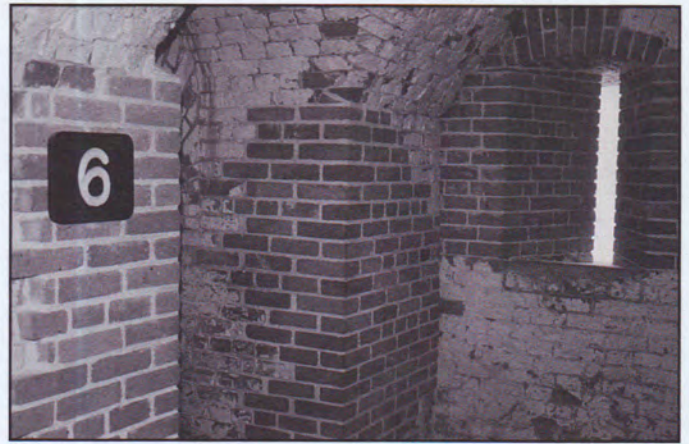
The restoration of this brickwork has been done in a manner that distinguishes the area of the repair while remaining compatible with the surrounding original masonry. Fort Barrancas, Florida.

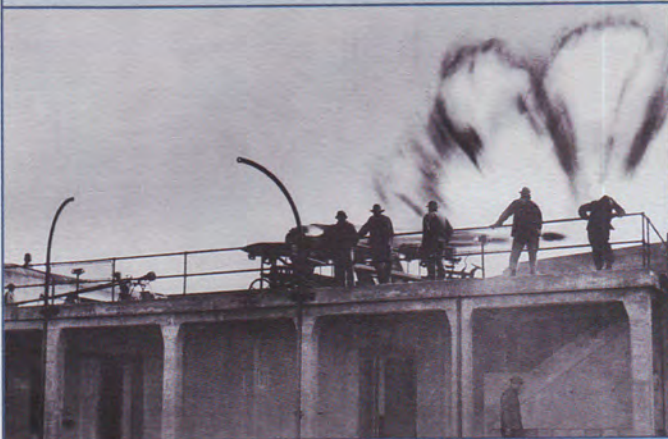
Figure 1. Firing practice at Battery Mendell, circa 1920. Note the projectile in flight.

The battery was named after Col. George Mendell, Corps of Engineers, who oversaw construction of 1870s and Endicott period fortifications in the San Francisco area. It was armed with two 12-inch breech loading rifles, model 1895, on disappearing carriages, model 1897, which bore on the north ship channel into San Francisco Bay (Fig. 1).

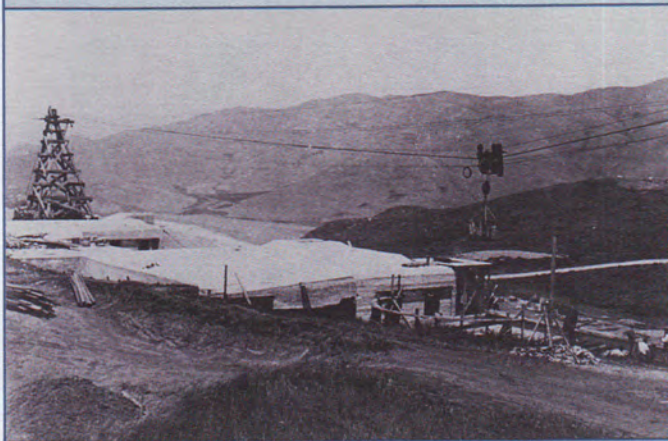
Figure 2. Construction of Battery Mendell, ca. 1902. Note the tramway erected to bring concrete plant to the cliff top site from a batching plant at the north end of the beach. Note the farm at the left center background—leased by a family of long-time dairymen of Portuguese decent.

Spectacularly set at the very edge of a high cliff that drops sheer to the Pacific surf below, the location that offered such a fine field of fire for the coast artillerymen provided challenges to the engineers who built the battery (Fig. 2). A report to the district engineer lamented, “[w]here batteries sites in this harbor are on elevated positions, they are generally located on ridges where foundation material is usually rock and shales tending to rock. An exception to this rule was found at this 12-inch disappearing gun battery. . .the surface dipped back from the face of the cliff, below, the rock was about parallel with the surface, but 40 feet and more below. The soil overlying the rock was for the most part light yellow clay, while some portion(s) of it were sandy clay. When excavated and placed in a spoil bank it settled 20 per cent. . .A foundation bed of that character could not be depended upon to carry the loading designed for the work. . .The entire area therefore was excavat-

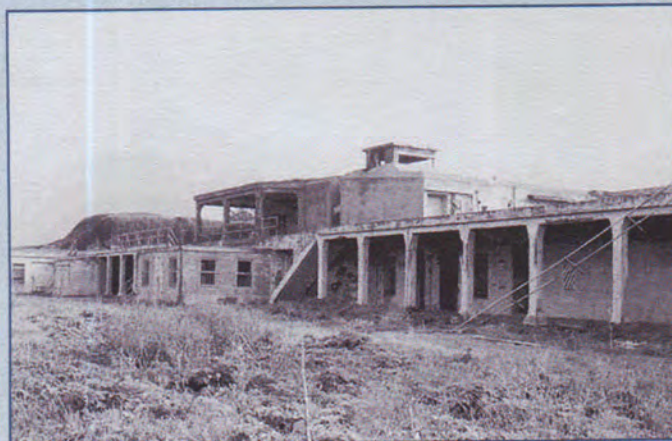
Figure 4. Deterioration such as spalling concrete and rusted railing is evident in this 1973 photograph taken shortly after Golden Gate National Recreation Area was established.

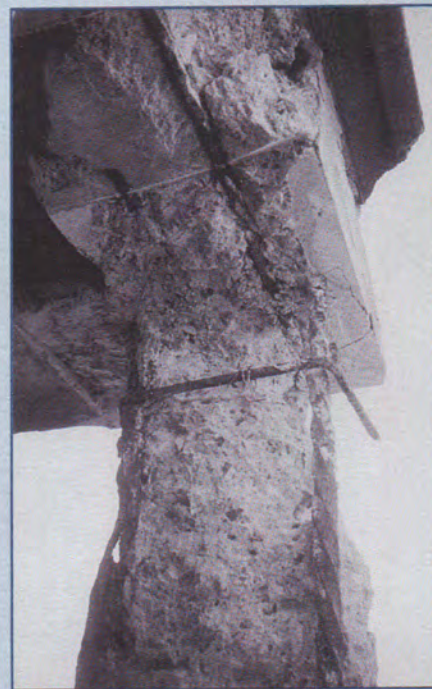
Figure 5. Severe spalling of vertical pillar supporting overhead protection at ammunition hoist, 2000.

About 1910, loading platforms were widened by eleven feet, and ammunition hoist tables with splinter proof overhead protection were added. Safety railing was installed in 1915. These functional improvements were supported structurally by a series of cast reinforced concrete pillars, which are the particular focus of this case study. Because of its remote site and north-westerly field of fire, it saw extensive use as a training battery regulars, reservists, and ROTCs. After the guns were dismounted in 1943, Battery Mendell served as ammunition storage and radar site for the anti-aircraft artillery set up overlooking Bird Rock during the Korean War, but then entered a long period of relative neglect and consequent deterioration (Fig. 4). The minimal caretaking given by the Army to the empty battery was hardly supplemented by the National Park Service, which fell heir to the historic military properties at the Marin Headlands in 1972. The spectacular site was admired more for its viewshed than for its field of fire.

where it was missing. At Battery Mendell, severe spalling at all five pillars on the upper level made it impossible to even mount replacement railing until repairs were made (Fig. 5). The imperative for safety provided the reason—and the funding—for restoration of the concrete.

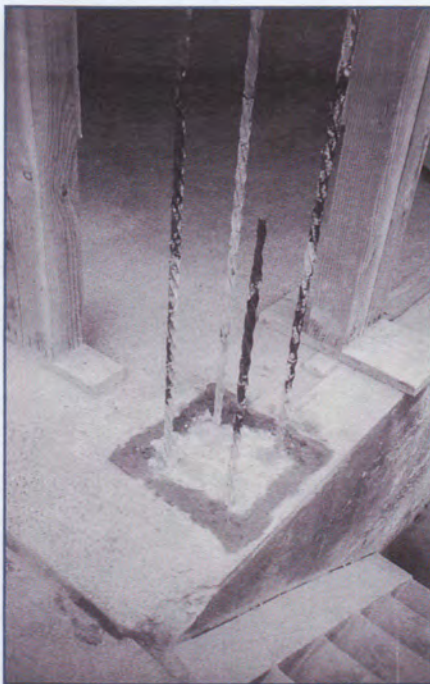
Figure 6. The deteriorated column was removed with careful saw cuts as well as power and hand hammers, leaving as much original rebar as possible.

In the summer of 2000, DBI Construction of Sacramento, California, contracted to make repairs, under supervision of maintenance craftsmen on park staff. As the deteriorated pillars supporting the ammunition hoist canopies were cut and jack-hammered away, examination revealed a relatively coarse mixture with a high sand to rock ratio, and twisted iron rebar placed close to the surface (Fig. 6). Perhaps improperly washed beach sand may have contributed to the effects of the moist salt air to intensify the spalling. Molds were constructed, new one-inch rebar was tied in place to overlap the old, and Five Star Structural Concrete with Rapid Set Cement was poured in place (Fig. 7). All metal was coated with Burgess Rust Destroyer, to inhibit corrosion. Great care was taken so that the new concrete closely resembled the old in texture and color. A thin coat of Rapid Set Non Shrink Multipurpose Grout covered the grain left by the wood forms, emulating—with compatible contemporary material—but not quite duplicating the sandy-grained parge coat originally added as the work was poured (Fig. 8). Upon the completion of repairs to the pillars on the upper level, railings were installed in historically appropriate locations, using industrial grade galvanized steel coated with a rust inhibiting primer.

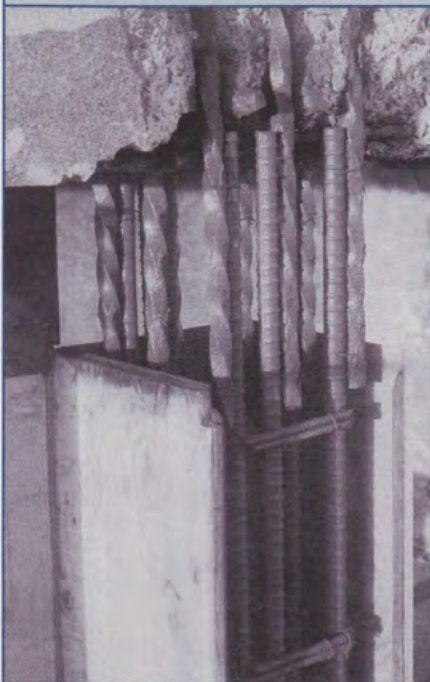
Figure 7. Replacement and original reinforcing rods are coated and tied together prior to pouring rapid setting concrete.

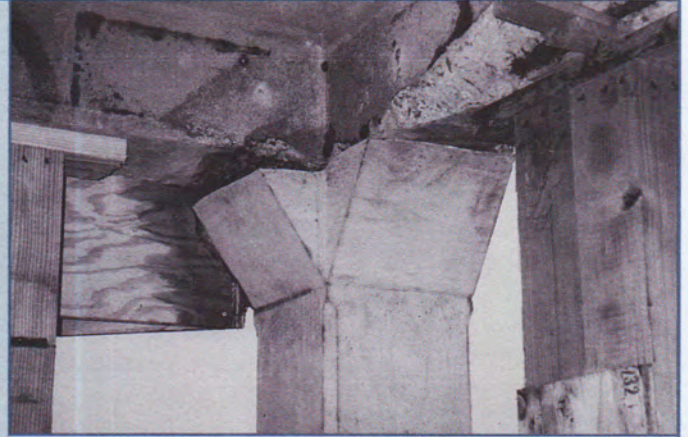
Figure 8. The repaired support pillar convincingly recreates the complex chamfers and cornices of the original.

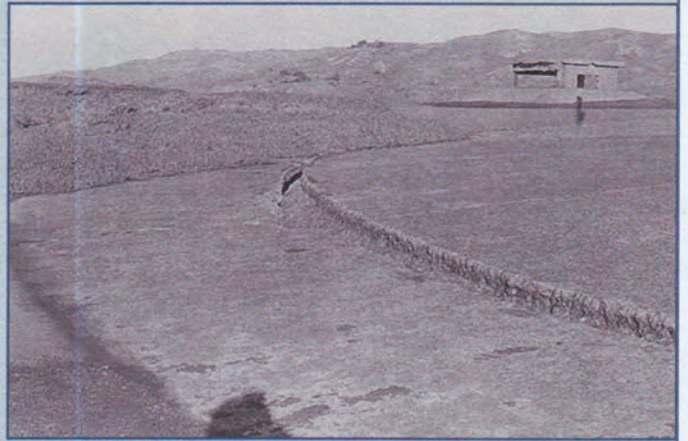
Figure 9. Looking north to BC station from the front of emplacement two, showing separation and subsidence of blast apron from the concrete mass of the remainder of the battery.

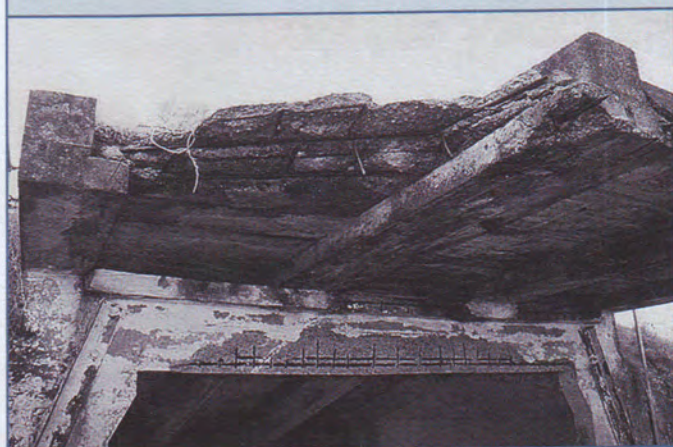
Figure 2. Spalling concrete, four-inch emplacement, North Head.

these veterans. The guns were emplaced in roofed concrete structures called 'Colchester' shelters, themselves a product of urgency and shortage of materials. The structures were built partly on the site and partly from prefabricated panels. Shortages of cement at the time has meant that these structures are now amongst the most heavily decayed of the coastal batteries with severe spalling over much of their surface. Deterioration is especially bad in the prefabricated parts of the structures. The concrete over the steel is of minimal depth and has lead to severe spalling as the steel reinforcing has rusted (Fig. 2).

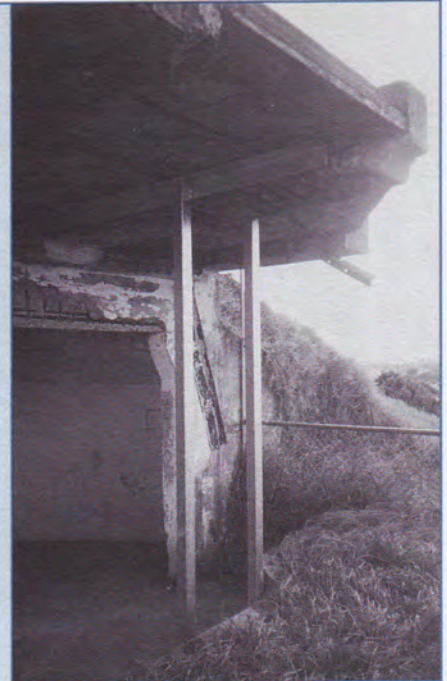
Figure 3. Steel supports for emplacement roof, North Head.

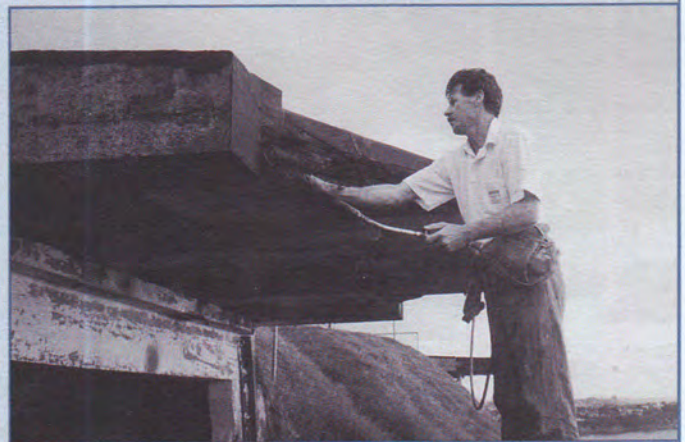
Figure 4. Applying waterproof membrane to emplacement roofs, North Head.

In 1995, a number of people were killed in the collapse of a viewing platform built by the Department of Conservation. Following the accident, a major assessment of all structures on Departmental land was carried out, including historic structures. The four-inch emplacements at North Head were deemed to be dangerous and there were calls for their demolition, estimated to be \$NZ10,000. There was insufficient funding available for a complete repair of the emplacements. At this stage a second engineer was called in who, in consultation with conservation architects and Departmental historic resources staff, came up with the alternative of building a steel frame to support the roofs. The cost was under \$NZ1,000 (Fig. 3). At the same time, a company specialising in the installation of waterproof membranes offered to reseal the roofs of both emplacements at no charge. The membrane has stopped the passage of water through the old concrete roofs and appears to have slowed the spalling (Fig. 4). More extensive repairs will still be necessary when funding is available.

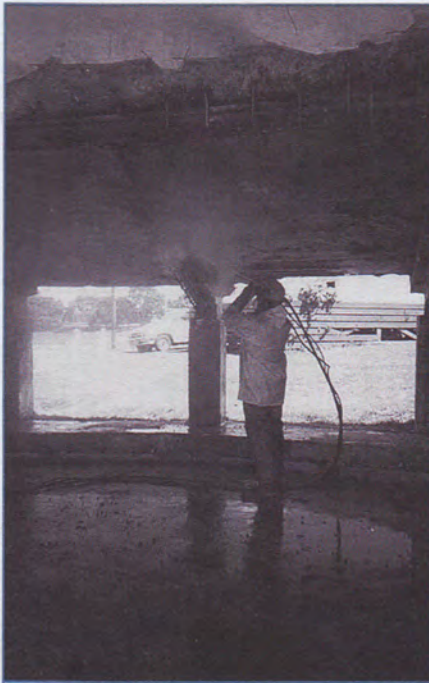
Figure 5. Cleaning steel, Fort Takapuna.

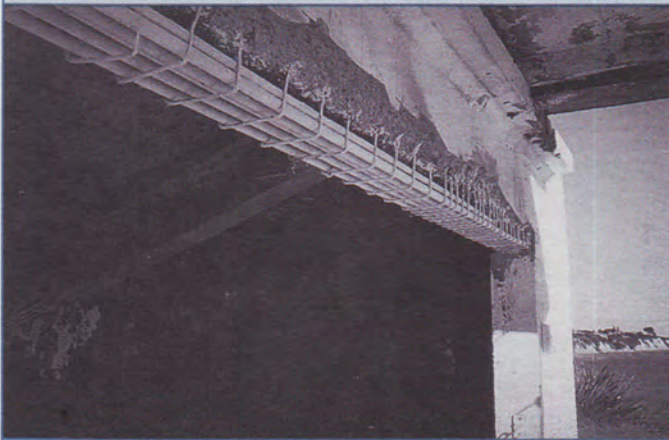
Figure 6. Reinforcing steel primed prior to plastering, Fort Takapuna.

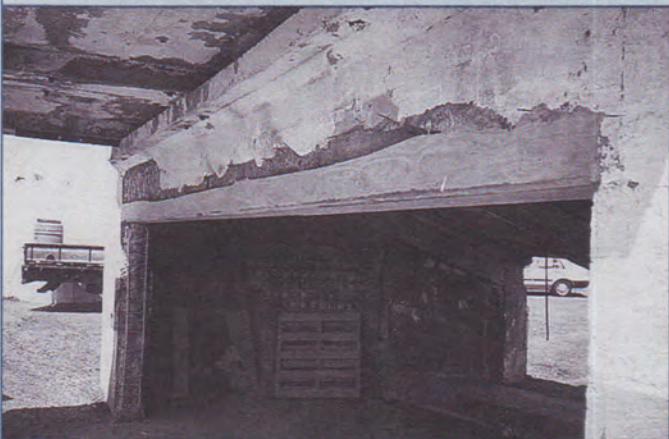
Figure 7. New plaster in place on main lintel, Fort Takapuna.

In 1999, the Department took over the management of a former Defence Department site at Fort Takapuna. The four-inch examination battery at this site was in a similar condition to that at North Head, although there was sufficient funding here to carry out repairs properly. Where the concrete had already broken away, the exposed steel was grit or water blasted (Fig. 5) and the product Nitocote CM210 was applied. Where the concrete had cracked but not spalled, the loose and drummy concrete was removed, the steel grit blasted and then primed with Nitoprime Zincrich (Fig. 6). The concrete was then treated with Nitobond HAR bonding agent and Renderoc HB 25 repair mortar used to repair the damaged areas (Fig. 7). Nitobond AR curing membrane was then applied and white Nitocote CM210 put onto the repaired areas.

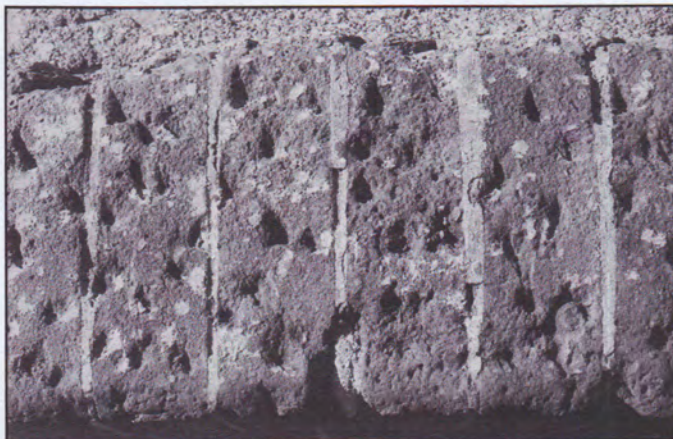
Pitted brick at Fort Point, California.

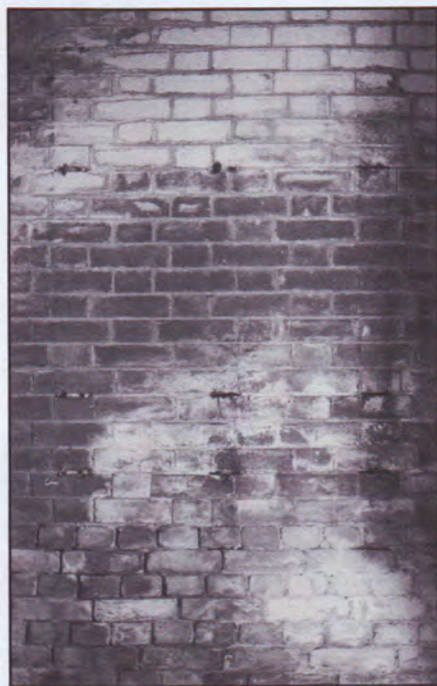
The appearance of crystalized salts is referred to as efflorescence. Battery Cavallo, Fort Baker, California.

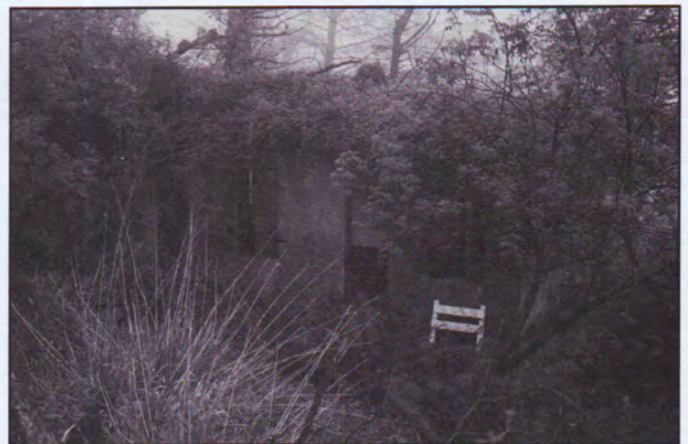
Uncontrolled plant growth can lead to the rapid deterioration of wood-frame structures that are also part of many fortifications. Fire Control Dormitory, Fort Canby, Washington.

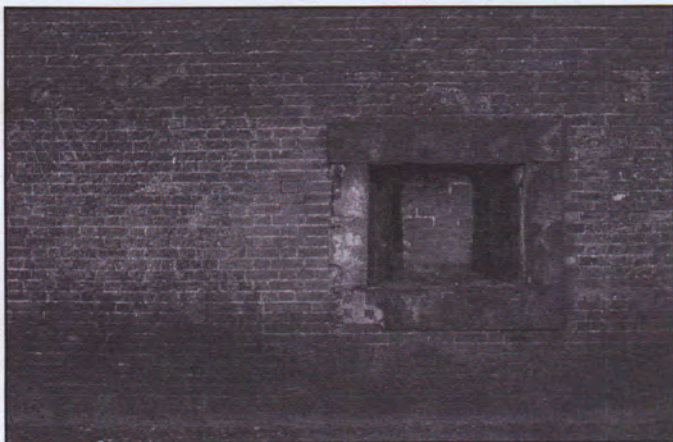
The dark area at the point of ground contact indicates rising damp. As the name suggests, the condition moves moisture upward as a result of capillary attraction. Fort Point, California.

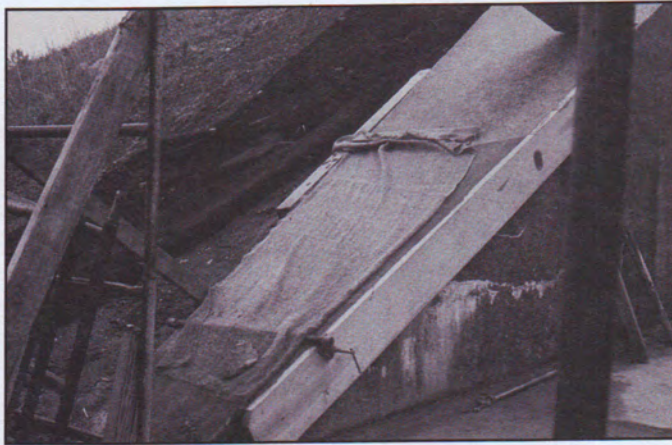
After new concrete was placed in the patch area, it was covered with burlap to encourage a better cure. Battery Gregg.

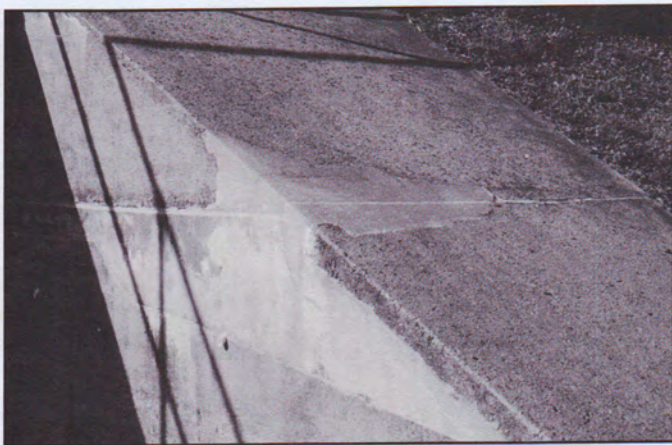
This view of a concrete repair at Battery Gregg was taken about five years after the work was completed. The patch is intact and appears to be well-bonded to the substrate.

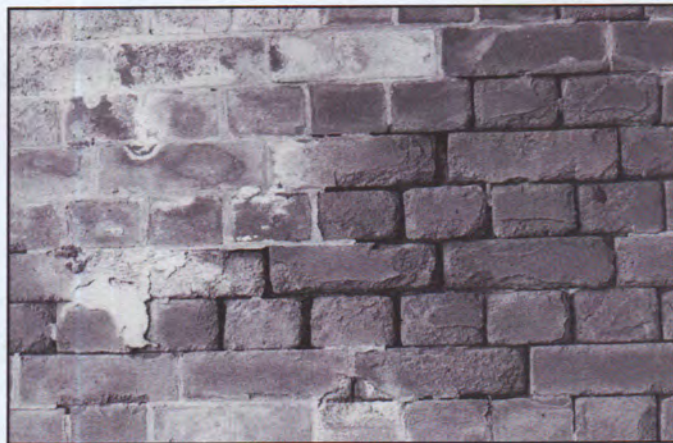
Open joints indicate that this brick wall is overdue for repointing. Battery Cavallo, Fort Baker, California.

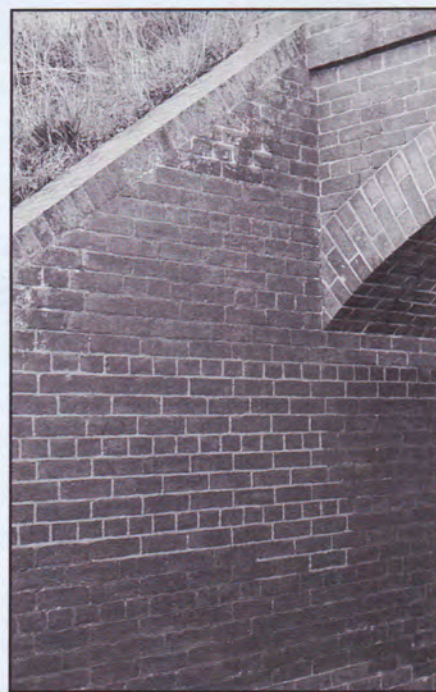
If the repointing mortar does not match the appearance of the existing mortar, the repair will be too noticeable. Battery Cavallo.

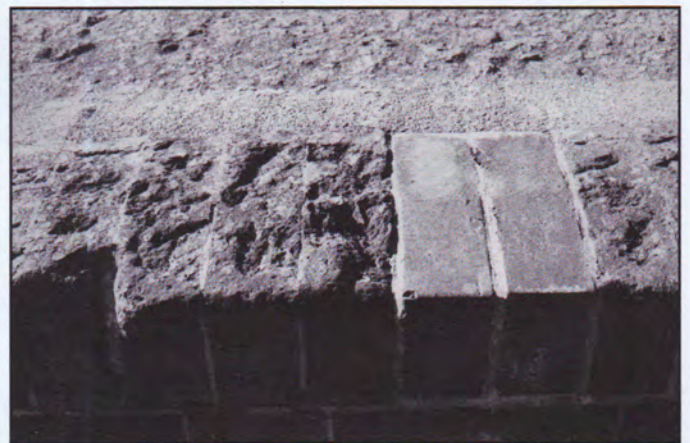
These two new bricks replaced damaged units. Avoid distressing new material to give it the appearance of age. Fort Point, California.

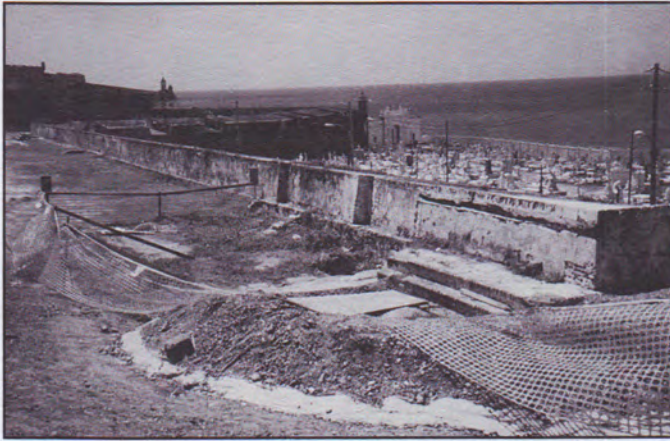
Above the area of the collapsed drainage tunnel, the terreplein has sunk and the stones of the firing steps along the parapet are beginning to drop away. City Walls, San Juan, Puerto Rico.

joints to prevent further collapse. The soil was backfilled to restore the ground level next to the wall and adjacent firing steps.

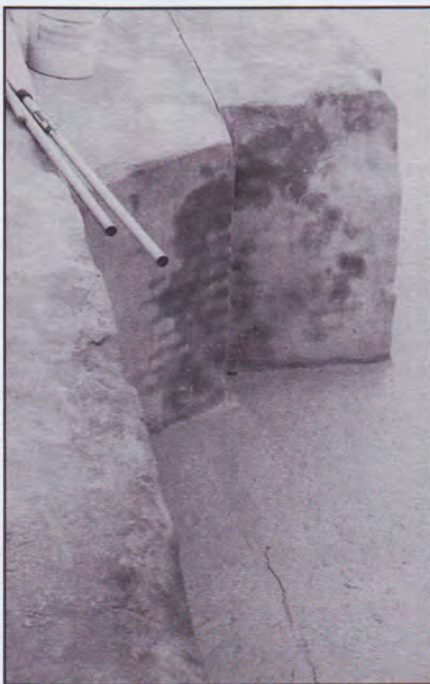
Close-up view of a new stucco application and an elastomeric membrane at Fort Sumter, South Carolina.

applied to the stucco for additional moisture protection. This coating is being re-evaluated due to the recent appearance of moisture in the stucco wall.

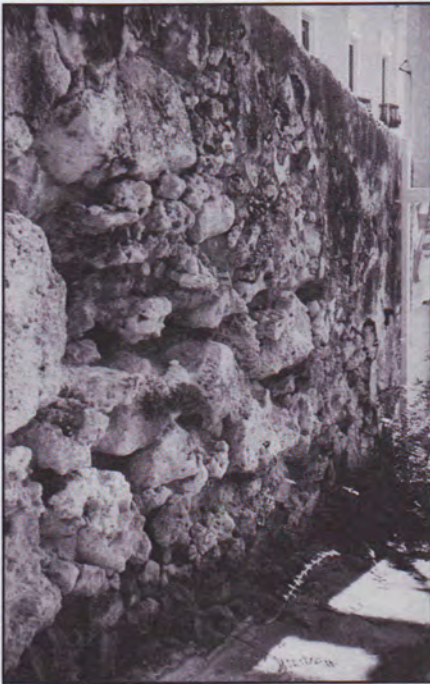
Critical lack of maintenance has led to advanced deterioration of the city walls in San Juan. The binder is all but gone, and only the weight of the stones hold them in place.

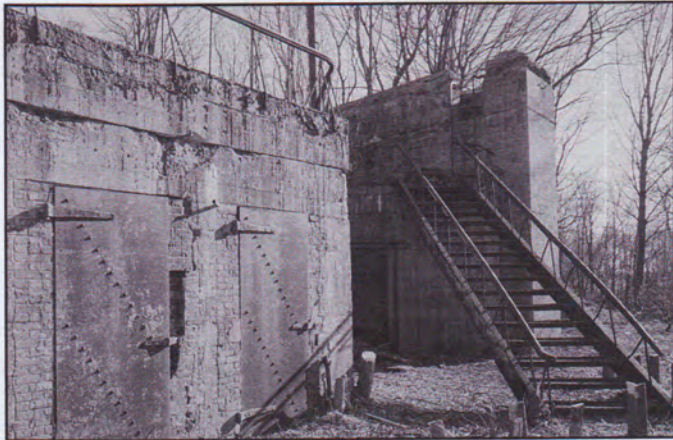
Plate steel, forged iron, galvanized iron, and structural steel shapes are all in evidence in this predominantly concrete fortification. Battery Richmond, Fort Wadsworth, New York.

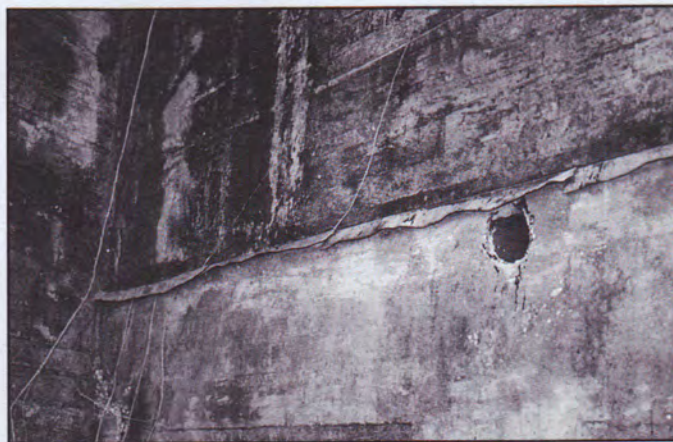
A sheet of non-ferrous metal acts as an impervious membrane between two concrete pours at Battery Pensacola, Fort Pickens, Florida.

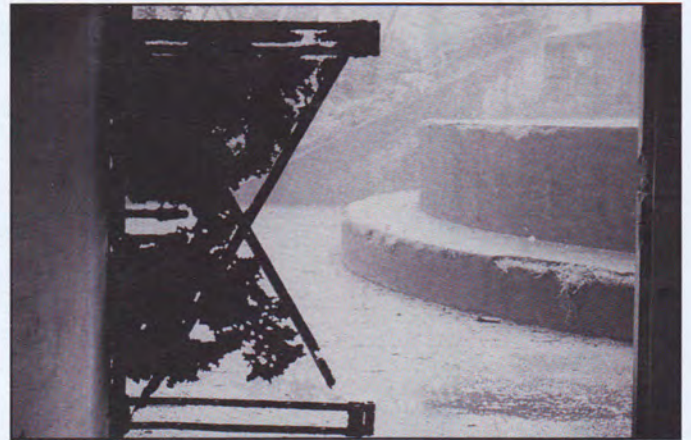
A wet climate and salt-laden fogs are ideal conditions for the rapid loss of ferrous metals, as suggested by this corroded door at Battery Harvey Allen, Fort Canby, Washington.

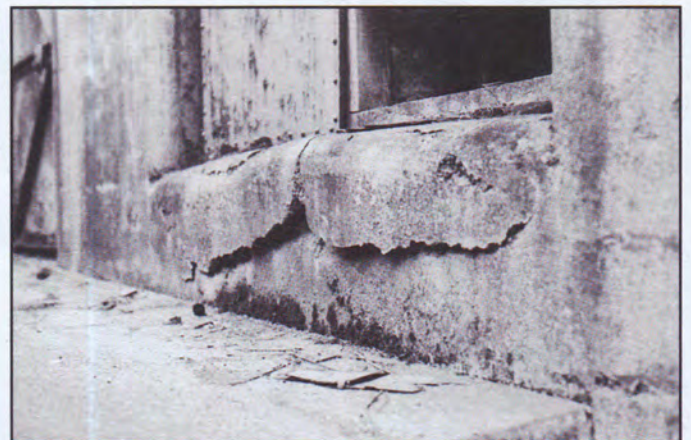
When corroded, metal expands to approximately ten times its original volume. The force is sufficient to break and detach surrounding concrete or masonry. Battery Tolles, Fort Worden, Washington.

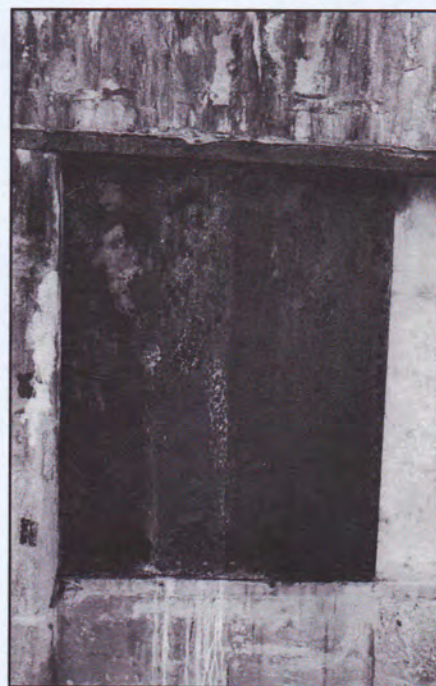
Always test products, especially rust converters. Here, several products are undergoing long-term trials (including one that has left a white residue on the surface) Battery Grattan, Fort Flagler, Washington.

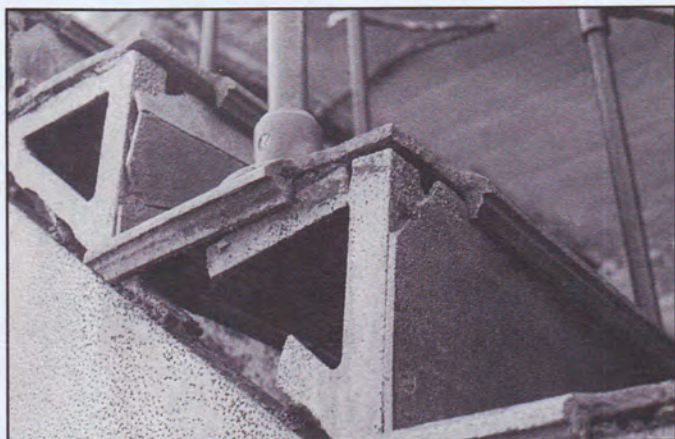
Repairing broken cast iron is difficult, especially if pieces are missing. Fixes include recasting a replacement section or fabricating a new section from appropriate substitute materials. Battery Harker, Fort Mott, New Jersey.

Cast iron breaks easily because of its brittleness, but even when broken elements can be pieced together, repair is difficult. Welding cast iron is a challenge. The job usually involves removing the damaged materials to a workshop where they can be preheated to avoid the creation of thermal stresses inherent with the welding process, and then welded with one of the alloys that are made specifically for the repair of cast iron.

Cold metal stitching is a more successful method. It is most often applied to cracks in cast iron, but it can also be used to attach patches. In this method, the crack is drilled out and replaced with threaded nickel steel pins called locks. The locks have the same coefficient of expansion as iron and bind across the crack. The repaired surface can be ground down to match the surrounding material and repainted to provide an almost invisible attachment.

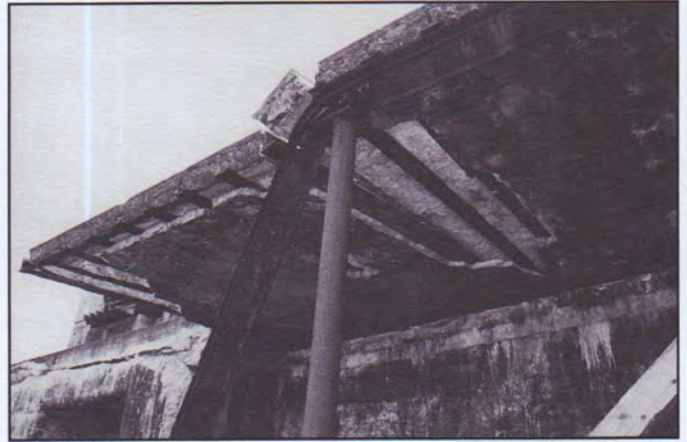
Several causes contributed to the failure of this platform at Battery Cullum at Fort Pickens. Included among them are loss of a supporting column, corrosion-induced loss of section in the beam, and questionable original design detail.

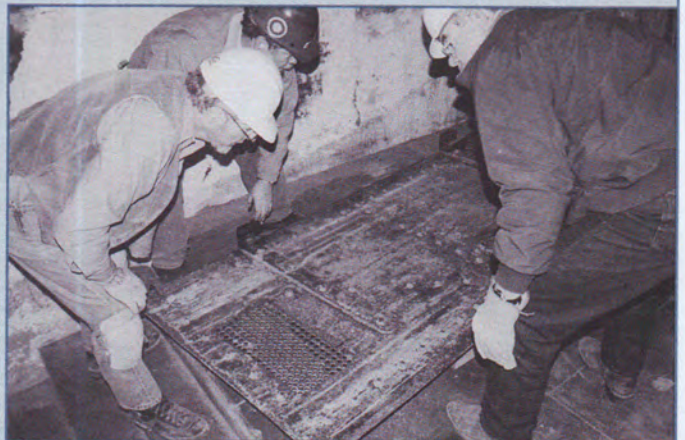
Figure 2. The door was lowered down to rest on wooden sleepers that had been positioned to receive it. The lighter color on the back of the door is the surviving layer of red lead.

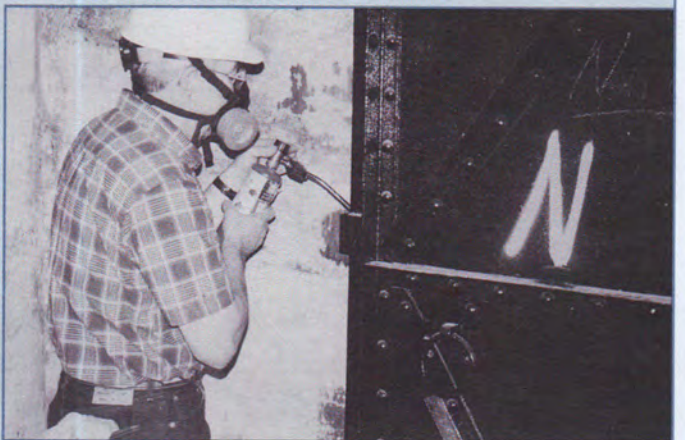
Figure 3. Using heat to loosen a frozen nut. Safety equipment was necessary because of the potential of lead paint hazard.

open position, and the brackets were attached to the concrete with threaded fasteners secured by welded nuts. The welds were broken and the nuts removed. In one instance, the nut was firmly rusted in place, and heat was used to loosen it (Fig. 1). Anthony Construction removed the doors by applying penetrating oil to the hinge pin and working the door slightly until it had some free motion. The door was levered upward until the pin was clear of its socket (Fig. 2), and then it was lowered to the ground by four workers; we estimated that the door, which was seven and one-half feet high, weighed about 225 pounds. Although the back of the door had not been painted in decades, the red-lead primer was still intact and prevented the spread of the corrosion that had destroyed the bottom edge (Fig. 3).

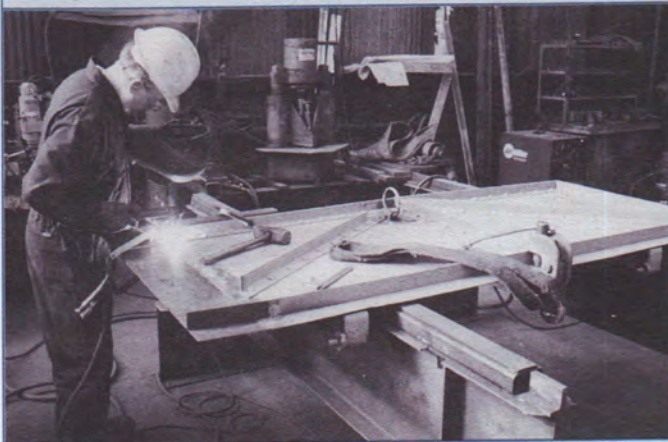
Figure 4. New steel plate being welded to an original door to replace the corroded section that has been removed.

the paint layers. When the doors arrived at Seidelhuber iron, we removed the bottom 10 inches of both doors to get to sound metal. We then welded in new plate and angles of similar dimension (Figs. 4 and 5). The heat generated by welding caused the doors to warp slightly, although the doors were significantly warped before the welding began. The warpage on the unrestored doors was caused in part by corrosion between the faying surfaces. This unevenness was enough to bind the door slides, and explains why they were not operational. The doors were straightened before the rivets were installed (Fig. 6).

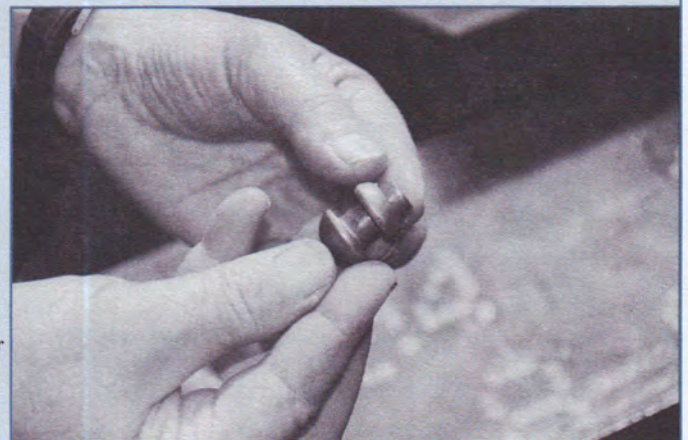
Figure 8. The process of duplicating the appearance of hot rivets began by drilling out the stem of one rivet (shown here on the right) so that it would fit over the stem of another rivet (left).

Our first step was to pre-punch the stiffener angles with twice as many holes than were required. Every other hole was plug welded to hold the angles snugly in position for riveting (Fig. 7). Holes were then punched in the door plate so that we could insert the shaft of the mushroom-shaped rivet. Extra rivet heads were drilled to receive the rivet stems (Fig. 8), and the joint between the two was welded. Each new rivet was heated and dressed so that its shape matched the distinctive truncated cone shape of the original (Fig. 9).

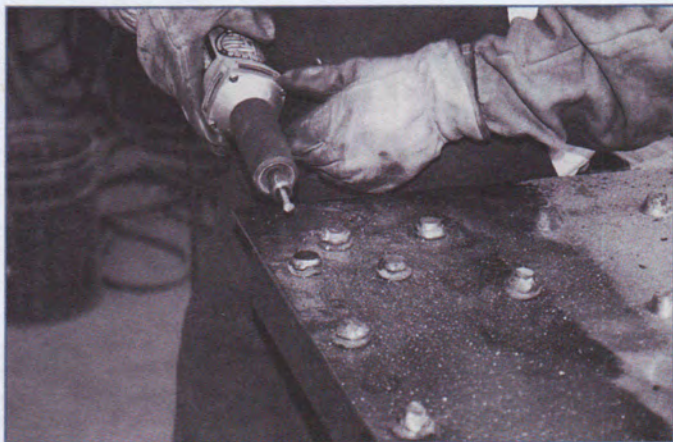
Figure 9. The two rivet elements were welded together and then shaped to the configuration of hot rivets.

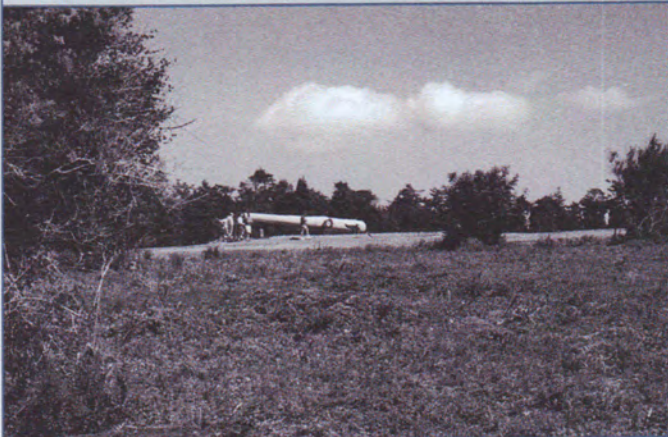
Clearing 6.5 acres of brush away from the main battery helps reestablish the historic appearance of the main battery and raises hopes that the Golden paintbrush population can establish itself above the minimum viability threshold.

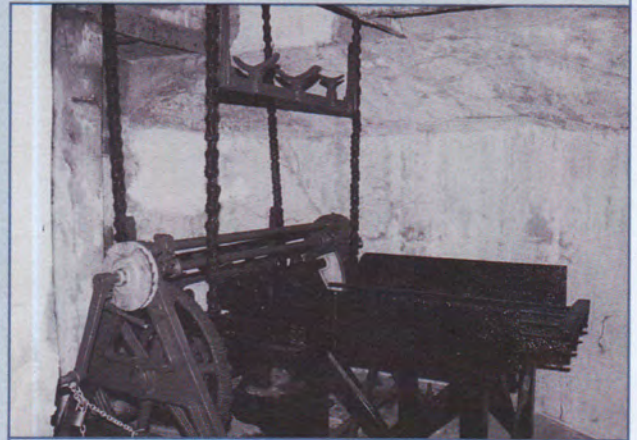
This rehabilitated hoist gives visitors a demonstration of how technology was used to lift heavy ammunition up to the guns.

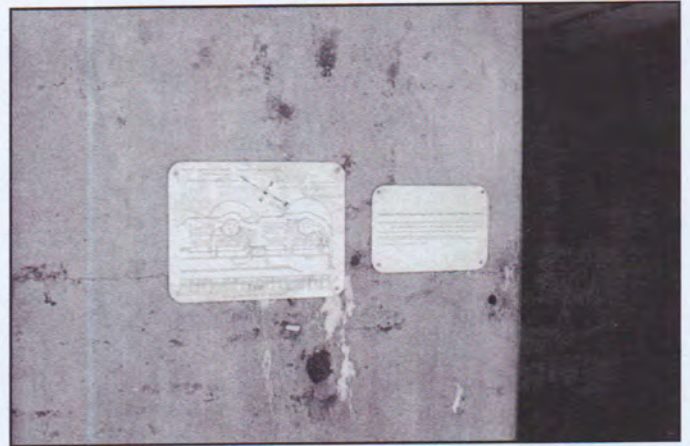
Signs bolted directly to a wall at Fort Casey. A preferred alternative would have been to attach the signs to non-intrusive brackets or freestanding bases.

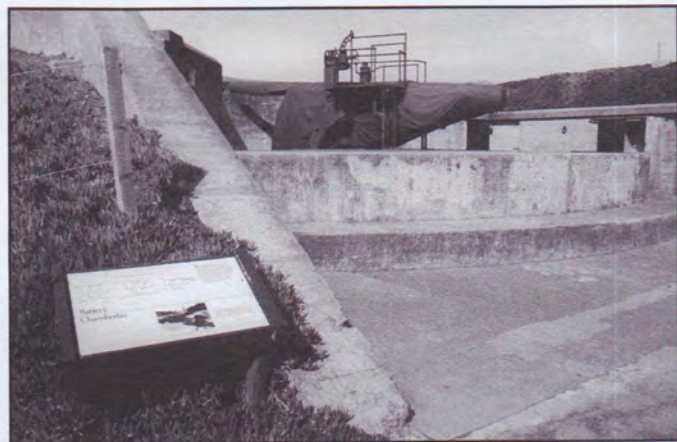
A wayside exhibit positioned in a manner that does not block views of the gun or emplacement at Battery Chamberlin, Fort Scott. The descriptive panel is helpful when the gun is covered to protect it from the elements.

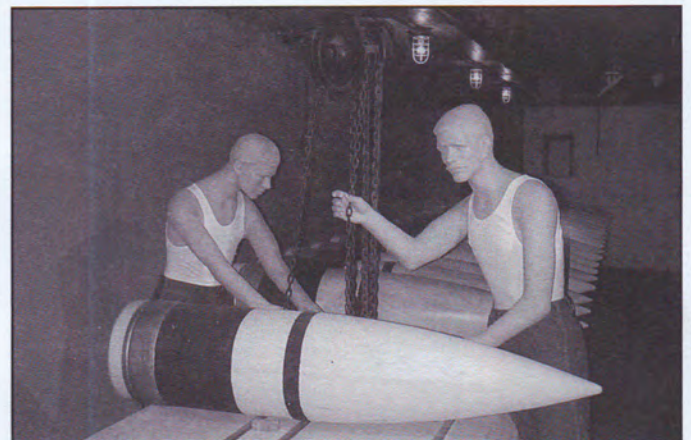
This projectile gallery at Fort DeRussy has been restored with replica 14-inch projectiles, overhead rails, lighting, and "crew." A waist-high fence, not visible here, separates viewers from the display.

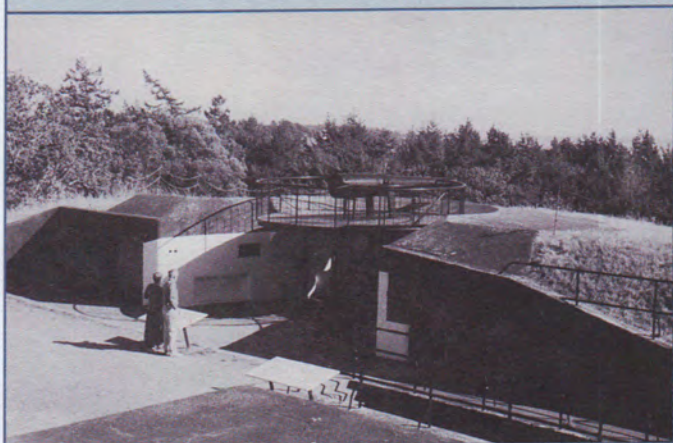
Combination. There are more cannon to be had than there are carriages. A six-inch gun lay dismounted for many years in the Upper Battery of Fort Rodd Hill, although no carriage was available to mount it. Parks Canada undertook the next best alternative. A structural steel framework now supports the original cannon in its firing position, giving visitors a sense of how the battery looked when it was armed.

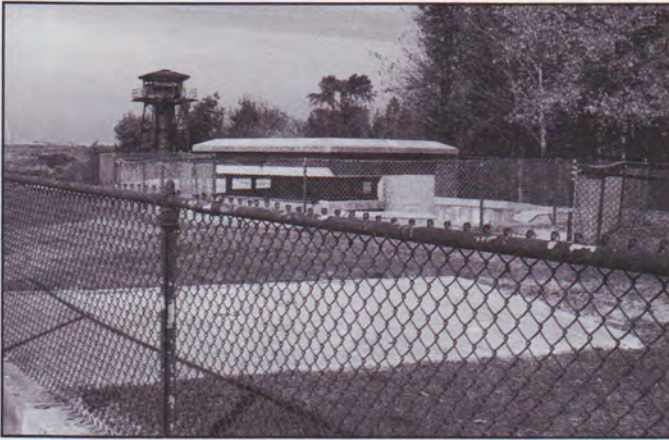
How much fencing is enough? Multiple fences obscure the historic resource. We need to determine if fences are to constitute an absolute barrier or if they are intended to warn people of a hazard. Fort Mott.

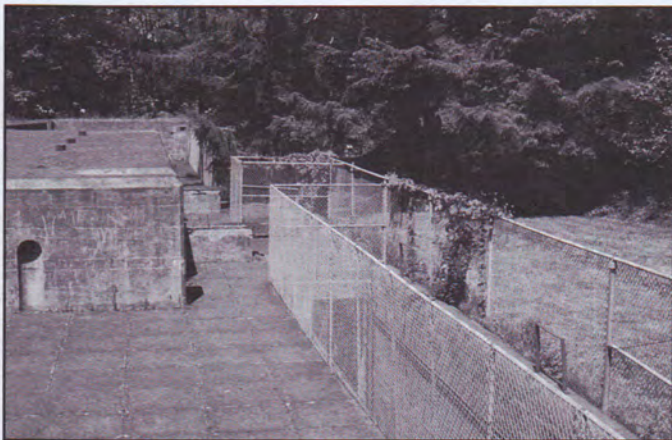
A fence surrounds a recessed floor at Battery Murphy, Fort Columbia. The decision to fence off the feature is a good one, although a shorter fence would be just as effective and less intrusive.

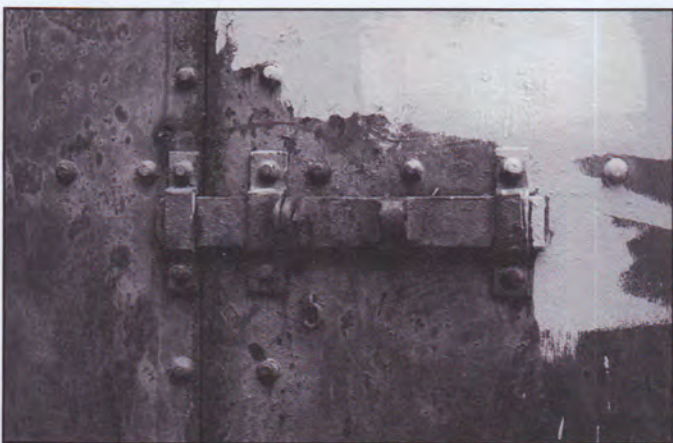
An operating slide secures this double-leaf door. The nut is welded to the bolt that passes through the padlock opening, but no part of the slide itself is welded. Periodic lubrication will ensure its continued functioning.
