Historic Fortification Preservation Handbook

Pacific Northwest Preservation Partnership

Published by Washington State Parks and Recreation Commission, 2003

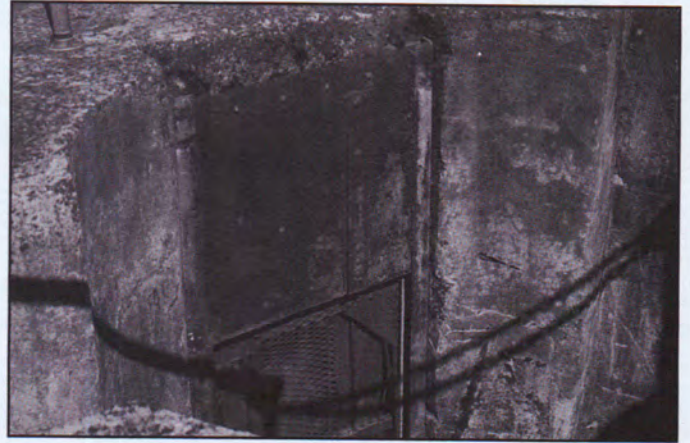
The historic resource should never be scavenged for materials. Doors taken from other locations have been cut and welded together to close this opening at Battery Mishler, Fort Stevens.

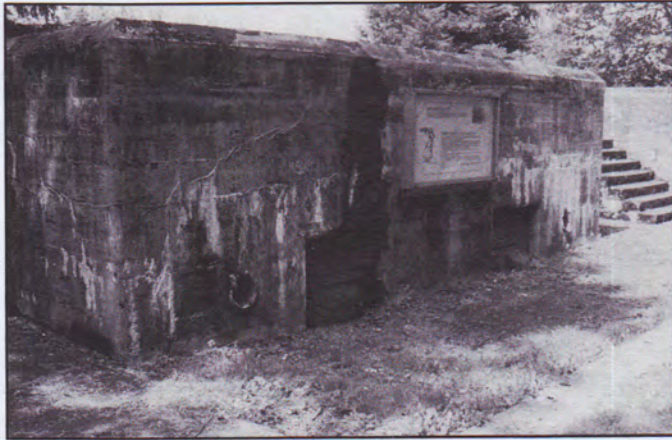
An earth-filled stairway at Battery Vinton, Fort Ward, Washington.

If used to fill a stairwell or other cavity, dirt ensures that there will always be a source of moisture to contribute to rising damp, corrosion, rot, and the growth of unwanted vegetation. It will plug floor drains, which could result in water accumulation in the closed-off rooms if the rooms themselves were not furnished with drains. Eventually the doors will collapse from a lack of maintenance, and the earth fill will slump into the rooms, permitting the access that the material was supposed to prevent.

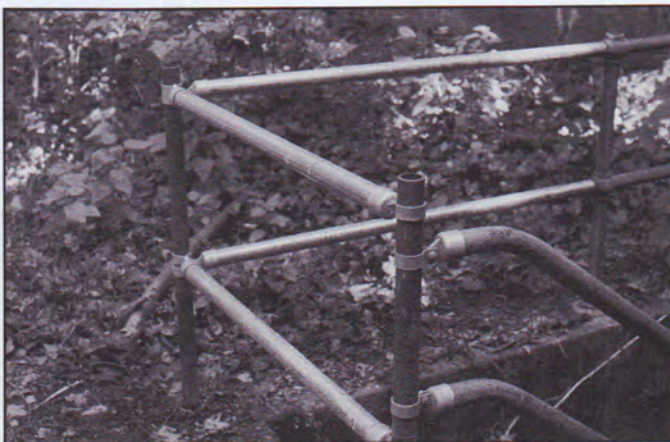
A simple and compatible replacement railing at Battery Thornburgh, Fort Ward. The railing clips to the original pipe rail stanchions.

Temporary replacement railings can be useful if they can be installed in a manner that does not damage historic fabric. Some original pipe railings were threaded into flanges attached to the surface with screws. The flanges can still provide an attachment for threaded pipe.

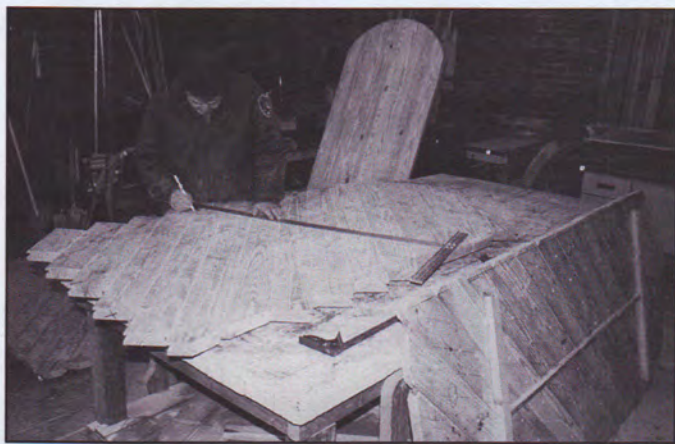
A volunteer carpenter builds a door following an historic design at Fort Pickens.

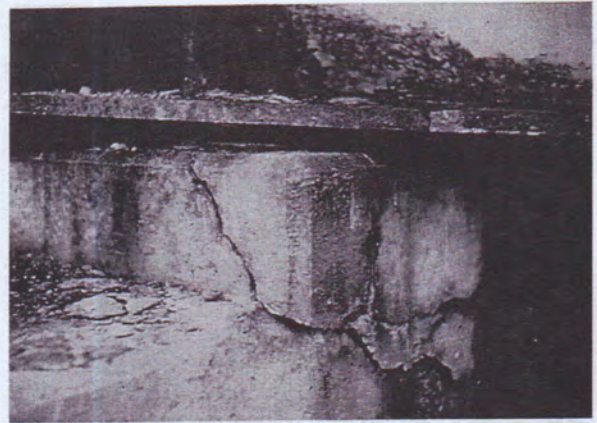
Fig. A.1.4-Diagonal cracks

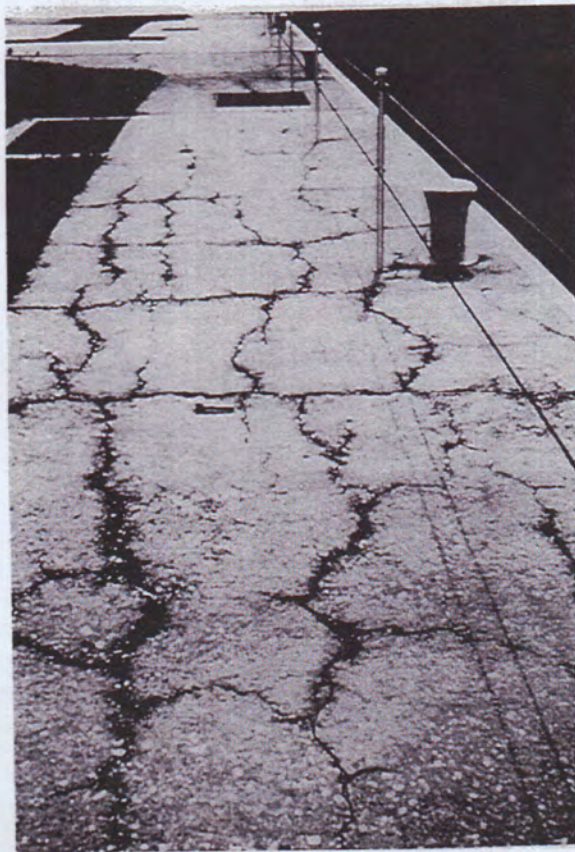
Fig. A.1.6d-Pattern cracking (alkali-silica reaction)

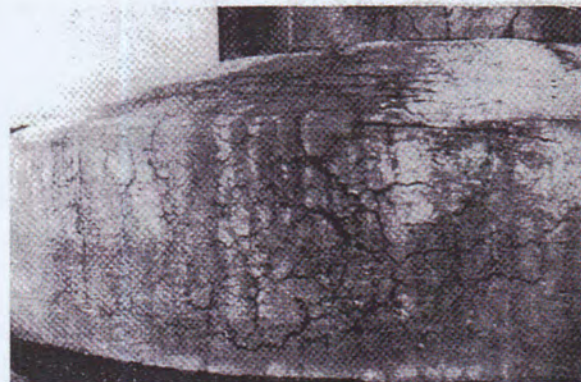
Fig. A.1.6f-Pattern cracking (alkali-carbonate reaction)

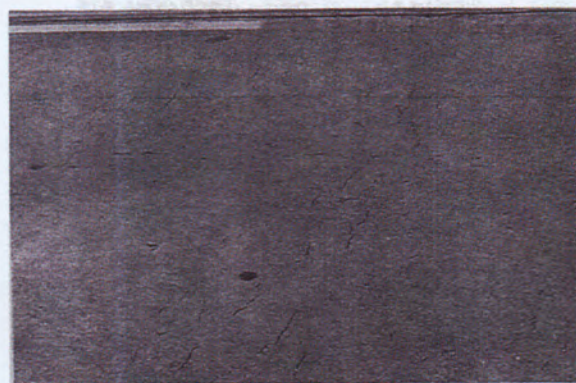
Fig. A.1.7-Plastic cracking

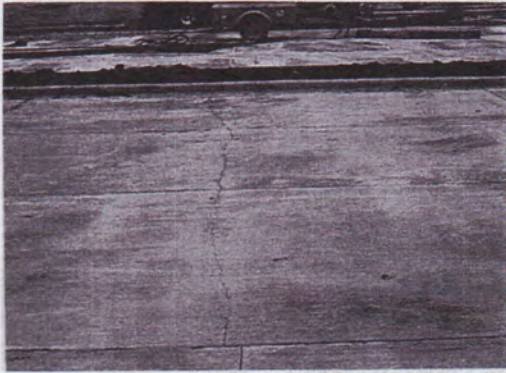
Fig. A.1.8-Shrinkage cracking

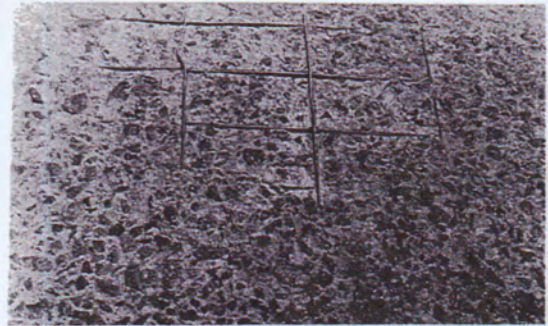
Fig. A.2.1-Abrasion damage

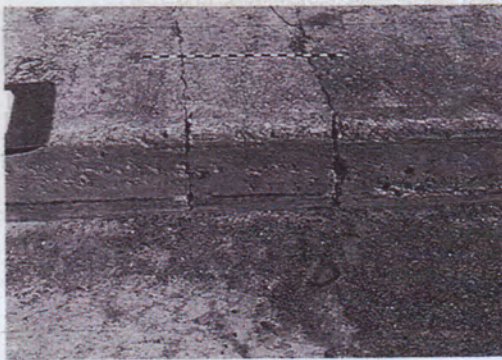
Fig. A.1.10-Transverse cracking (wide)

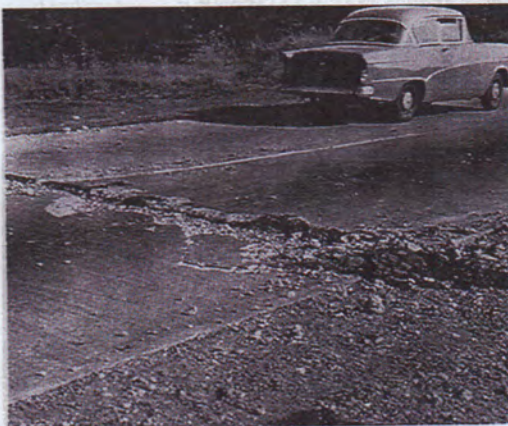
Fig. A.2-Disintegration

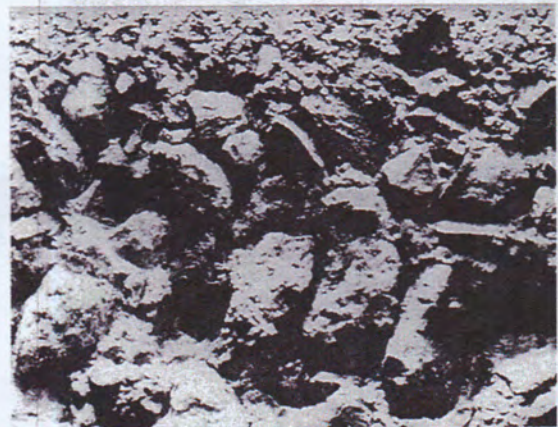
Fig. A.2.3-Cavitation damage

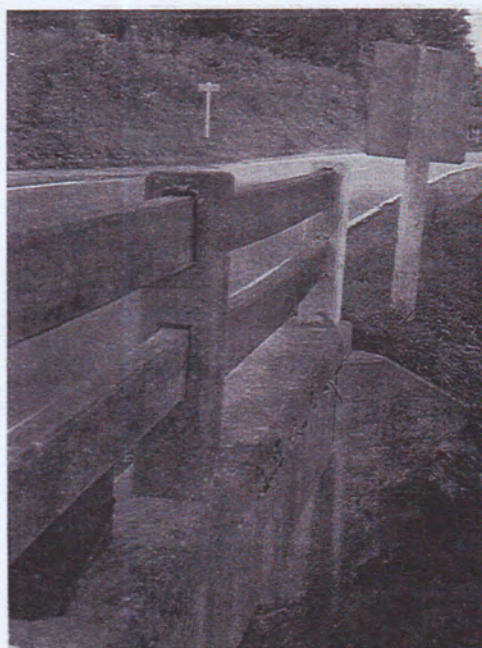
Fig. A.2.10-Distortion

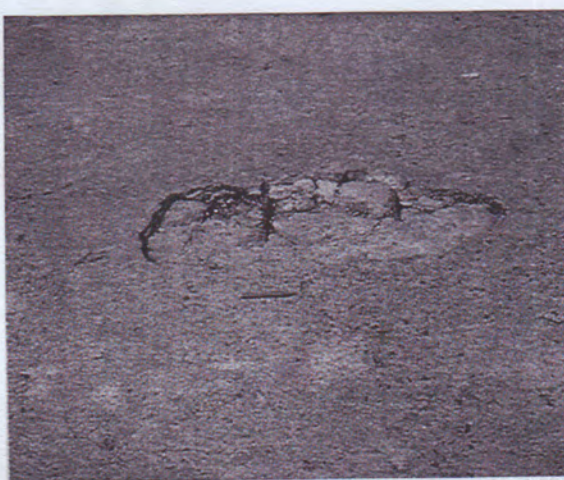
Fig. A.2.9-Delaminations

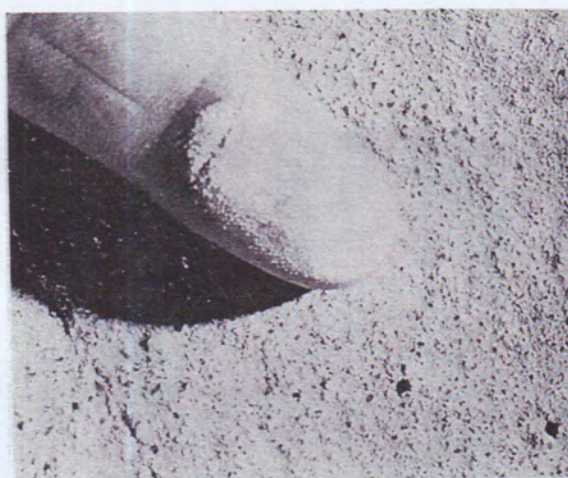
Fig. A.2.11-Dusting

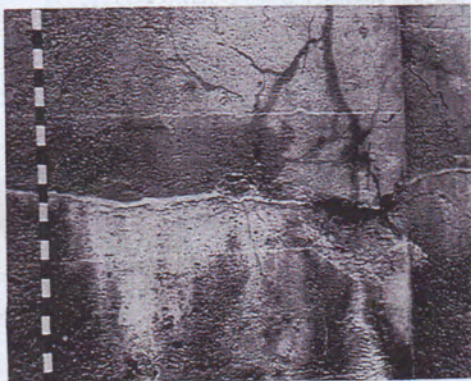
Fig. A.2.15-Exudation

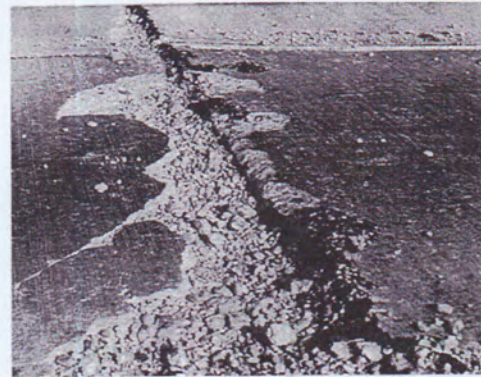
Fig. A.2.16a-Joint spall

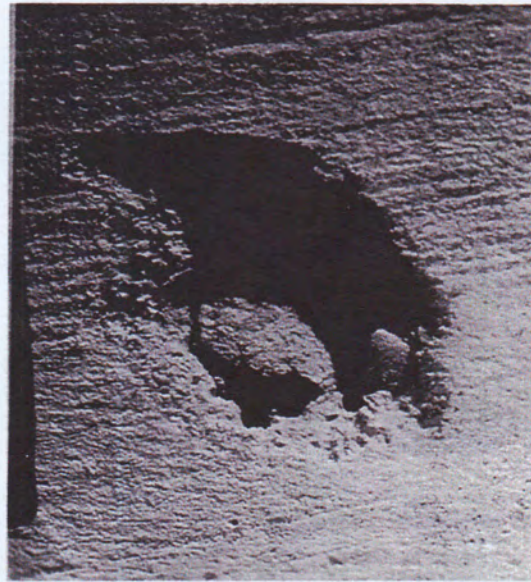
Fig. A.2.19—Popout

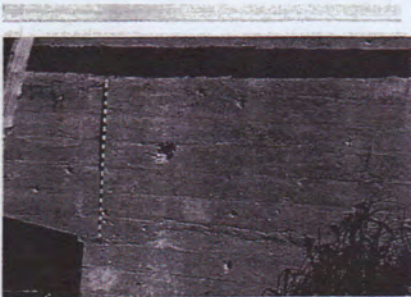
Fig. A.2.19.3-Popout (large)

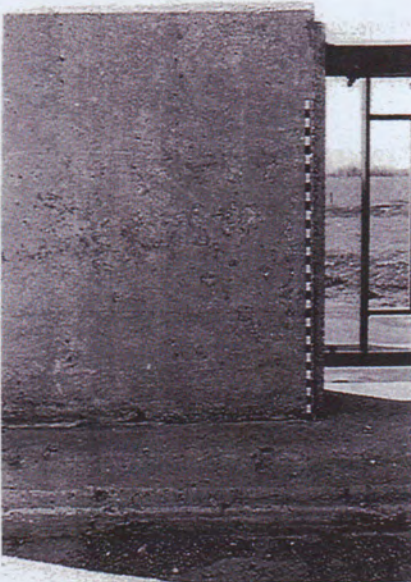
Fig. A.2.20.1a-Scaling (light)

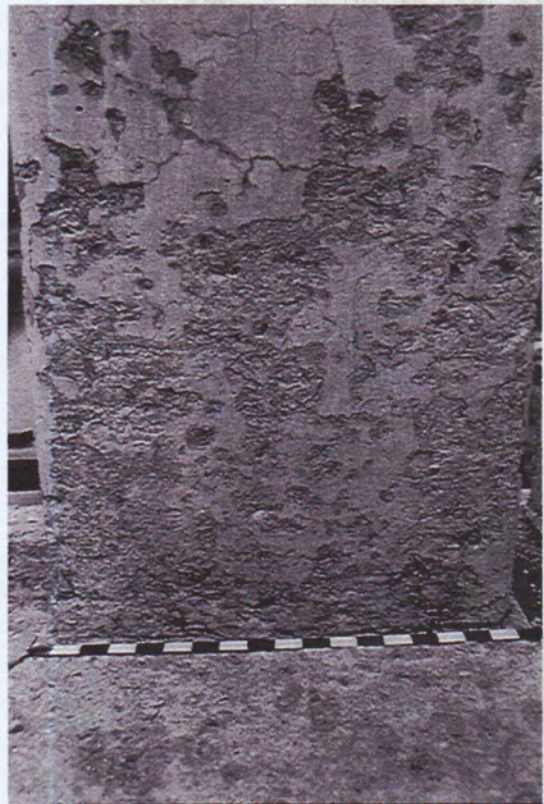
Fig. A.2.20.2a-Scaling (medium)

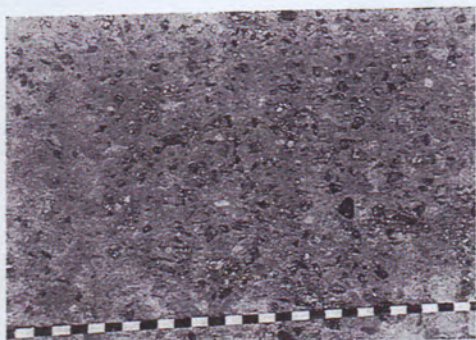
Fig. A.2.20.2b-Close-up scaling (medium)

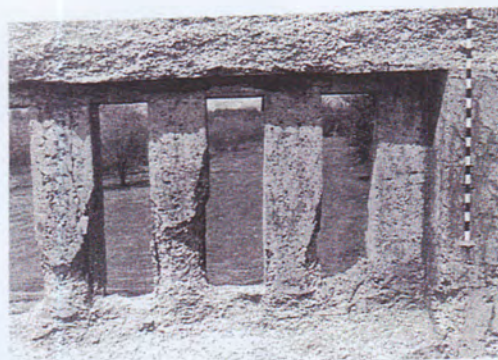
Fig. A.2.20.4a-Scaling (very severe)

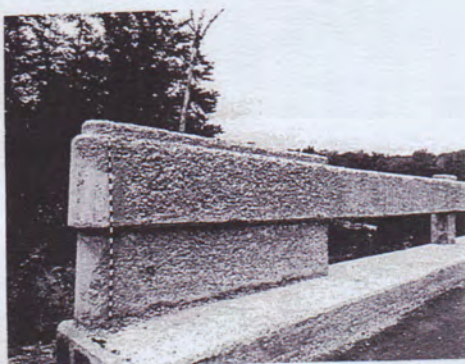
Fig. A.2.20.3a-Scaling (severe)

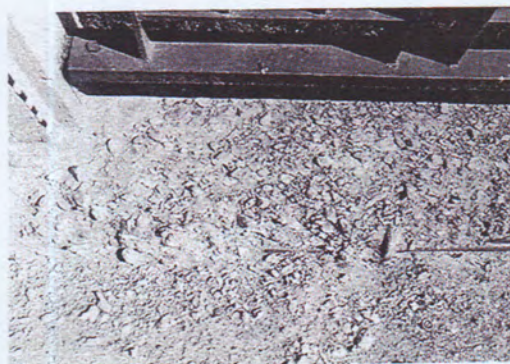
Fig. A.2.20.4b-Close-up scaling (very severe)

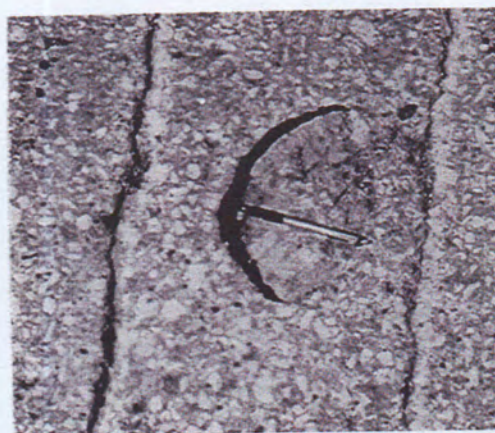
Fig. A.2.21.1-Small spall

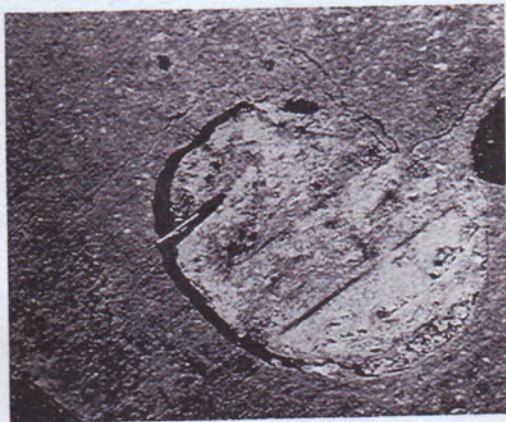
Fig. A.2.21.2—Large spall

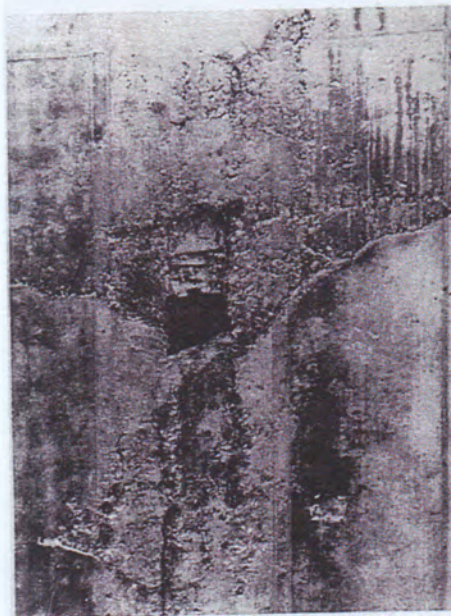
Fig. A.3.5—Cold joint

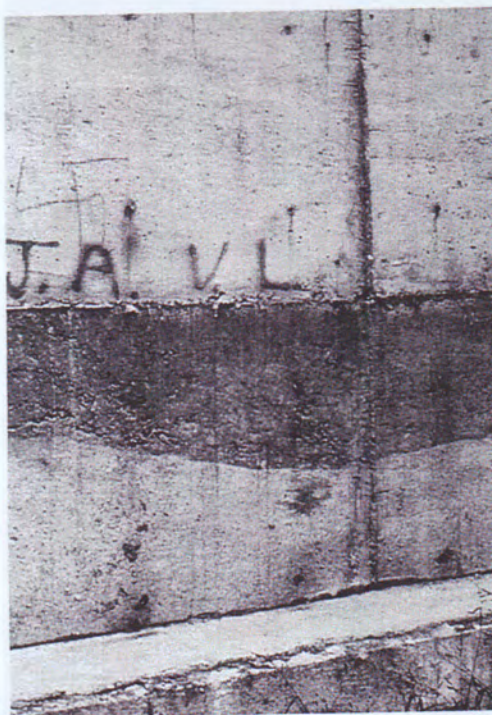
Fig. A.3.6—Discoloration

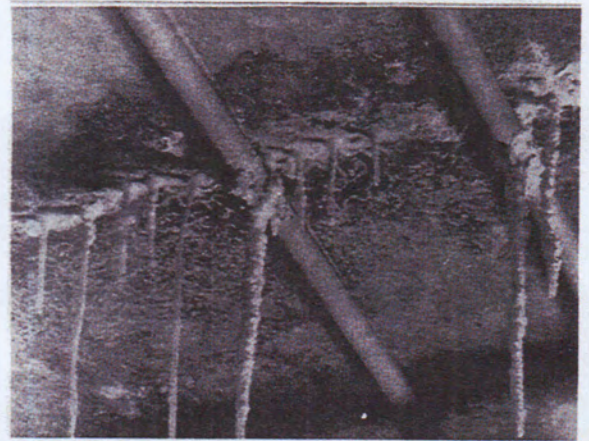
Fig. A.3.14—Stalactite

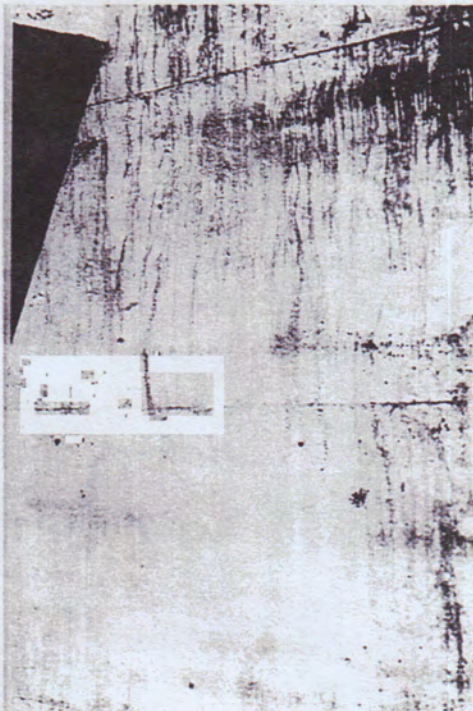
Fig. A.3.12—Sand streak

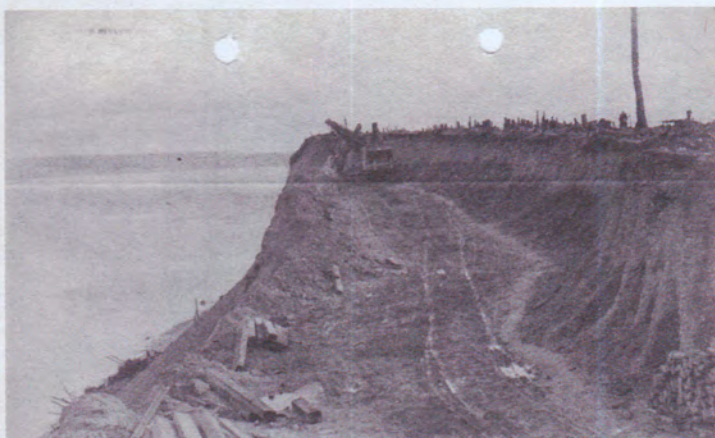
Figure 2. National Archives & Records Administration

In 1897, work began to cut down the height of the bluff as part of the modifications necessary to fortify the site. As shown in Figure 2, the area has been logged off and perhaps burned, and the steam shovel has removed earth along the crest of the bluff, creating a bench some 15 feet below the original ground surface. The photograph also documents the depth of the original top soil.

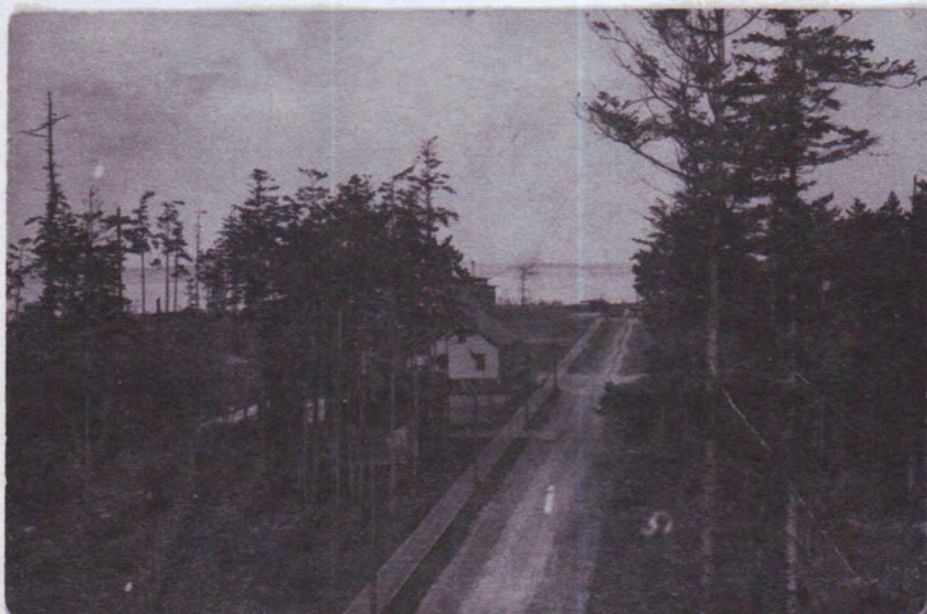
Figure 3. Park Collection

Figure 3 is a view looking north along the main battery access road with the silhouette of Battery Wilhelm's gun number two visible in the distance. The photo is undated, but it is after 1910 and prior to 1918. As expected, there are no trees on the horizon nor is there any vegetation of appreciable scale to the rear of the main battery.

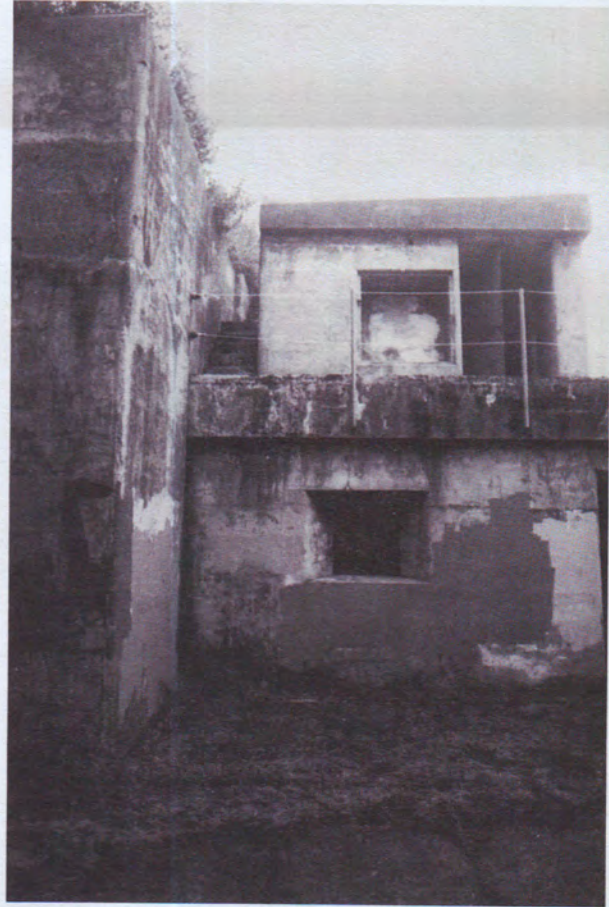
The western edge of Battery Benson viewed from the roadway at the rear of the gun emplacement.

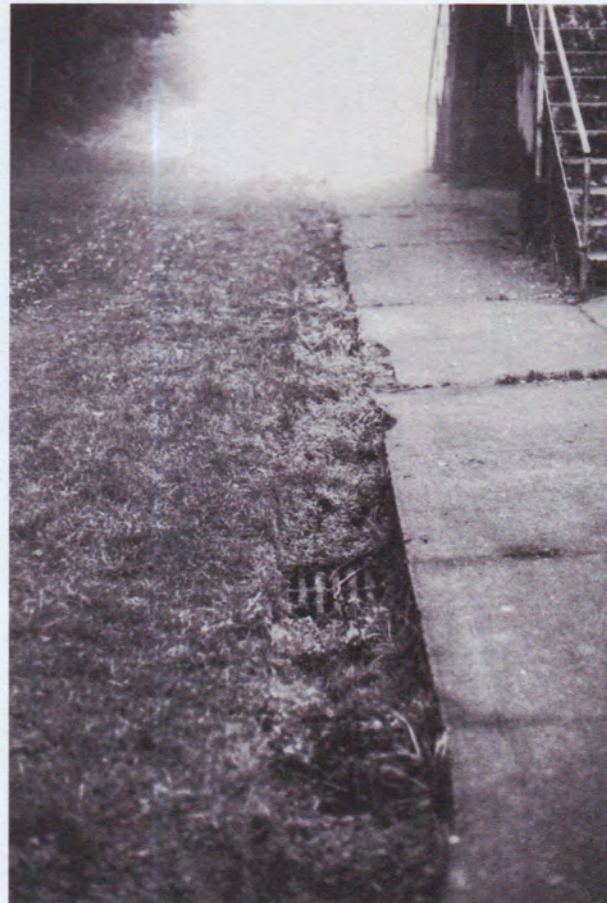
Detail of gutter filled with debris and soil at rear edge of gun emplacement. The gutter and drainage system should be cleaned and restored to a functioning system.

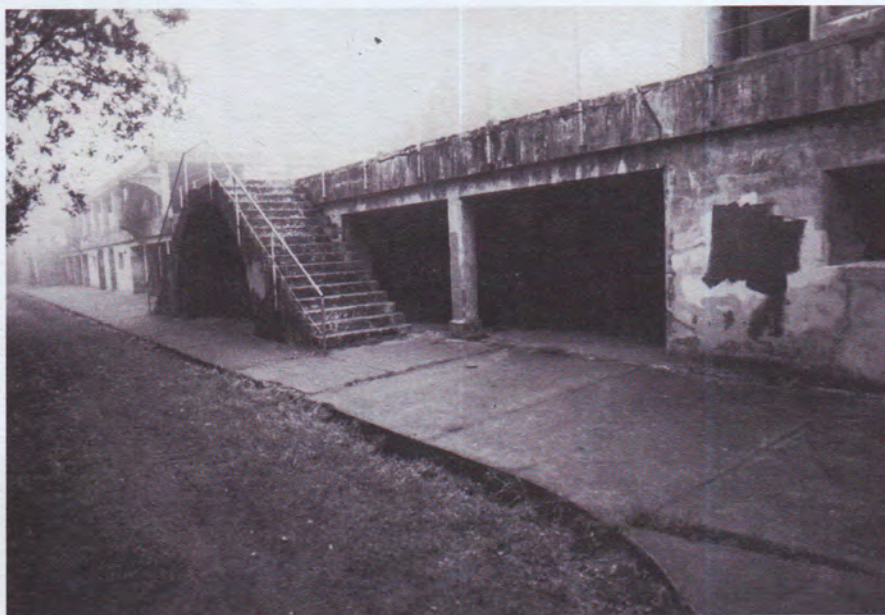
Battery Benson is one of four gun emplacements for the 10 inch disappearing rifles at the crest of Artillery Hill. Battery Benson is separated from Batteries Ash, Quarles and Randol by a parados.

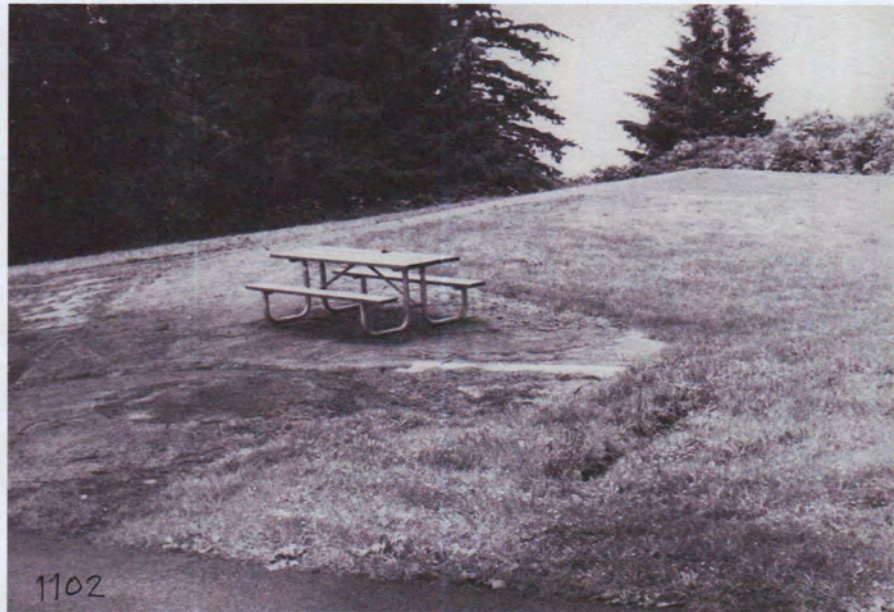
View of large recreational area atop Battery Ord #3. Ord #3 was buried with sand as fill material. The area is covered with grass.

The entombment of Battery Ord #3 was accomplished with the importation of sand to fill the gun emplacement platform and to fill in the area adjacent to the battery to form a smooth transition with the surrounding natural surfaces.

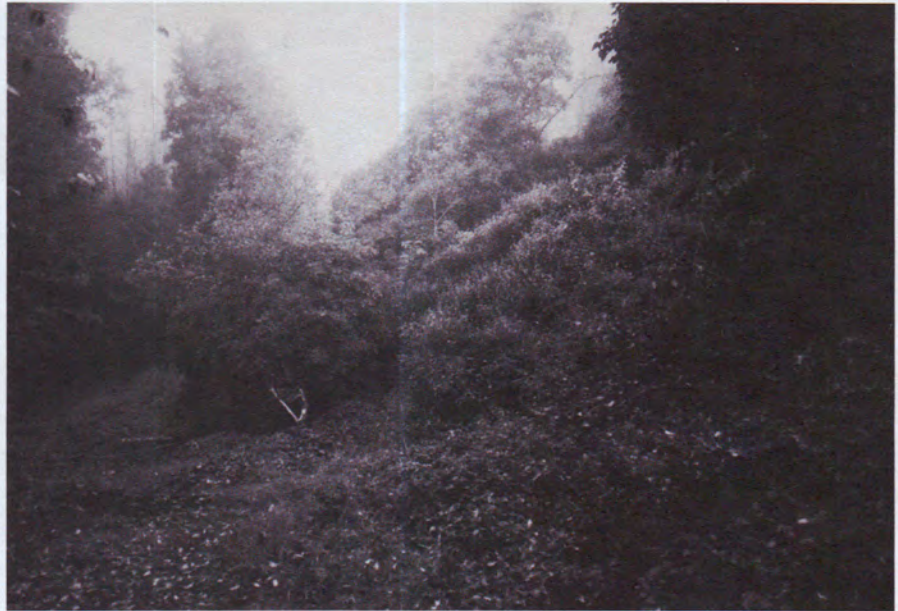
View of mound covering the Switchboard. Heavy growth of English Ivy covers the entrance to the corridor leading to the Switchboard.

The long-term conservation of the Switchboard can retain the existing earthen cover; however, the size and density of the vegetation has compromised the integrity of the water proofing qualities of the mound. The mound relies on its shape to direct rain water away from the structure. Numerous plants with their root systems have formed depressions and other irregularities in the mound's surface causing water to pond and drain into the Switchboard. The long-term conservation solution would be to remove the vegetation, re-construct the mound and add an additional waterproof membrane.

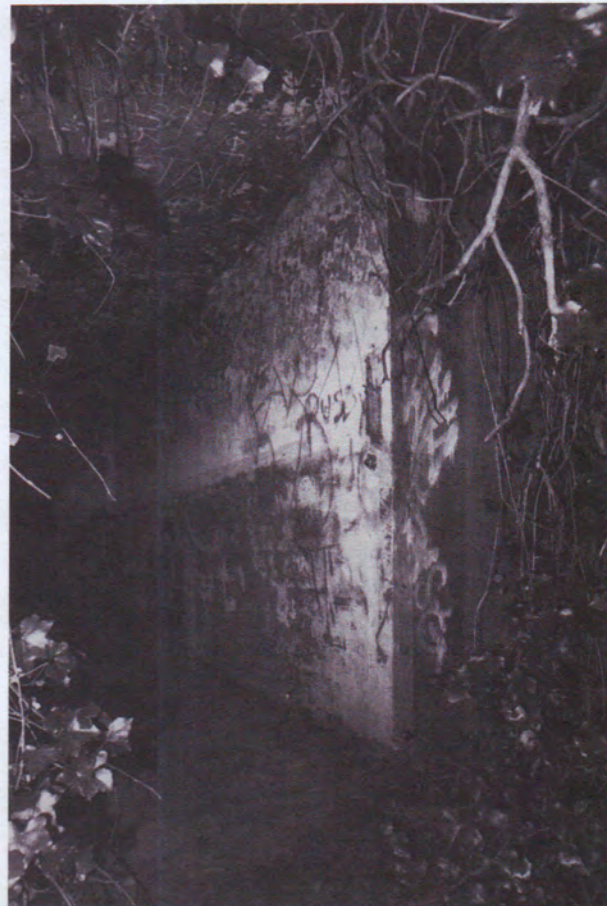
Unauthorized access to the interior of the Switchboard has been a major problem. Vandals have set fire to debris placed in the Switchboard. The single door providing access to the corridor and Switchboard room has been removed and no barriers prevent access. The entry to the Switchboard is overgrown with vegetation. The concept for controlling access includes the addition of a gate to be placed as close to the doorway as possible without making physical contact or promoting damage to the structure.
