## Saint Babs XXI, Harbor Defenses of Long Island Sound

Gary Paliwoda

*Wednesday, April 30, 2003*

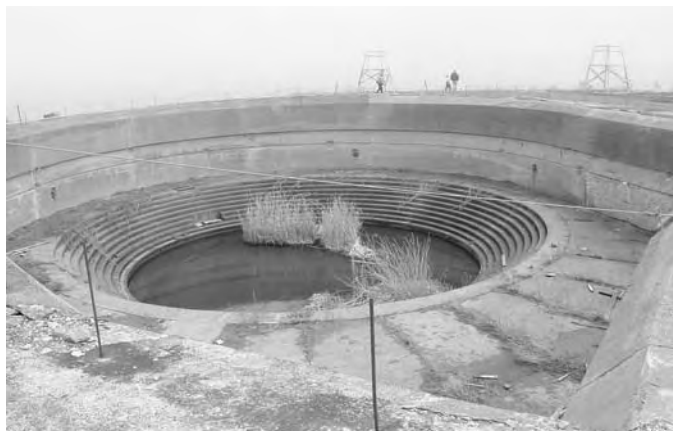
Battery J.M.K. Davis, Fort Michie (M Berhow)

The group then headed to Battery Davis, one 16-inch M1919 gun on the only M1917 disappearing carriage, and scattered throughout and over the battery. Some members climbed to the BC position and departed via the hatch in the ceiling. Walking down the slope of the BC station, one attendee broke his ankle, requiring a 911 call to Suffolk County Police for a medical evacuation. Minerals seeping through the wall and ceiling and covering the board have damaged the tool board visible in 1986. The battery was one of the few major American batteries with all-around-fire capability, and its circular pit was the largest in any

American work. Most of the pit remains in good shape, despite considerable spalling on the west wall of the pit, most exposed to the elements.

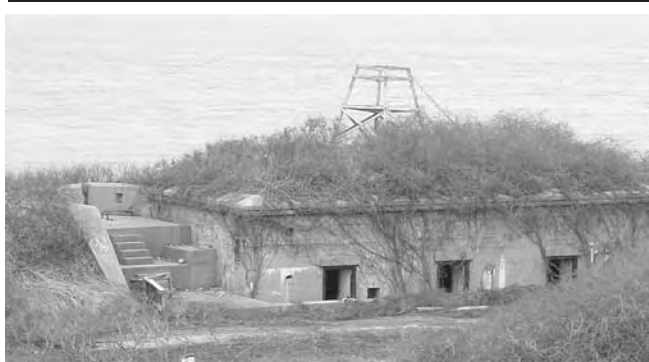
Battery Pasco, Fort Michie (M. Berhow)

Battery Pasco is to the west, two 3-inch guns on pedestal mounts. Just beyond Pasco on the way to the dock is the CRF station for Pasco, considerably worse for wear, very exposed on the north side of the island. Further west but still on the north side of the island is a considerable amount of debris and a number of cable galleries or sewer manholes with pipes sticking out of the concrete.

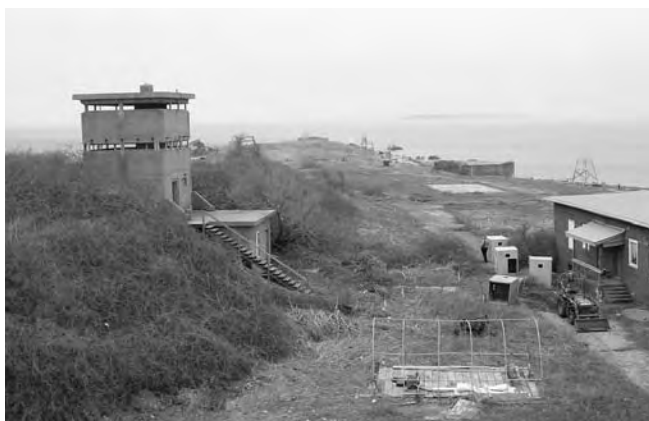
Fire control tower (originally M1/2), Fort Michie (M Berhow)

Through the tunnel, on the left is the tall tower behind Maitland, M1/2, later G3G4, and still later HEOP3/B3/5S3/5 BCN 217 R3 SS3. Despite the low clouds and fog, the tower provided good elevated all-around pictures of the island. Somewhat de-

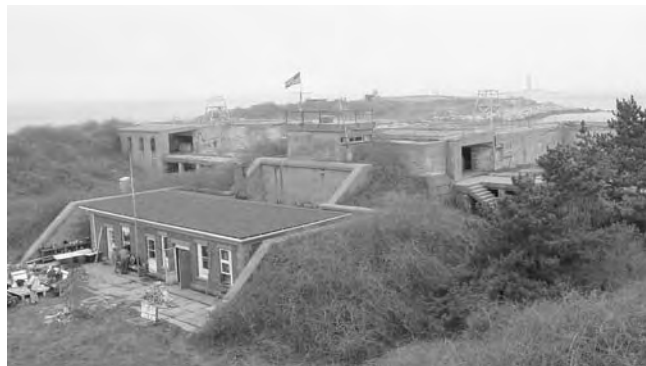
Mine casemate and Battery Palmer, Fort Michie (M. Berhow)

Battery Palmer, two 12-inch disappearing guns in the center of the island, was the final stop. The battery's platforms were extended, and the BC station at the rear of the center traverse now serves as Helen's summer home. It is probably the sturdiest BC station seen in this type of battery. The upper ends of the hoists have a concrete roof over the entire area to the rear of the traverse, due to vulnerability to fire from all sides. The No. 2 emplacement of the 3-inch AA battery was atop the left traverse, which allowed elevated pictures of Battery Pasco. The No. 1 AA emplacement is on the right traverse.

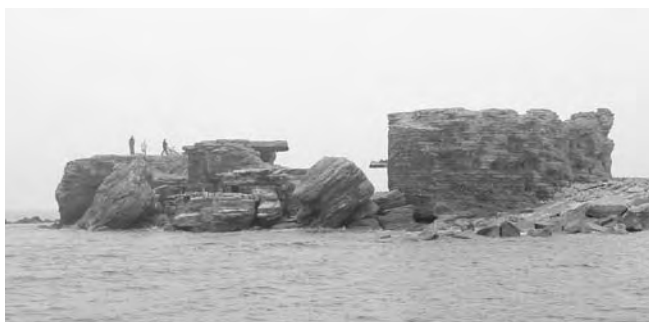
The ruins of Fort Tyler (M Berhow)

and rocks blocked the path, due to settling or the deposit of silt. About one quarter of the No. 2 gun block remains, with six bolts in place. The entire seaward concrete wall and front three quarters of the block no longer exist, broken up by the surf. The front wall of the center traverse, though still intact, has one large piece broken off, but less than a quarter of the mass that once existed. The rear portion of the center traverse remains intact so that one can discern its shape. The covering over the shell hoist remains, as does the hoist shaft.

At the No. 1 block, the front wall and front of the block is similar to that at No. 2, except some pieces do remain in the water at the magazine level. Standing atop the right traverse looking north along the front wall, one can view the interior of the magazine entrances, now opening to Long Island Sound in lieu of the magazines that once stood here. The crows nest remains, though partially collapsed. The battery has settled, and the loading platform level is now about five feet above the parade. Cutting across the parade and up the steps to 5-inch emplacement No. 2, no signs of the bolts were found, the area being covered with broken concrete from surrounding walls that have collapsed.

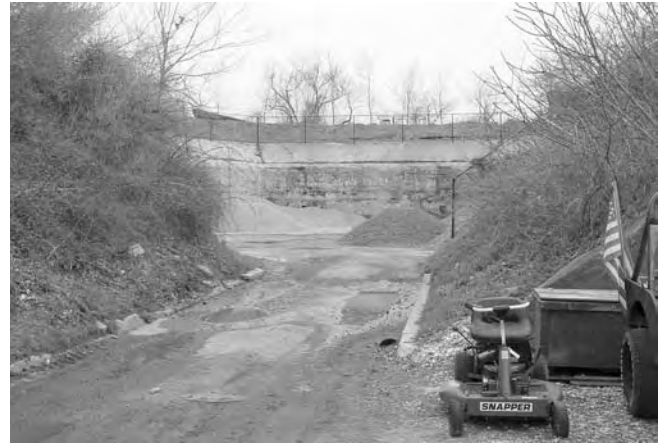
Battery Clinton, Fort H.G. Wright (M Berhow)

We stopped at the parapet for a look down into Battery Clinton's mortar pits, one of which is used to store aggregate. Further downhill are the pit entrance and access to the interior. The magazines have some items stored within but are fully acces-

sible. The A pit has been completely filled in with island debris and earth, some of which is coming into the magazines. To the west, the power plant is open for the first time in all of my visits here. An arched roof provided strength to cover what is today a workshop.

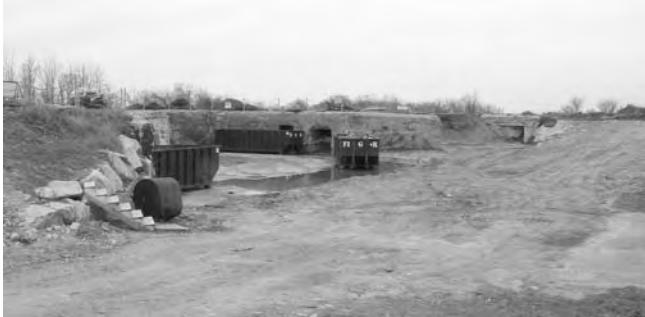
Battery Butterfield, Fort H.G. Wright (M Berhow)

To the north, Battery Butterfield, two 12-inch DC, is completely buried except for its parapet. The BC station stands behind the battery. Next in line is Battery Barlow, two 10-inch DC with a BC behind. Several of the group found a path down the hill to Batteries Hamilton and Hoffman. A CRF station for Battery Hoffman, two 3-inch guns, is off the north edge of Hamilton. Some members made it down to Hamilton. The group then took a path into Battery Hoffman from the beach. The battery remains in good shape but almost lost in the undergrowth.

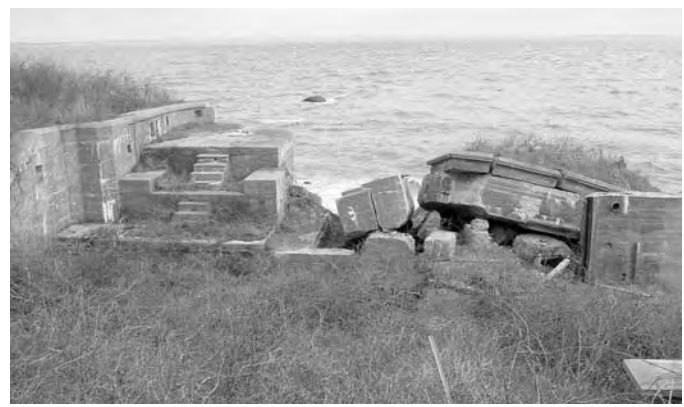
Battery Campbell, Fort Terry (M Berhow)

As we moved around the point to the southwest corner, we saw the remains of Battery Campbell, long undermined by the surf and broken apart. The No. 1 gun block is down in the surf, and the center traverse has collapsed into and in front of itself. The No. 2 gun block remains in place but from our position we could not determine how undermined it was.

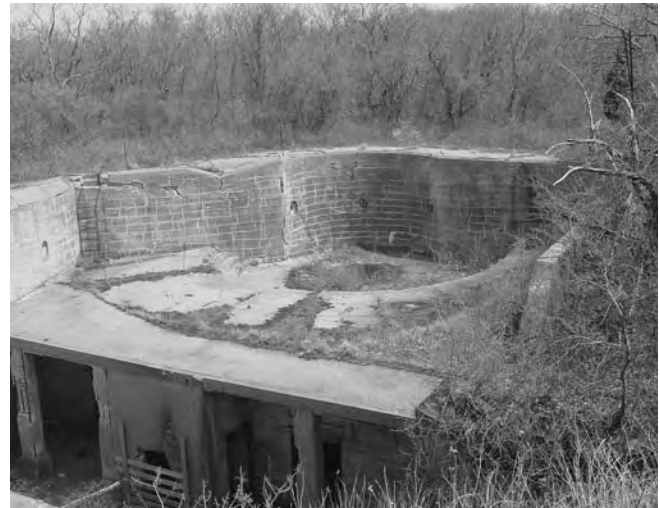
Battery Steele, Fort Terry (M Berhow)

10-inch battery. We walked into the battery past several animal loading pens and the transformer building of the SCR radar previously visited, which has been moved here after military use - its sides and roof remain intact. Down the path we arrived at the rear of emplacement No. 1. On the right a long staircase rose up to the right-flank crows nest. To the left of the staircase began the magazines for the No. 1 gun. Around to the left a staircase led down through the battery power plant to emplacement No. 2, much lower than No. 1.

Ascending the stairs to the No. 1 loading platform, we noted the steel and concrete overhang extending from the walls over the gun pit. The No. 1 gun was felt to need increased protection while the lower gun was not, due to the terrain. To protect them, the hoists are not in their usual position relative to the gun, but are at the end of an L-shaped corridor off the right front of the loading platform. This corridor begins under the overhang on the side of the pit, extends into the right traverse, and then turns right. The hoists are on the right side of this latter corridor. The hoists were originally balanced platform, and the Taylor-Raymond hoist is in one of the old shafts. In the left wall of the back part of the corridor are the remains of the cylindrical powder hoist. The remaining portion of this powder hoist can be seen below near the powder rooms. The ceiling of this corridor is reinforced with steel bar on the lower side for additional protection.

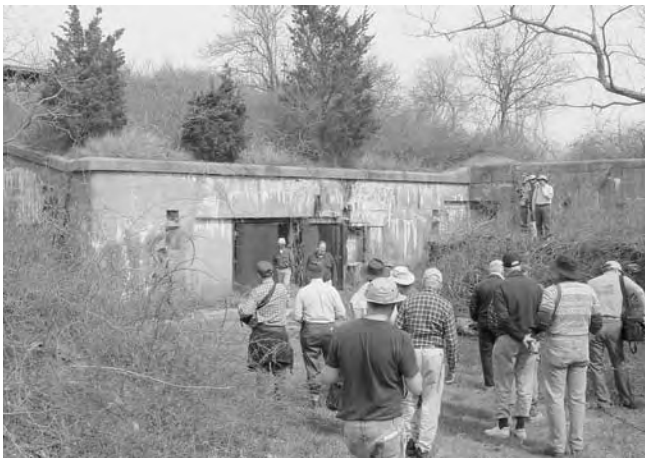
Battery Floyd, Fort Terry (M Berhow)

Turning north, the bus dropped us off at Battery Floyd, two 6-inch DC, with a BC station atop the rear of the traverse. Reasonably clean compared to others on the island, the No. 2 emplacement was roped off, with a nuclear-hazard sign. After a quick walk through the battery the group walked north to Battery Eldridge, two 3-inch pedestals, similar to the three-inch batteries on East Point, with the same shrine-style BC behind the

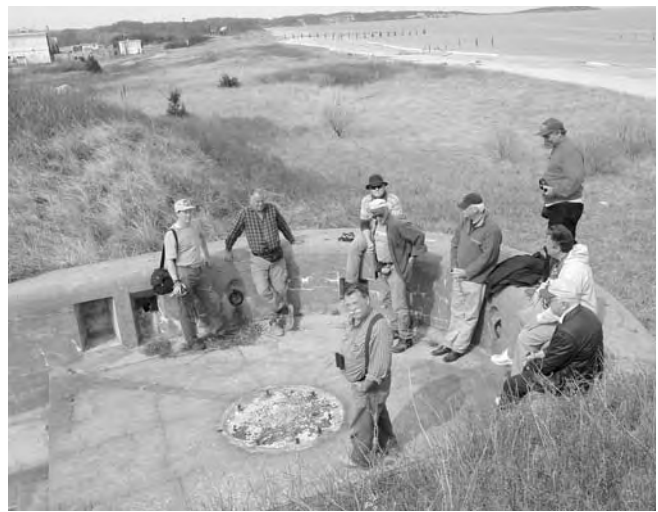
Battery Eldridge, Fort Terry (M Berhow)

battery. This battery is easily accessible, though a large portion of its earthen front parapet is gone. To the left of the battery is its CRF station, whose roof has now collapsed.

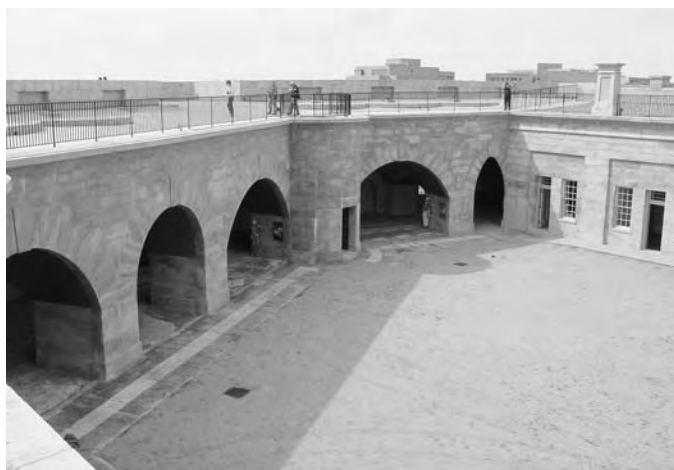
Sunday morning, Jon Lincoln, head ranger at Fort Trumbull State Park, led the group inside the visitors center for a short welcoming speech and then we headed to the second floor for the movie. Afterwards we toured the museum before entering the fort, where we marveled at the way the State of Connecticut had developed this fort as a tourist site. It was clean and looked much like a just-built fort. All 20<sup>th</sup> century structures have been removed, gravel covers the parade, the casemates have been cleaned and painted, and a replica gun, carriage and crew have been placed in one casemate. The rooms in the landward casemates have been restored to their original colors, though lacking furniture.

Upstairs, the parapet provided more wonderful views of the fort and the surrounding area. Outside the fort, North and South Batteries have been restored. South Battery contains two 10-inch smoothbore Rodman guns converted into 8-inch rifles. North Battery has one original and two rebuilt emplacements. Two more emplacements were outlined on the ground to show the layout.
